FINAL REPORT

In-flight Engine Fire Incident

**Northwest Airlines
Boeing 747-200F Registration N617US**

AIB/AAI/CAS.013

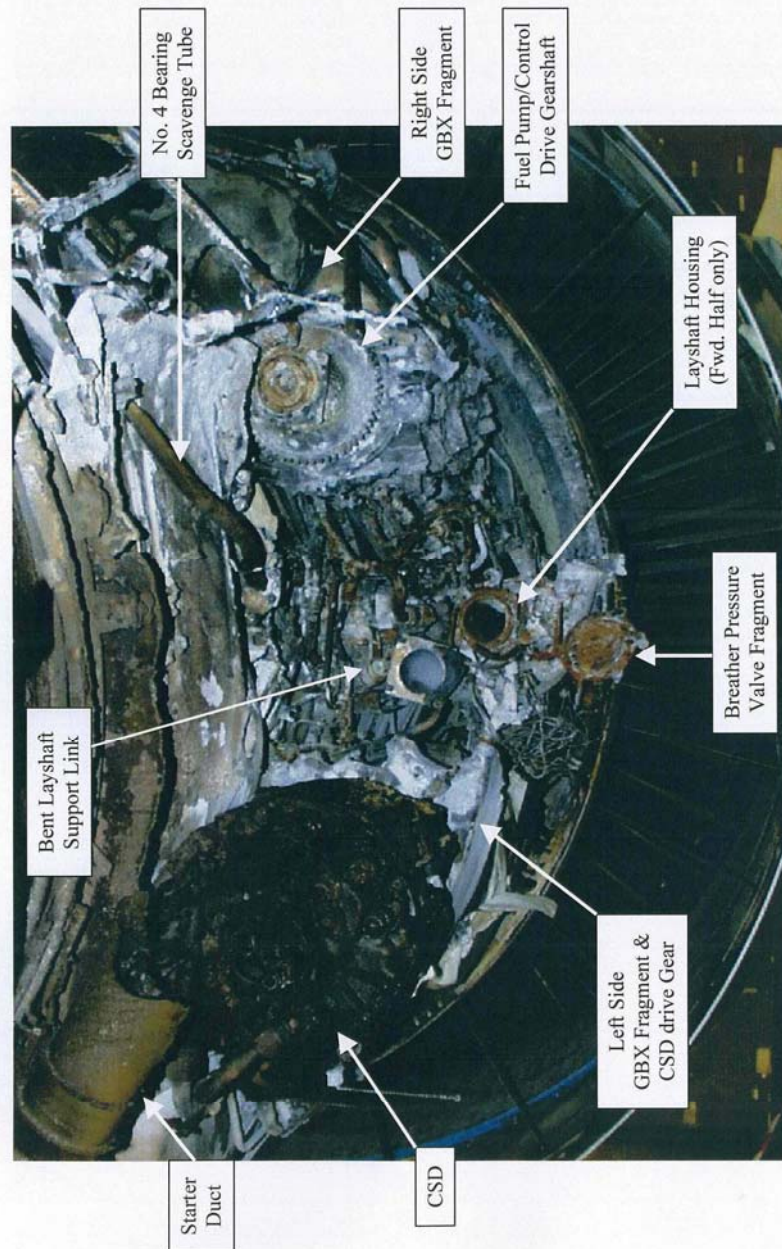
A substantial number of components were lost overboard and thus are unavailable for review (Figure1). The condition of the available hardware is discussed below in detail. In general, damage was concentrated around the centre of the main gearbox. Many components were covered with a white fire retardant residue (white deposits).

The layshaft housing consisted of two halves. The forward half was attached to the angle gearbox as shown in Figure 1. The aft half of the layshaft housing was bolted to the main gearbox housing, and was missing (either lost overboard or consumed by the fire).

The support link attached to the aft layshaft housing was not hanging vertically but tilted aft slightly and bent left by almost 90 degrees, as shown in Figure 1. The bolt and nut were present in the lower link bearing, but the layshaft housing lugs appeared to have been consumed by the fire (as was the entire aft layshaft housing). Examination of the link, lower bolt and nut did not reveal impact damage to explain the deformation, however there were impact marks on the layshaft that were similar in size and shape to the link nut.

Figure 1: - Photo from engine teardown (view is aft looking forward)
 Showing the general condition of the gearbox area during engine teardown. Note that the layshaft and starter drive gear were removed prior to this photo; these shafts were found hanging out of the layshaft housing.

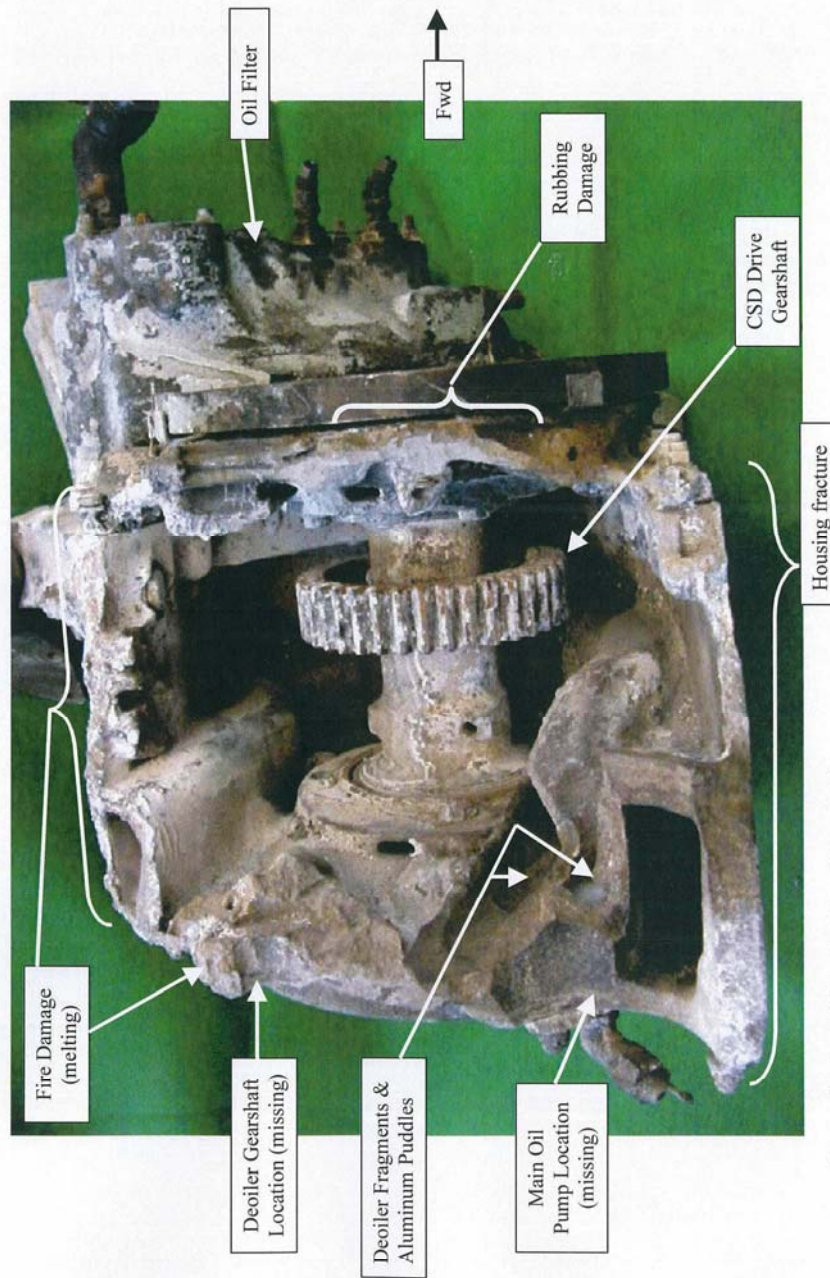
Figure 2: - Left Side Gearbox Fragment

The exposed edges of the left side gearbox fragment exhibited areas of melted and re-solidified metal consistent with fire damage, as shown in Figure 2, as well as areas of cracking. In particular, melting and damage from the magnesium fire was typically found along the upper areas of the housing and cover, while bottom areas exhibited fracture surfaces suggestive of cracking or rubbed surfaces suggestive of wear damage. The oil passages cast into this housing that were associated with the missing oil pump were still oil wetted and contained areas of black deposits (probably oil coke). The left side gearbox housing also had the oil filter housing still attached (the oil tank had been removed), which was intact and undamaged.

Showing the condition of the left gearbox fragment. Note that the deoiler gearshaft and main oil pump were not recovered. The visual examination found fire damage was more prevalent near the top, while cracking was more prevalent near the bottom.

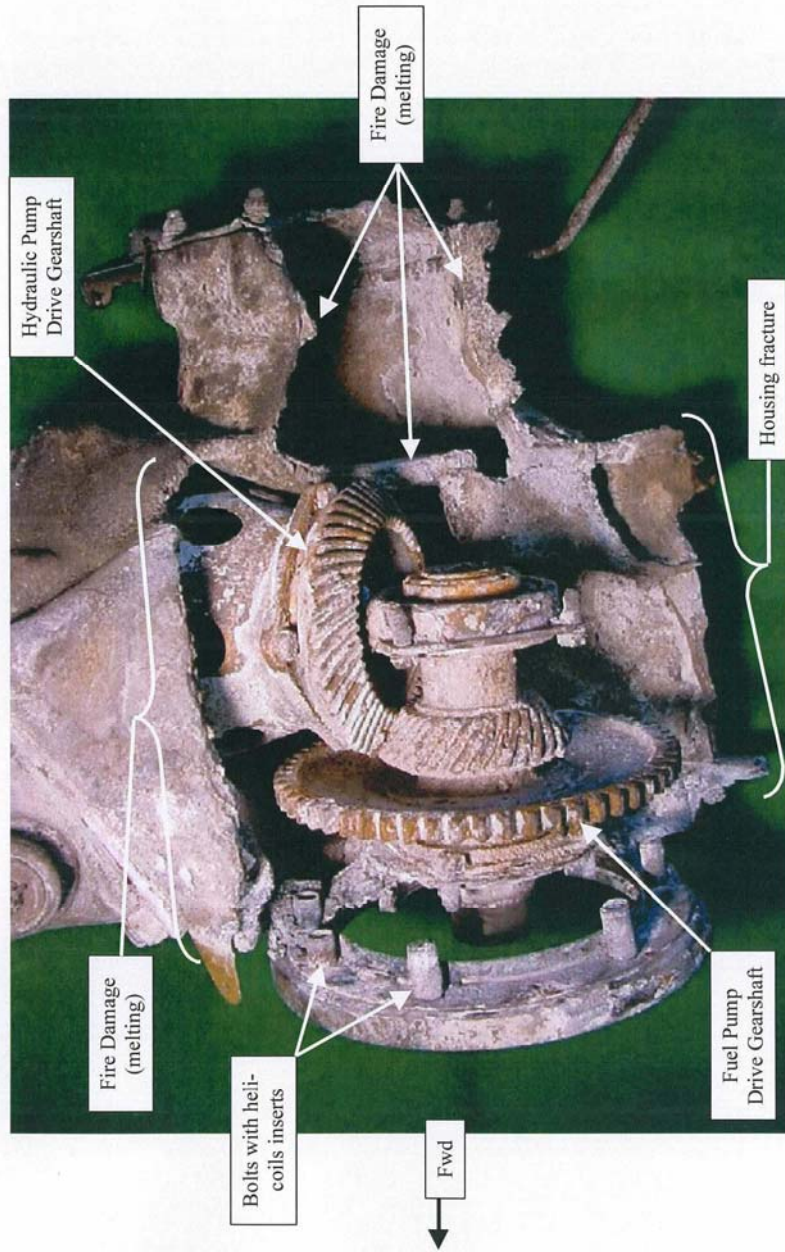
The exposed edges of the right side exhibited areas of melted and re-solidified metal consistent with fire damage as well as cracking, as shown in Figure 3. Similar to the other gearbox housing fragment, fire damage (melting) was typically found along the upper areas of the housing and cover, while the bottom areas exhibited fracture surfaces suggestive of cracking, as shown in Figure 4.

The fuel pump drive gear shaft was found contained within the right side gearbox housing fragment, as shown in Figure 3. The gearshaft was intact and except for a coating of external deposits from the fire appeared undamaged. The gearshaft was subsequently disassembled from the gearbox housing and cleaned to remove these deposits. The gearshaft was fully disassembled including removal of the roller and ball bearings. The bearing cages (both ball and roller) still exhibited a layer of silver plate. Looking at visible areas of the balls and rollers, these bearings appeared to be in good shape. The forward carbon seal and seal face areas were intact and did not exhibit damage. Visual and binocular examination of the gear teeth after cleaning did not find unusual contact patterns.

Figure 3: - Right Side Gearbox Fragment
 Showing the condition of the right side gearbox fragment. The visual examination found fire damage was more prevalent near the top, while cracking was more prevalent near the bottom. Note how steel components, gears & bolts, etc, were not melted.

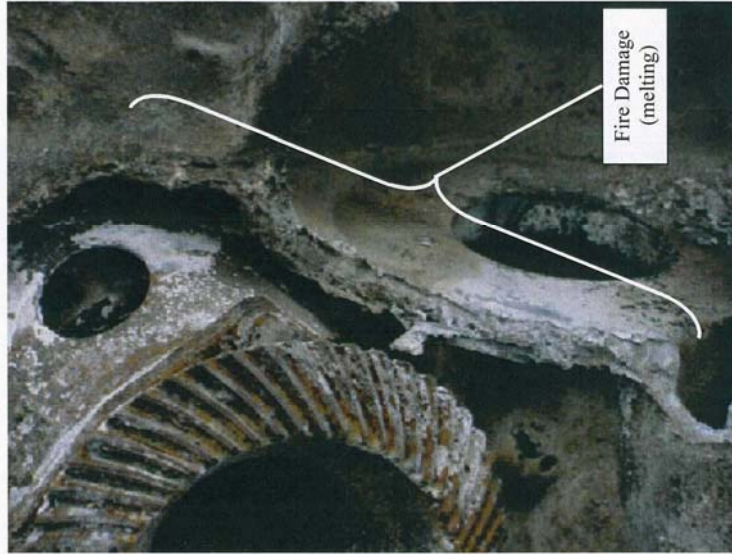
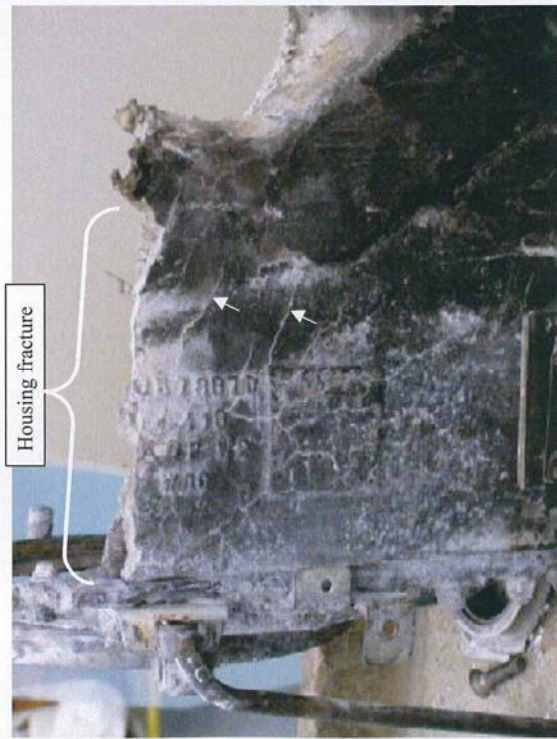
Figure 4: - Right Side Gearbox Fragment
Showing additional views of the different types of damage visible along the right side gearbox housing fragment.

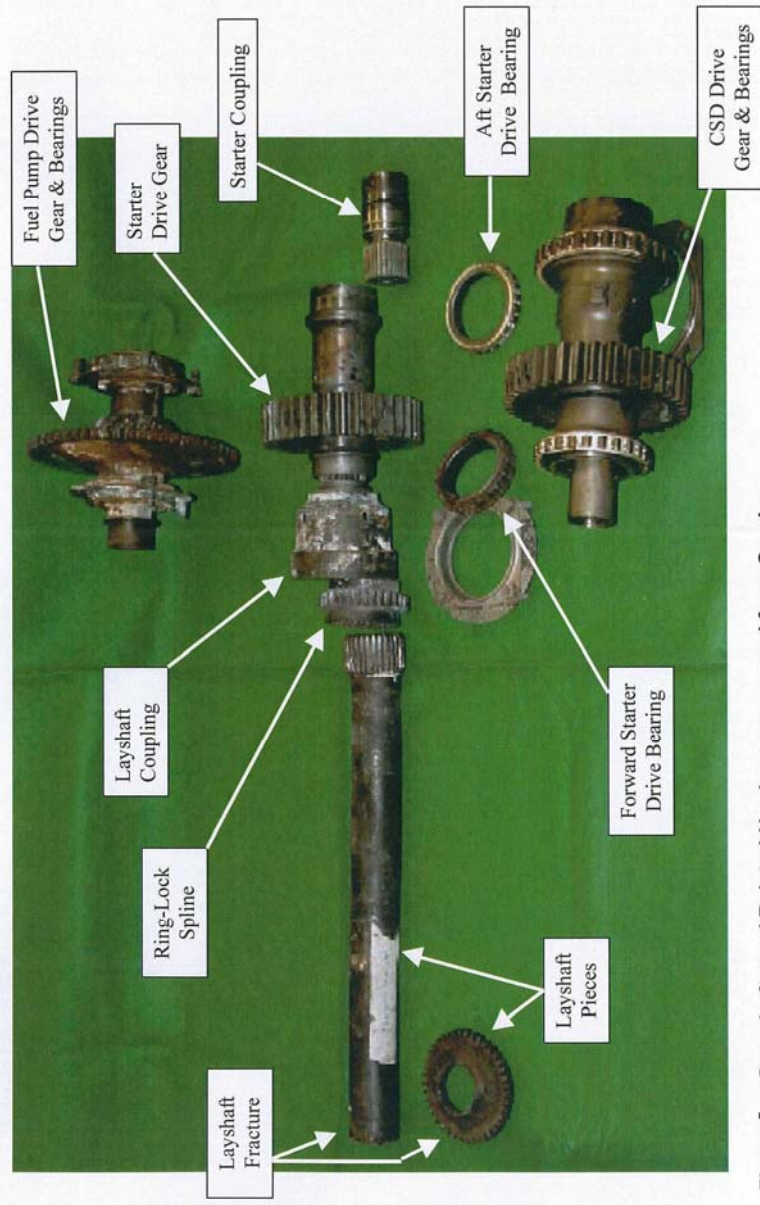
This shaft was fractured adjacent to the forward spline, as shown in Figure 5. The fracture surface exhibited necking consistent with an overstress mode of fracture. The shaft was also bent, with more pronounced bending along the aft end near aft spline. There were also splinelike indentations along the outside of shaft adjacent to aft spline, as shown in Figure 6, suggesting this shaft had shifted axially out of mesh at some time during the fire event and rode on the inside surface of the Ring-Lock Spline. Areas of impact damage and scoring were found along the middle of the horizontal drive shaft. The scoring damage was circumferential and appeared to be in the area of the slip joint in the layshaft housing. Also an indentation was found along the shaft exterior surface that matched the shape of the castellated nut attached to the bolt in the lower bearing of the layshaft link (Figure 7).

Figure 5: - Gears shafts and Related Hardware recovered from Gearbox
 Showing the layshaft, starter drive gear, fuel pump drive gear, CSD drive gear, fuel pump drive gear and associated couplings and bearings, after these components had undergone the cleaning treatment to remove deposits from the fire.

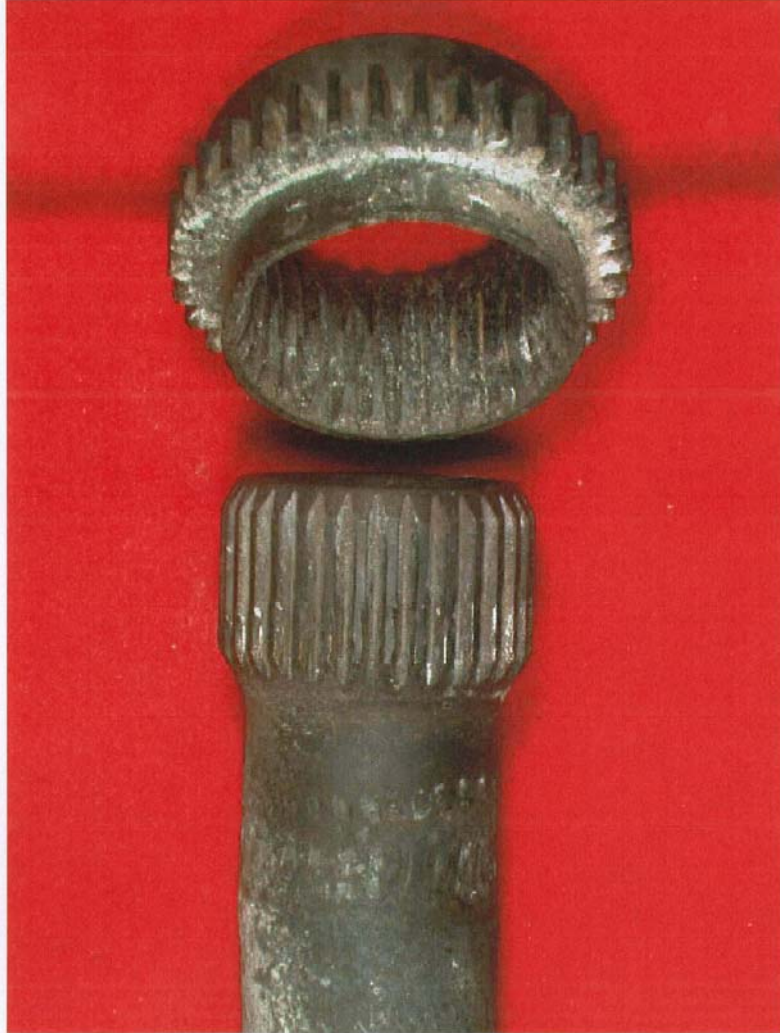
Figure 6 : - Layshaft and Ring-Lock Spline
Showing spline impressions on the layshaft indicating it had come out of mesh with the Ring-Lock Spline.

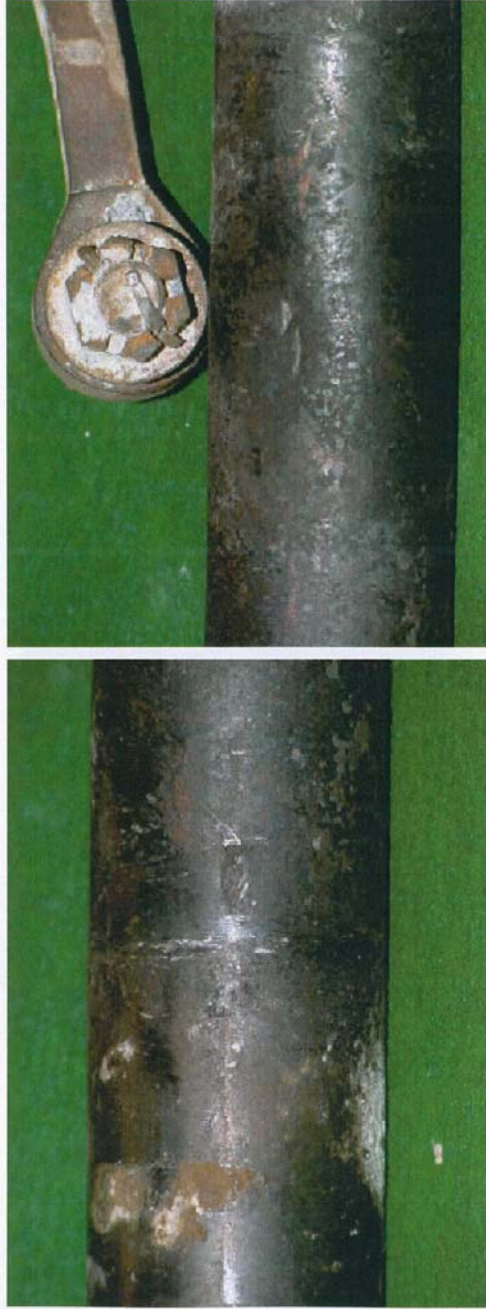
Figure 7 : - Layshaft and Layshaft Housing Support Link
Showing circumferential scoring damage along the layshaft (left) and (right) one of several indentations in the layshaft OD that was similar to the castellated nut on the nearby support link.

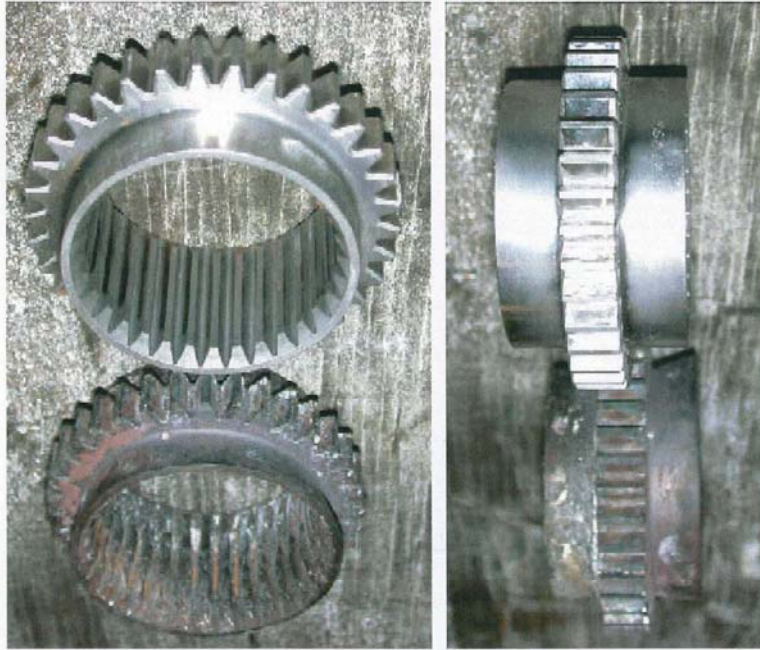
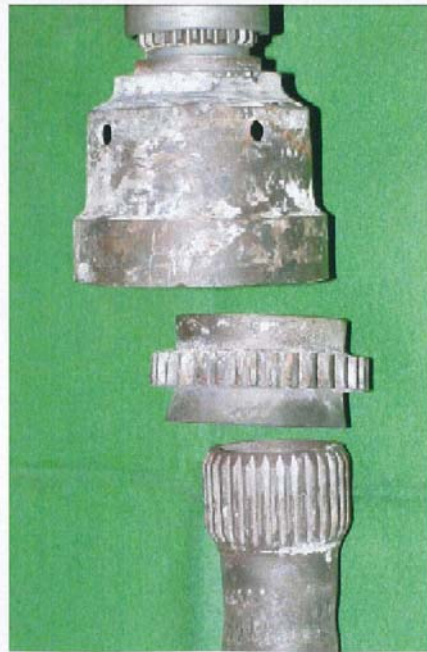
This ring contained a spline on both its inside surface and outside surface and is assembled between the layshaft and the layshaft coupling (Figure 5). This ring was heavily and uniformly deformed around its circumference (Figure 8), indicating it had experienced an unusual radial load or displacement while it was still rotating. The aft end of the inside spline exhibited damage attributed to clashing with the layshaft spline after these two components were disengaged.

Figure 8 – Ring-Lock Spline
Showing the condition of the ring lock spline, which was deformed uniformly around its circumference (shown at right compared to a new spline).

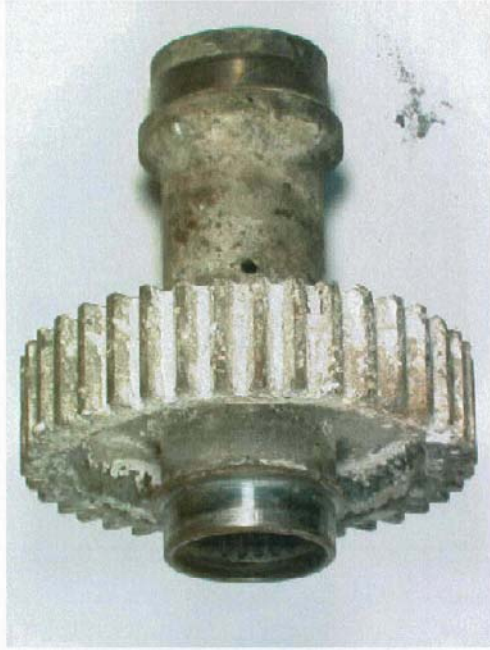
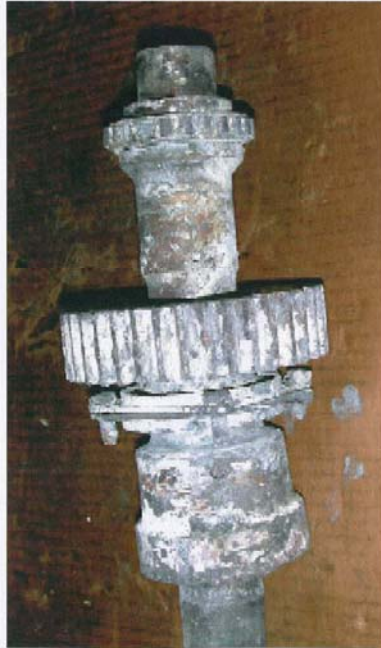
This gearshaft was covered with a layer of white deposits, as shown in Figure 9 which was presumed to be from the fire. Visual examination of the gearshaft after cleaning revealed both axial and circumferential scoring along the aft bore (Figure 10). This was the bore where the starter coupling was installed. Visual examination of the gear teeth revealed impact damage, nicks and dents, as well as faint gear contact patterns, as shown in Figure 11. The impact damage to the gear teeth was also smeared, which suggested that much of this impact damage had occurred while the gear was still rotating. Visual examination along the aft end of the shaft, where the aft carbon seal would run, revealed that surface appeared normal. The associated carbon seal was not recovered.

Figure 9 : - Starter Drive Gear
Showing the condition of the gear during engine teardown (left) and (right) after disassembly.

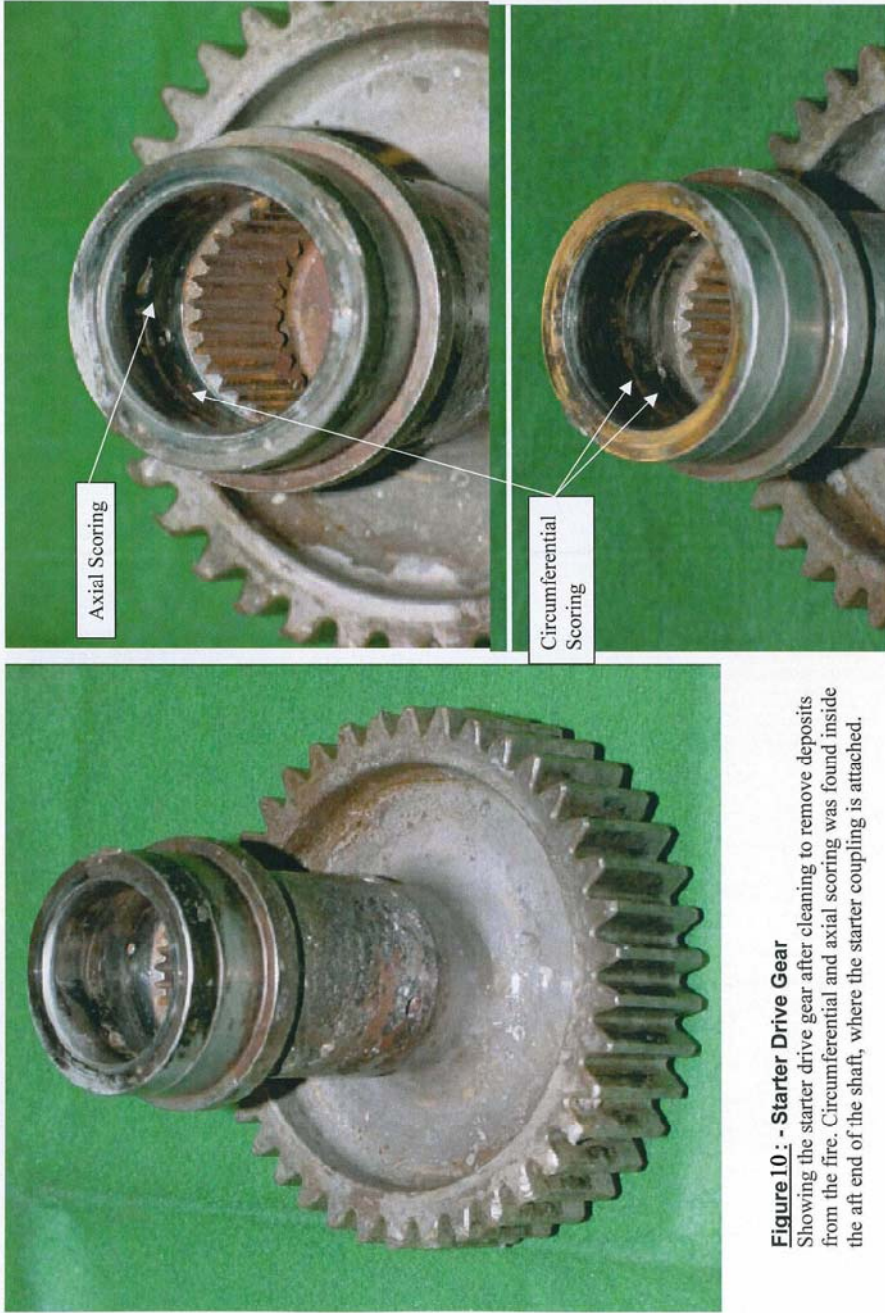
Figure 10: - Starter Drive Gear
Showing the starter drive gear after cleaning to remove deposits from the fire. Circumferential and axial scoring was found inside the aft end of the shaft, where the starter coupling is attached.

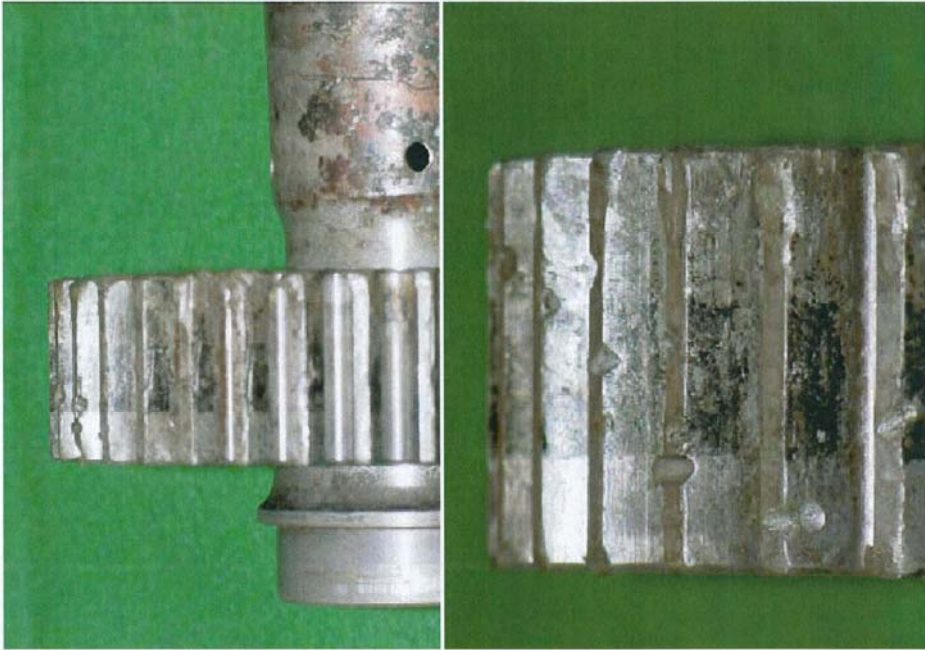
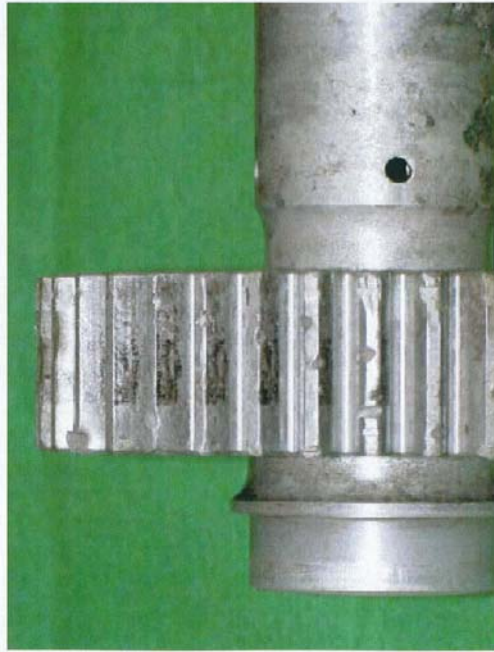
Figure 11: - Starter Drive Gear
Showing contact patterns and smeared impact damage along the gear teeth of the starter drive gear.

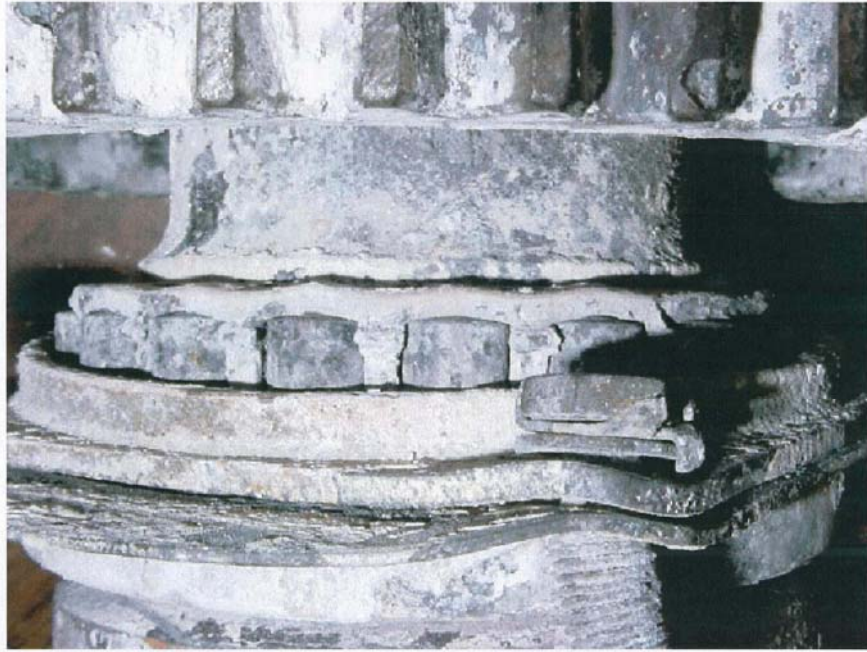
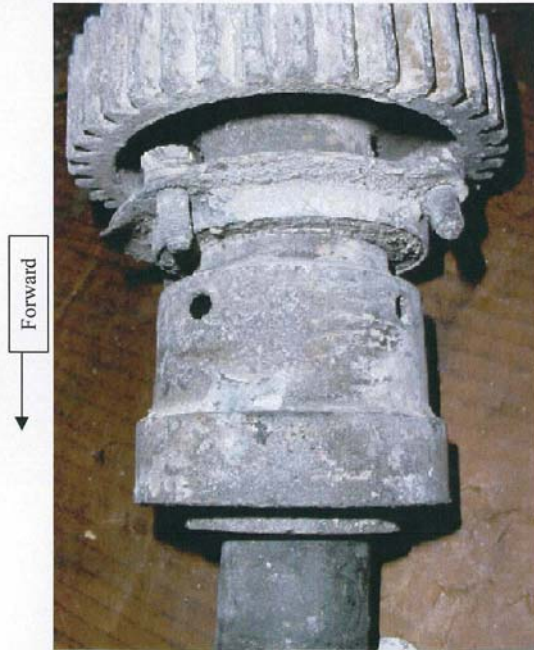
The forward starter drive roller bearing was covered with white deposits, as shown in Figure 12, presumed to be from the fire. After cleaning to remove these deposits, it was found that there was no silver plate left on the cage and the cage was deformed. The rollers exhibited heavy end wear, while both the inner and outer races were deformed, as shown in Figure 13. Otherwise, the radial bearing surfaces of both the inner and outer races were not cracked or spalled. Further destructive examination of the forward bearing inner race revealed hardness values that ranged from 22 to 24.5 HRC (converted Vickers), compared to the minimum hardness of HRC 58 specified by the part specification indicating that substantial softening had occurred as a result of the fire.

Figure 12: - Forward Starter Drive Bearing
Showing the condition of the bearing during engine
teardown. Note the cage is deformed at each roller.

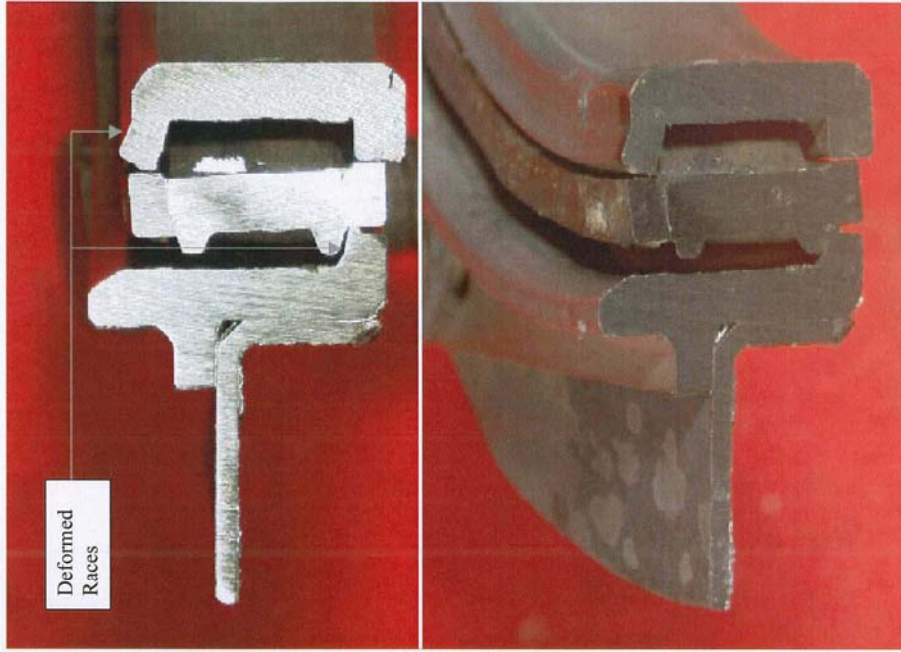
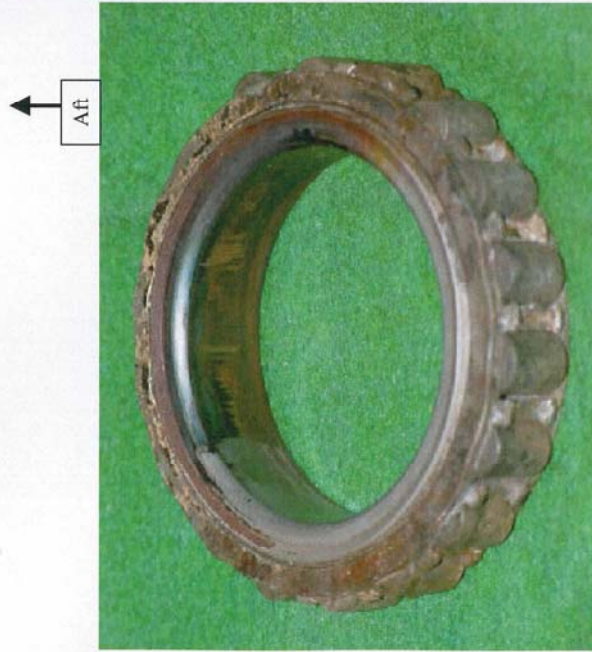
Figure 13 – Forward Starter Drive Bearing
 Showing the condition of the bearing after cleaning.
 Note the deformed areas of the inner and outer races.

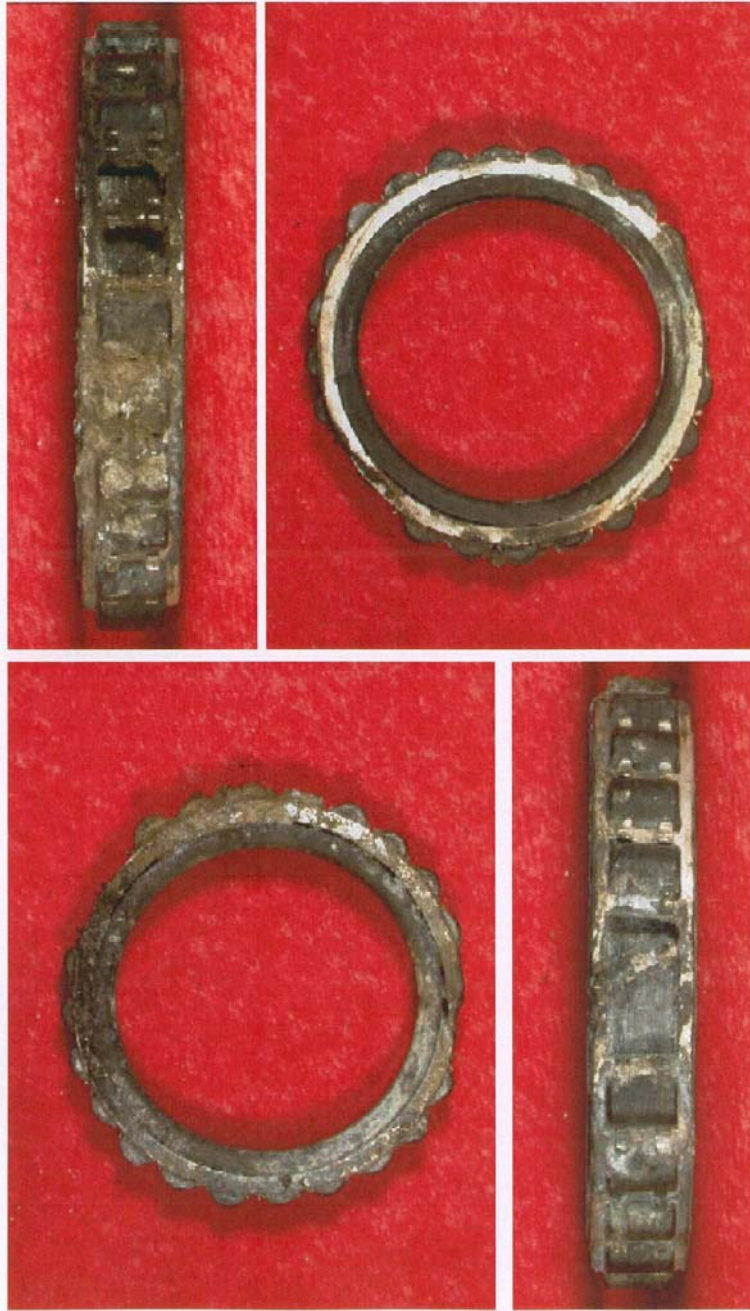
The aft starter drive roller bearing had only a light covering of the white deposits. Overall the cage appeared to be in good shape including the silver plate, except for several areas of impact damage which had dislodged several rollers and distorted and locally overstressed the cage, as shown in Figure 14. The rollers were intact. The inner race was intact. The outer race was missing and presumed to be lost overboard during the fire. There was no sign of prior distress on available hardware. Further destructive examination of the aft bearing inner race revealed hardness values that ranged from 40 to 49 HRC (converted Vickers), compared to the range of 58 to 62 HRC specified by the part specifications.

Figure 14: - Rear Starter Drive Bearing
Showing the condition of the bearing, which exhibited heavy impact damage.

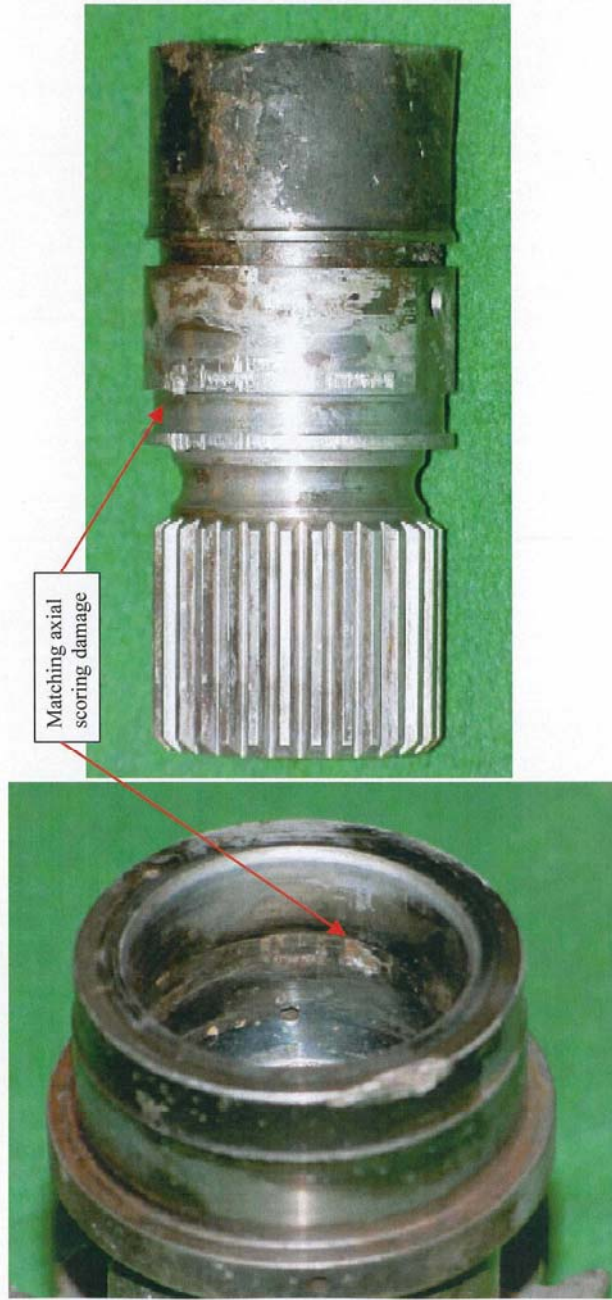
The starter coupling was found to be frozen inside the starter drive gear, and had to be forcibly removed during teardown. The outside surface of the coupling exhibited areas of deep axial scoring, suggesting an interference with the starter drive gear, as shown in Figures 15. Further examination of the layshaft coupling suggested the starter coupling had not been fully seated into the starter drive gear, as shown in Figure 16. The pattern of this damage suggested the starter coupling had been at

Figure 15: - Starter Coupling
Showing matching areas of axial scoring damage on the starter coupling as well as inside the starter drive gear. This damage suggested the coupling was not fully seated inside the starter drive gear. See also Figure 21.

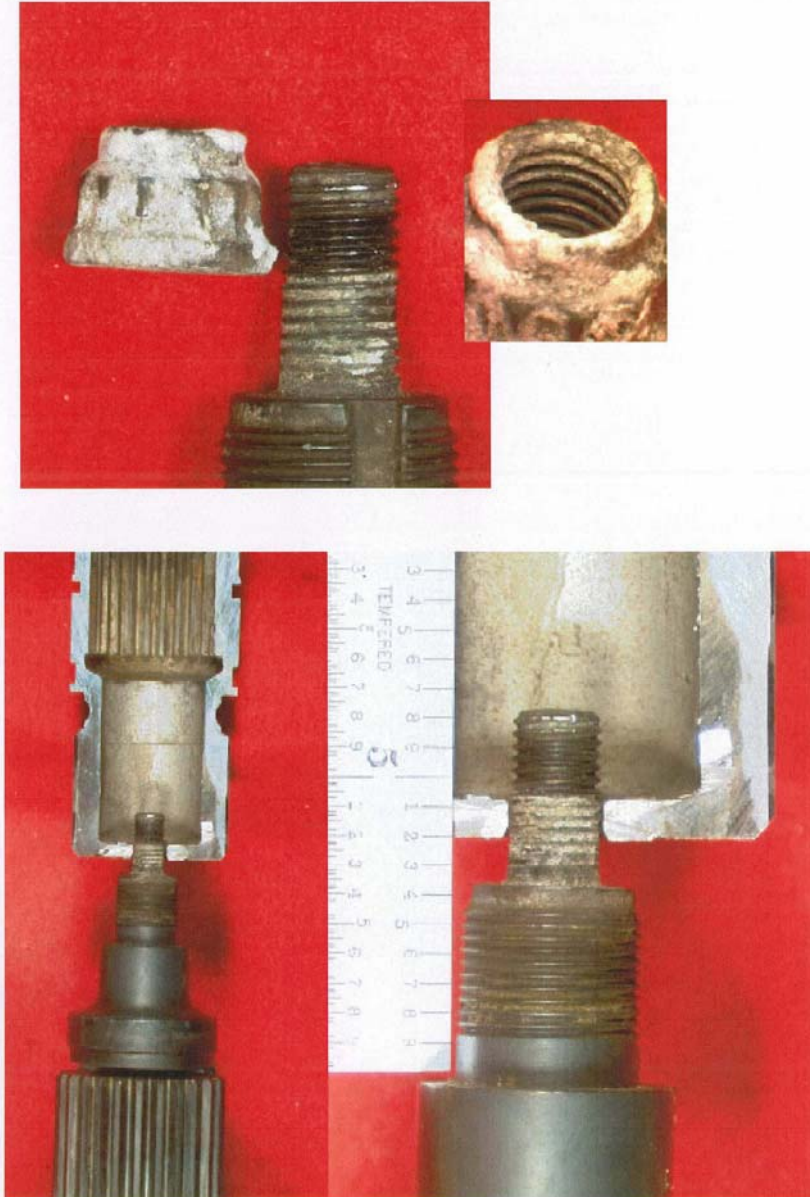
Further visual examination of the starter coupling did not reveal unusual contact patterns along the outside spline. However, forward of the inside spline, a circumferential contact pattern was observed. Visual examination of the outside spline did not reveal evidence of unusual contact patterns. Finally, the aft end of the coupling exhibited impact damage, similar to that of the aft starter drive roller bearing. The nut used to assemble the starter coupling to the starter drive gear was found to have white deposits on the threads at the aft end of the nut confirming the coupling was not fully seated into the starter drive gear.

Figure 16: - Starter Coupling
Showing deposits along the threaded end of the layshaft coupling, which suggested the starter coupling was not fully seated inside the starter drive gear and was too far aft by more than 0.1”.

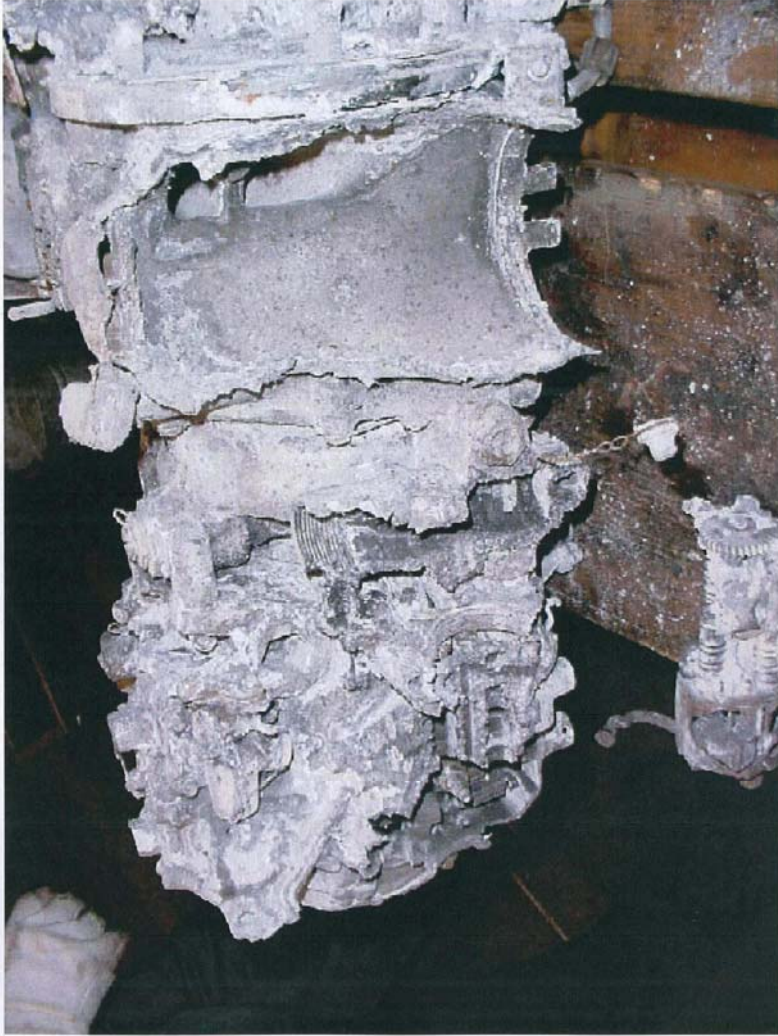
Extensive fire damage was noted to the left side of both pump and control modules, i.e. the side facing the layshaft housing, as shown in Figure 17. The exposed surfaces of these cast aluminium housings exhibited localized melting and areas of re-solidified metal due to the

heat of the fire. Comparing the extent of the fire damage, the fuel control had experienced much more damage to its housing than the adjacent fuel pump. The fuel control exhibited extensive melting of the housing on its left and forward (i.e. dome) sides exposing the upper linkage bracket assembly, thus exposing the insides of the control. The fuel outlet boss, which mated to the fuel out manifold, was fractured, although part of the fracture surface was fresh. This area was not fractured on the engine, but had a large crack, which could have spilled a considerable amount of fuel into this area during the course of the fire.

Figure 17: - Fuel Control and Fuel Pump
Showing the condition of these units at engine teardown. These housings exhibited numerous areas of localized melting, which had resulted in the severe distress to these units.

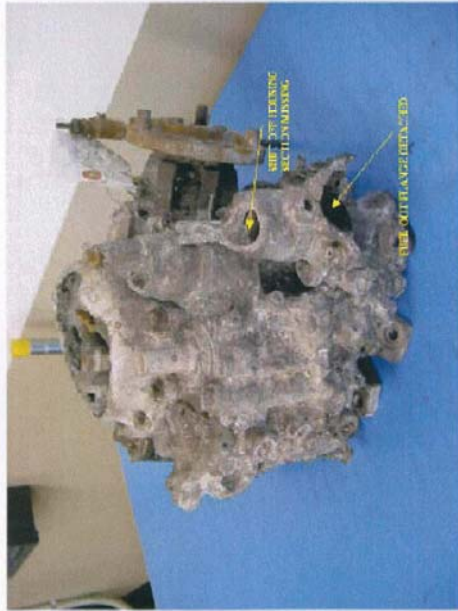
Figure 18: - Fuel Control at Hamilton Sundstrand

Figure 18 shows the condition of the fuel control parts. The speed servo cam was visible through the missing section of the main cover, and the position of the cam was measured in its final position. It was determined that the cam was at 0.565 inch from a 0-speed reference point, thus from design curves it was determined that the control was operating at approximately 3870 RPM control speed. This correlates to idle speed on the JT9D-7 engine indicating the fuel control did not freeze at a high fuel flow during the flameout event.

NWA GEARBOX FIRE INCIDENT
 JFC68-3 SHOWING SHUT OFF VALVE HOUSING FUEL CUT FLANGE MISSING

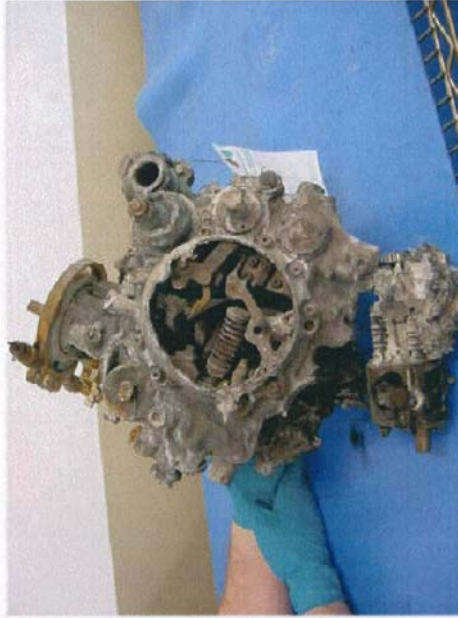
NWA GEARBOX FIRE INCIDENT
 JFC68-3 SHOWING MAIN COVER DOME MISSING

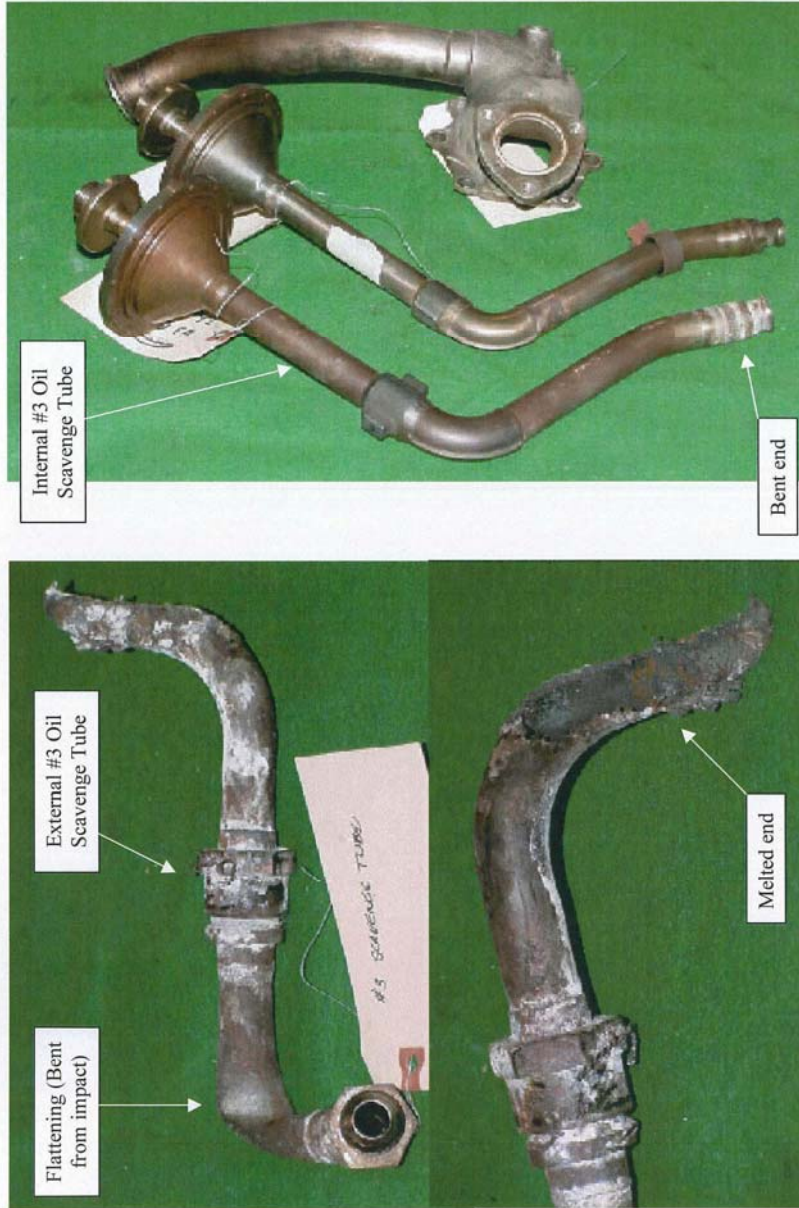
The No. 3 bearing scavenge tube was melted at the gearbox end, and about half of the tube was missing, as shown in Figure 19. This tube connected to the scavenge pump on the front of the gearbox at a boss to the right of the layshaft housing. At the diffuser case end, the external No.3 scavenge tube was bent suggesting it had taken an impact. Included in the hardware was the mating internal No.3 scavenge tube, which was bent and deformed at its outboard end, further evidence of a substantial impact.

Figure 19: - Internal and external #3 Oil scavenger tubes showing distortion due to impact along both the internal and external #3 scavenger tubes. The external tube was also partially melted away.
