FINAL REPORT

**GROUND COLLISION BETWEEN
A PIPER PA28 AIRCRAFT, REGISTRATION 9V-BOE
AND A VAN
IN SELETAR AIRPORT, SINGAPORE
ON 23 MARCH 2006**

AIB/AAI/CAS.032

**Air Accident Investigation Bureau of Singapore
Ministry of Transport
Singapore**

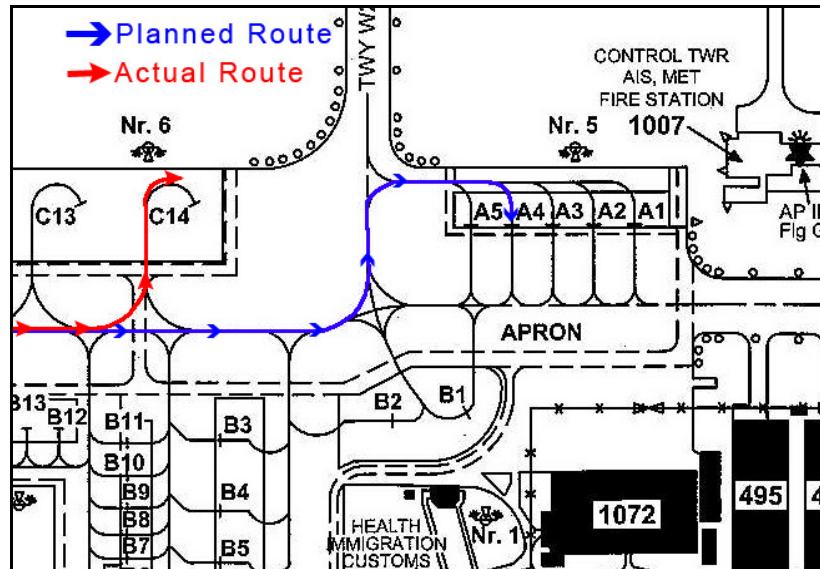
- 1.1.7 After turning off from Taxiway W1 and into the main taxiway in the apron area, the student pilot's intention was to taxi to Taxiway W2 and then to Bay A4. The student pilot stated in his subsequent interview with the investigation team that, while proceeding southwards on the main taxiway in the apron area, he became disoriented and mistook the taxiway line leading to Bay C14 as the line leading to Taxiway W2 and turned left prematurely into Bay C14. Figure 1 shows the path that the student pilot intended to take and the path actually taken.

Figure 1. Taxi path taken by the student pilot

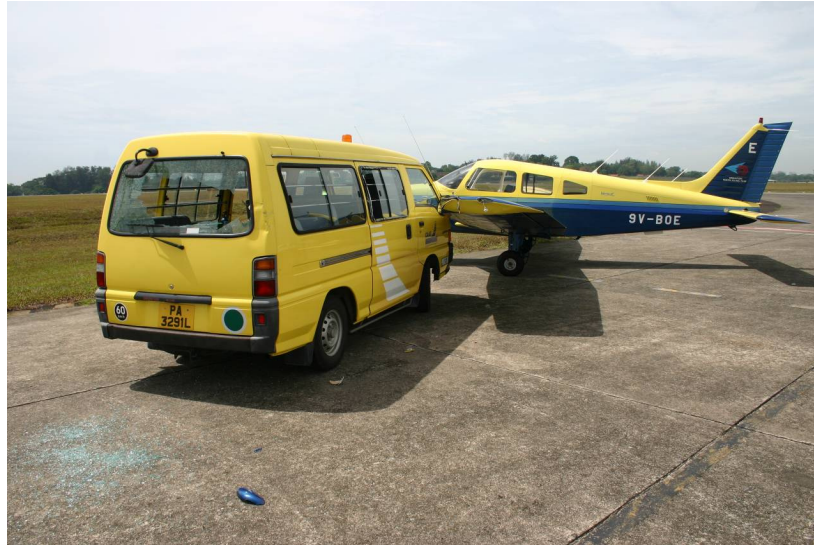
- 1.1.9 The student pilot assessed that he would comfortably avoid collision with the van while taxiing behind the Learjet. He focused his attention solely to his right side to keep clear of the Learjet and did not look at his left side. Just when he had cleared the Learjet, he heard a loud 'bang' and felt the aircraft swerve to the left. He immediately applied brakes and stopped the aircraft. The van's driver had seen the approaching aircraft in his rear-view mirror, and attempted to move the van out of the way, but he had insufficient time to do so. The collision occurred at about 1023 hrs. Figure 2 shows the aircraft and the van after the collision.

Figure 2. Position of the aircraft and the van after the collision

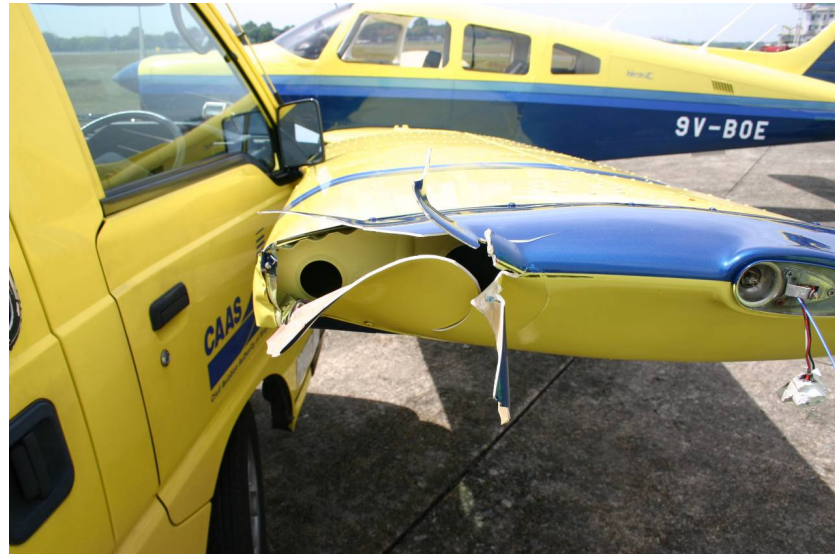
- 1.2 **Injuries to persons**
- Nil.
- 1.3 **Damage to aircraft**
- 1.3.1 The port wing tip and the associated navigation lights were damaged. The leading edge of the port wing suffered skin damage. The aircraft did not sustain any structural damage. See Figure 3.

Figure 3. Damage to the aircraft
