FINAL REPORT

BOEING 777-300, REGISTRATION 9V-SYH TURBULENCE ENCOUNTER 17 OCTOBER 2011

AIB/AAI/CAS.078

**Air Accident Investigation Bureau of Singapore
Ministry of Transport
Singapore**

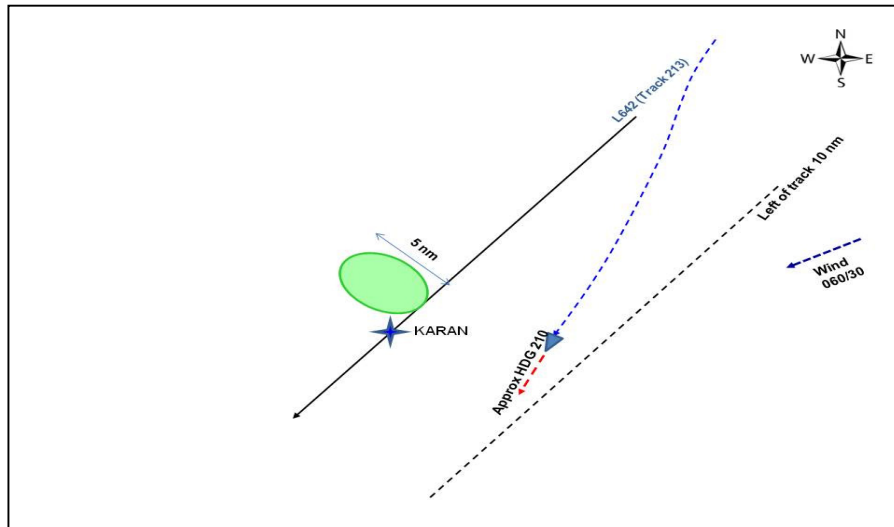
Figure 1: Illustration of flight path (not to scale)

- 1.1.3 About 3 hours into the flight, the aircraft was cruising at 35,000 ft about 80 nm from waypoint KARAN. The aircraft was on autopilot flying along the airway L642, and the antenna tilt control of the weather radar was in the automatic mode. The PIC's and SFO's Navigational Display (ND) was set at a range of 160 nm and 80 nm respectively². The SFO noticed a green dot on his ND, which suggested a weather cell ahead³. The weather cell was about 5 nm in diameter and the track of the aircraft would pass by the left edge of the cell (**Figure 1**).

- 1.1.5 Two and a half minutes later, the SFO selected a heading and turned the aircraft back to a track that was parallel with the original track. From the ND, the SFO estimated that the deviation was 5 to 7 nm to the left of the original track. From the GPS coordinates recorded in the Flight Data Recorder (FDR), the deviation track was deduced to be 4.5 nm left of the original track.

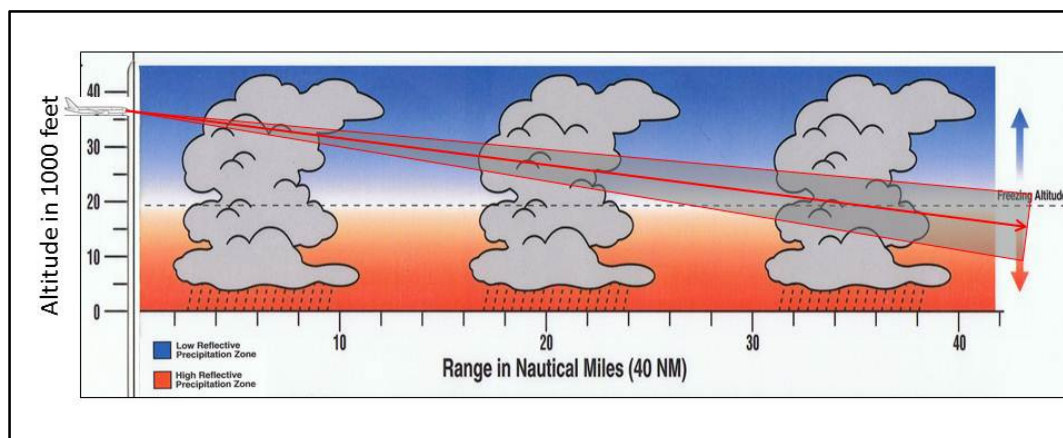
Figure 2: Illustration of antenna tilt angle and reflective zone of precipitation

- 1.4.2 The intensity of the reflection of the radar wave by the weather cell depends on the content of the weather cell. Water droplets and wet hail provide very good reflection while dry hail, ice crystal and snow do not reflect radar waves well. In a column of thunderstorm cloud, the freezing altitude where super-cooled water is transformed to ice is about 20,000 ft. A radar beam that is tilted to scan the region above this freezing altitude would most likely be scanning ice crystal that has poor reflectivity and the resulting display on the ND may not reflect the true nature of the weather cell.

2.2.3 At the 40 nm range selection with an antenna tilt of -2°, the RDR 4B system could not “see” the part of the weather cell below 20,000 ft and so could not provide an accurate display of the weather cell. In contrast, a RDR 4000 system would automatically scan the entire sky in front of the aircraft from ground level up to 60,000 ft to provide an accurate display of the weather cell.

- 4.1 In view of the safety actions carried out by the operator, the investigation team made only one other suggestion, based on the discussion in paragraph 2.2.5, that the operator consider retrofitting the RDR 4B system with the RDR 4000 weather radar system.
- 4.2 The operator evaluated the suggestion but considered that the RDR 4B radar system is effective in differentiating weather severity. Nevertheless, the operator indicated that it had strengthened the recurrent training programme for its flight crews as regards the use of weather radar and weather avoidance, to ensure that its flight crews are proficient in operating the RDR 4B radar system.
