FINAL REPORT

BOEING B777, REGISTRATION 9V-SWH LOSS OF SEPARATION EVENT

AIB/AAI/CAS.109

Air Accident Investigation Bureau of Singapore Ministry of Transport Singapore

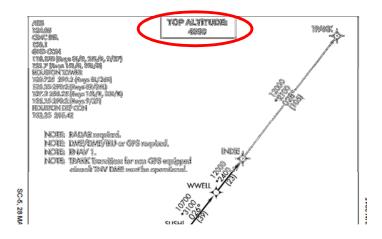
Figure 3: Amended SID with the Top Altitude clearly shown

- On the other hand, had the altitude restriction of 4,000ft appeared more prominently in the Jeppesen chart, the flight crew might have been able to notice such a piece of information. As it was, the SID's altitude restriction was not found in the 'Initial Climb' section, but was in SID's text box under the 'Routing' section. It is not intuitive to look for information on altitude restriction for the Initial Climb phase in the 'Routing' section.

3.4 The FAA has amended their standards for charting RNAV SIDs, including the INDIE ONE procedure, to clearly show the top altitude in a box at the top centre of the chart (see **Figure 3**).
