AIRBUS A380 REGISTRATION A6-EVJ RUNWAY EXCURSION ON LANDING, CHANGI AIRPORT

2 MARCH 2023

TIB/AAI/CAS.216

Transport Safety Investigation Bureau
Ministry of Transport
Singapore

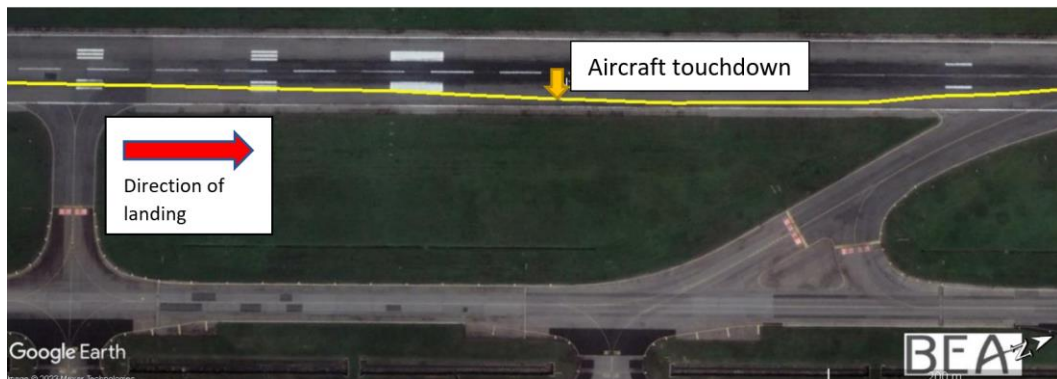
Figure 1: Ground path of aircraft

1.1.12 The FDR data indicated that when the aircraft was about 15ft AGL, the PF momentarily applied a sharp left rudder input (from 2° to 9°) and a left roll input, resulting in a bank angle less than half a degree to the left. These actions caused the heading of the aircraft to turn left towards the runway centreline but the aircraft continued to drift towards the right. Shortly thereafter, the rudder input was removed (i.e. the rudder was set to neutral) and a right roll input was applied, resulting in a bank angle to the right of up to 4 degrees. At about 1427h, the aircraft touched down to the right of the runway near the runway edge line and veered slightly further to the right (see **Figure 1**). The PF told the investigation team that while he was aware that the aircraft had touched down to the right of the runway, he believed he was still within the runway limits. The aircraft was steered back towards the runway centreline and, while still tracking towards the centreline, thrust reversers were applied.

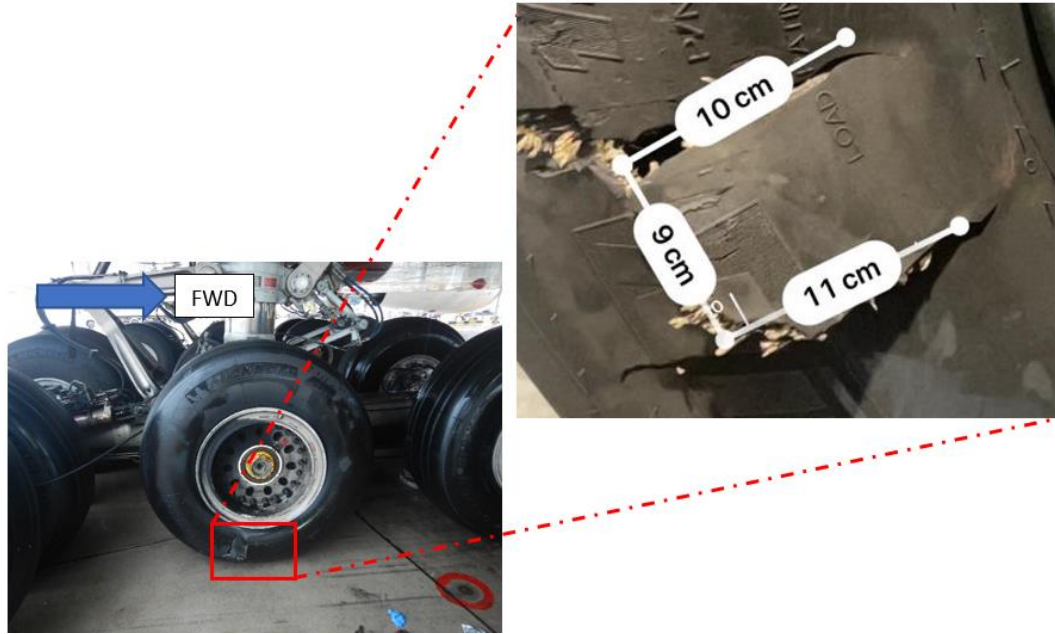
Figure 2: Punctured tyre

- 1.2 Injuries to persons
 - 1.2.1 There was no injury to any person.
 - 1.3 Damage to aircraft
 - 1.3.1 One of the RH MLG tyres was punctured (see **Figure 2**), and another RH MLG tyre was found with a circular incision (see **Figure 3**).

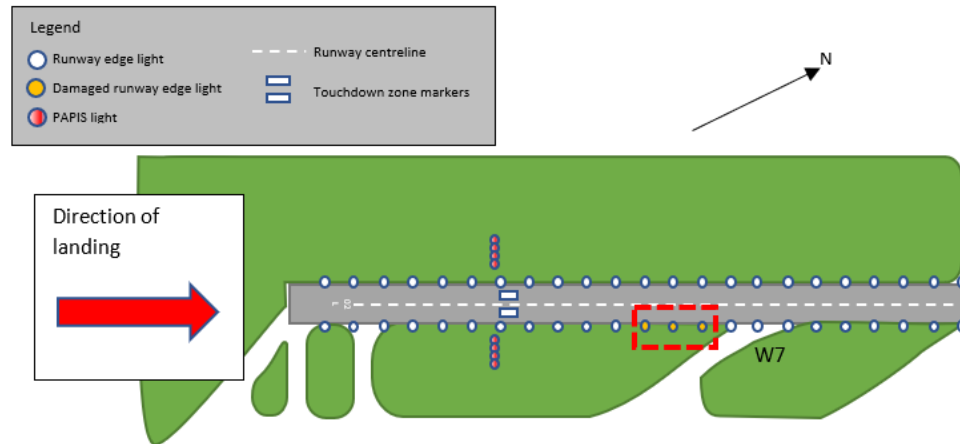
Figure 4: Location of damaged runway edge lights

1.4.1 Three adjacent runway edge lights on the right side of Runway 02L were broken. The location of these broken runway edge lights and the recovered debris are shown in **Figure 4** and **Figure 5** below respectively.

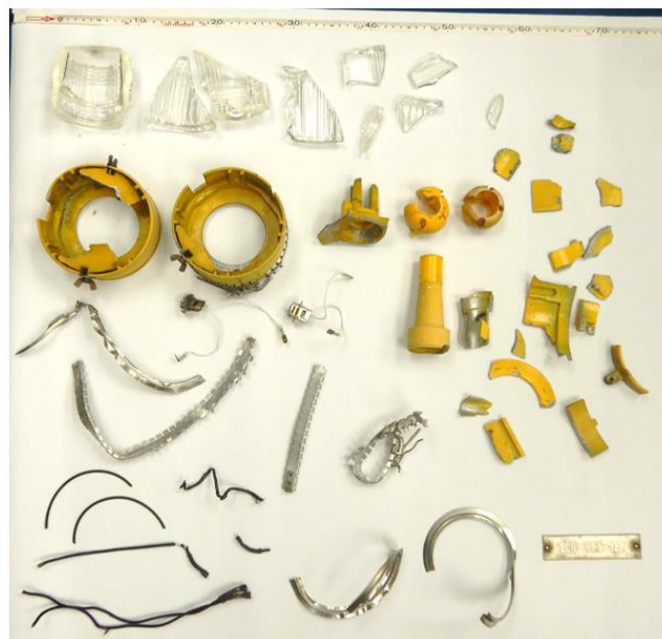
Figure 5: Debris from the broken runway edge lights

- 1.1.17 At about 1616h, another runway inspection vehicle, Rover 35, when conducting a scheduled runway inspection, found three runway edge lights broken. Some light fitting debris pieces were found scattered on the runway shoulder pavement area and in the grass patch area. Some light fitting debris pieces were also found on Taxiway W7.
