FINAL REPORT

WING CLIPPING INVOLVING BOEING B787, REGISTRATION 9V-OJA AND AIRBUS A380, REGISTRATION A6-EUB AT SINGAPORE CHANGI AIRPORT ON 30 MARCH 2017

AIB/AAI/CAS.143

**Transport Safety Investigation Bureau
Ministry of Transport
Singapore**

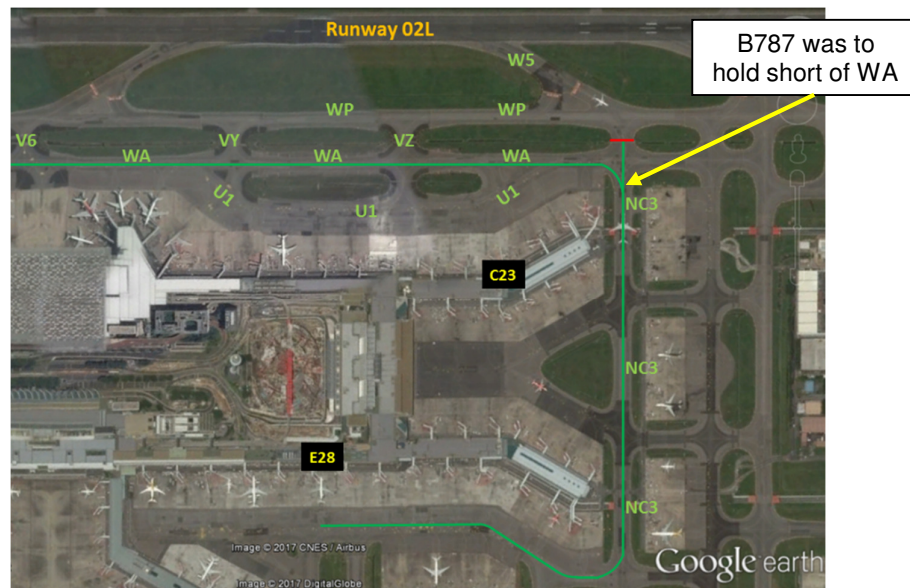
1.1.3 At that time, the green taxiway centreline lights² along A6, NC3 and WA towards the threshold of Runway 02L were illuminated (see **Figure 1**). The illuminated lights had been in that configuration as a few aircraft had taxied on WA in the past 30 minutes.

Figure 1: Green taxiway centreline lights configuration at the time of taxi instruction issuance

2.1.4 Thus, seeing that the green taxiway centreline lights on WA were illuminated, and having been instructed to proceed to V6, and not having been told that they were to taxi on WP, the flight crew quite naturally followed the greens on WA.

- Switching off the green taxiway centreline lights on WA
- Verbalising the intended taxi route
- Switching on the red stop bar lights at the holding position on NC3 short of WA

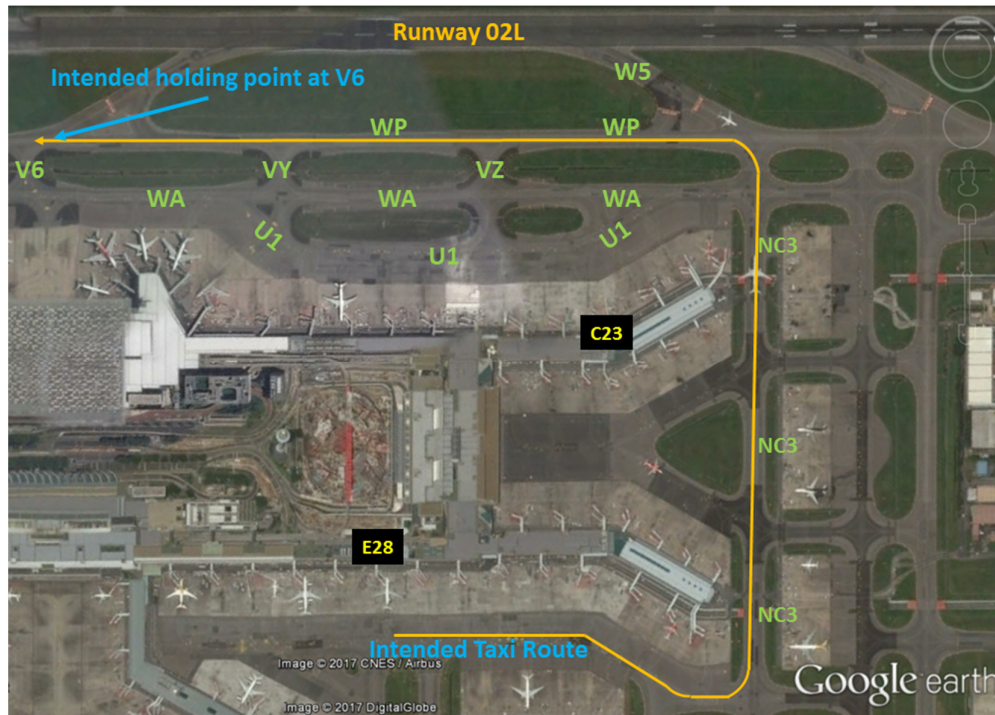
- 1.1.4 According to the OJT trainee, her plan was to have the B787 taxi on Taxiway WP after an arriving aircraft had landed and vacated Runway 02L via Rapid Exit Taxiway W5,. She would then switch off the green taxiway centreline lights leading to WA and switch on the green taxiway centerline lights leading to WP (which was parallel to WA) to guide the B787 onto WP, and to hold short of it at Taxilane V6 towards the runway holding position of Runway 02L (see **Figure 2**).

Figure 2: Intended taxi route for B787

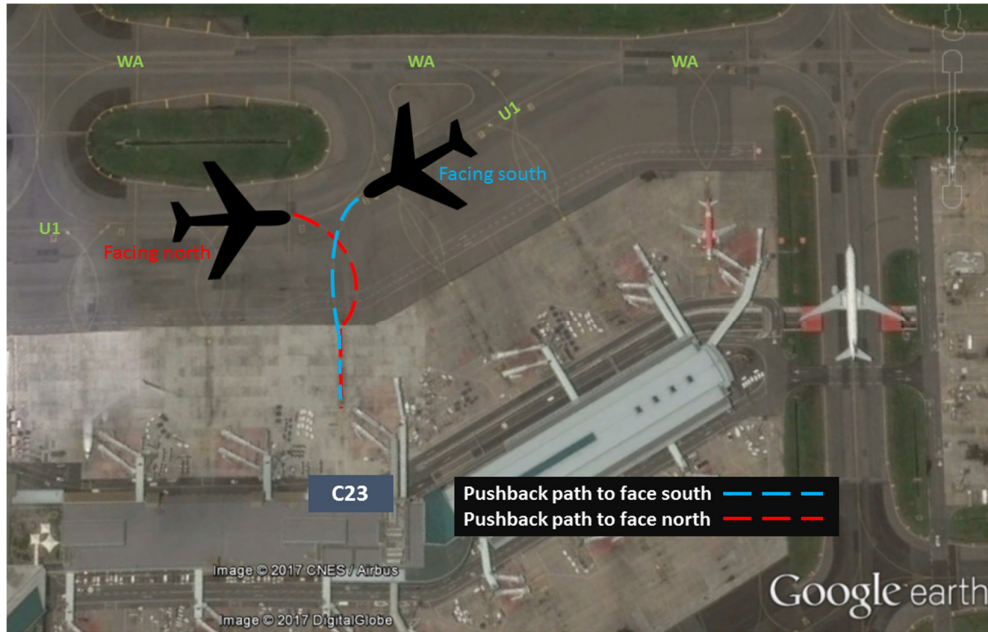
Figure 3: Pushing back of A380 from parking bay C23

- 1.1.13 Meanwhile, the A380 had been pushed out of C23 onto U1. The tow tug driver saw the B787 approaching. He stopped the tow tug as he was unsure if there was sufficient clearance.

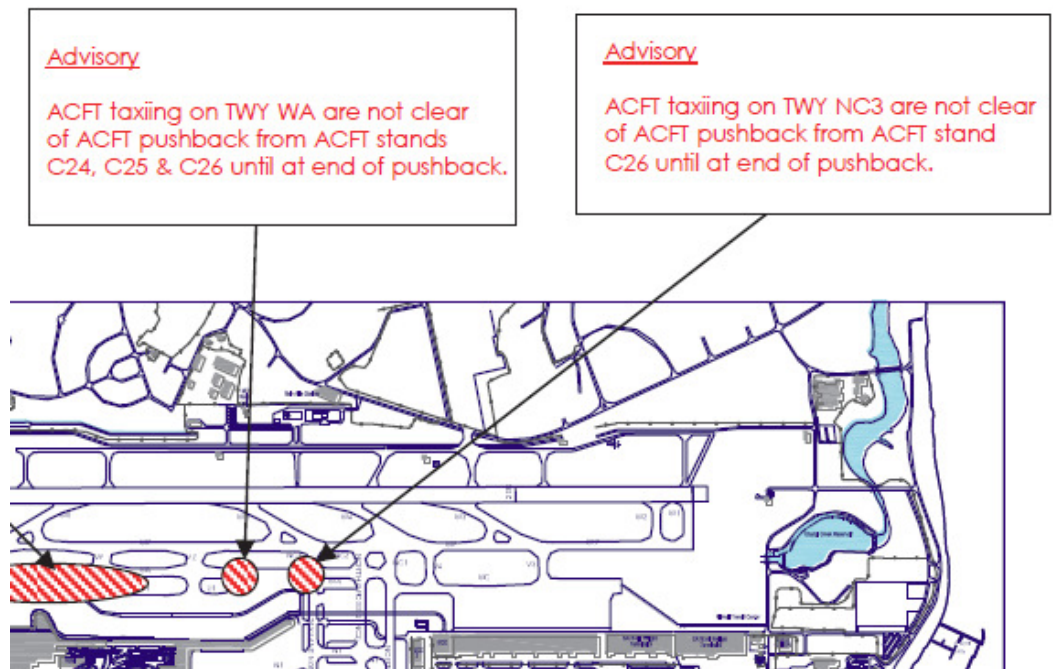
- 1.9.4.1 The Singapore Aeronautical Information Publication (AIP) included an advisory⁵ (see **Figure 4**) since 15 January 2009 that aircraft taxiing on WA were not clear of aircraft that were being pushed back from parking bays C24, C25 or C26. The OJT trainee and trainer and the flight crew of the B787 were aware of this advisory. However, C23 was not a subject of the advisory. The ATSP was unable to advise if there had been a risk assessment that concluded that there would not be clearance problem with C23.

Figure 4: Excerpt of Aerodrome Advisory Chart AD-2-WSSS-ADC-3 in the Aeronautical Information Publication

- 2.4.2 It was stated in Aerodrome Advisory Chart AD-2-WSSS-ADC-3 that “ACFT taxiing on TWY WA are not clear of ACFT pushback from ACFT stands C24, C25 & C26 until at the end of pushback.” This piece of information was useful for the air traffic controllers as this would make them avoid instructing another aircraft to taxi on WA when they are aware that an aircraft was being pushed back from C24, C25 or C26.

- 2.4.3 However, the way this piece of information is written could give the impression that the advisory is relevant only when there is a pushback. If a pilot taxiing on WA sees an aircraft already on the angled portion of U1 (as shown in Figure 3), it might not occur to the pilot that the aircraft had been pushed back from C24, C25 or C25 and, thus, the pilot might not think that the advisory is of relevance, thereby missing the implication therein – that the taxiing aircraft would not be clear from any aircraft on the angled portion of U1, regardless of whether this latter aircraft was stationary, taxiing or being pushed back. To better ensure that pilots seize the significance of Aerodrome Advisory Chart AD-2-WSSS-ADC-3, perhaps the advisory could be reworded as “ACFT taxiing on TWY WA are not clear of any aircraft occupying the angled section of U1”, or similar wording to the same effect.

- 4.8 The air traffic services provider consider revising the piece of information in the Aerodrome Advisory Chart AD-2-WSSS-ADC-3, viz. “ACFT taxiing on TWY WA are not clear of ACFT pushback from ACFT stands C24, C25 & C26 until at the end of pushback”, to ensure that pilots will not miss the information. [TSIB Recommendation RA-2018-011]
