Final Report

ALLISION OF DUTCH FLAGGED VOX MAXIMA AND SINGAPORE FLAGGED MARINE HONOUR, PORT OF SINGAPORE ON 14 JUNE 2024

TIB/MAI/CAS.169

Transport Safety Investigation Bureau
Ministry of Transport
Singapore

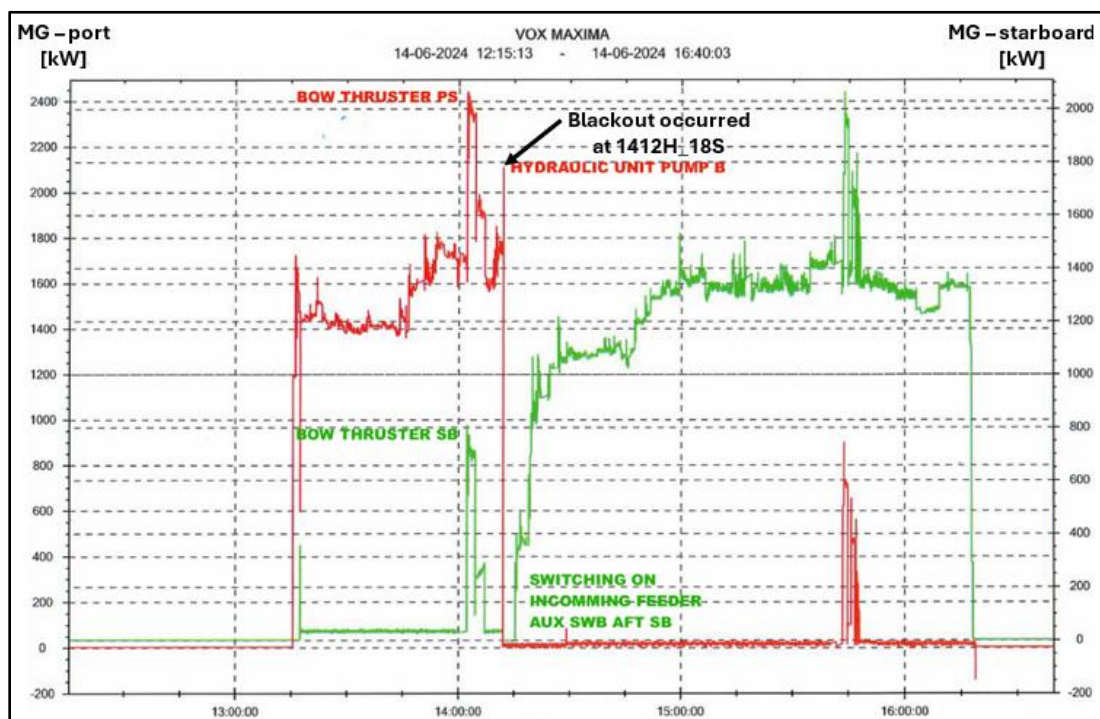
- 1.4.2.5 An in-house monitoring⁴⁸ application was used to monitor shipboard electrical load, and all captured data was sent back to VM-Company through a VODAS⁴⁹ system in a separate network. This data could be collected and read by an in-house developed logging system, named “NC Logger”, which analysed the network data and created files from all signals sent through the network.
- 1.4.2.6 The data extracted from the monitoring system for the period of 1215H – 1640H on 14 June 2024 (see **Figure 9**) indicated that the electrical load of MG-PS (in red) was much higher than MG-SB (in green). The blackout happened when HPU-B was started (read as hydraulic unit pump B in the electrical load graph below).

Figure 9 – Electrical load graph captured in Simplot.Net system
(Source: VM-Company, the blackout text annotated by TSIB)

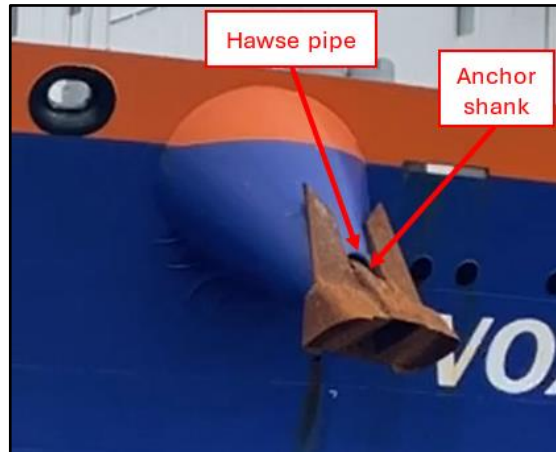
- 1.4.3.3 At the time of the blackout, the port anchor was not able to be released. It was discovered post incident that the anchor shank was stuck in the hawse pipe (see **Figure 11**) preventing the port anchor to be released from its stowed position. Releasing the windlass brake completely did not help the anchor shank to clear from the hawse pipe. Ship's records indicated that the port anchor was last used on 16 April 2024 and was secured on the same day. It remained in secured condition till the occurrence day.

Figure 11– Illustration view of the port anchor at its stowage position
(Source: the TSIB)

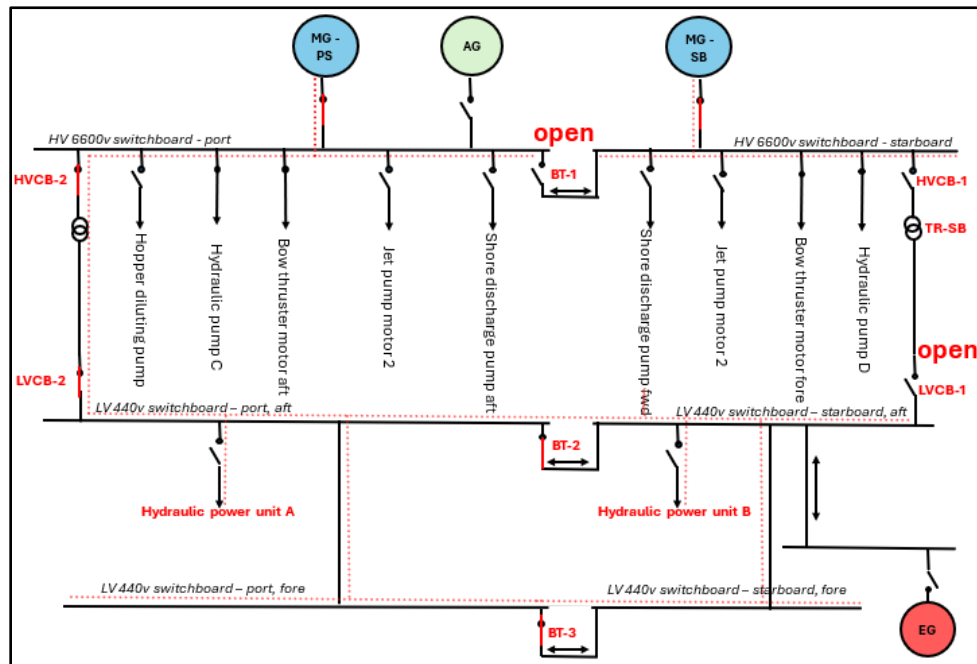
- a) Opened⁵³ HVCB-1
- b) Opened LVCB-1
- c) Kept BT-1 open and BT-2 and BT-3 closed
- d) Kept HVCB-2 and LVCB-2 closed

Figure 13 – Configuration of the switchboards with TR-SB isolated

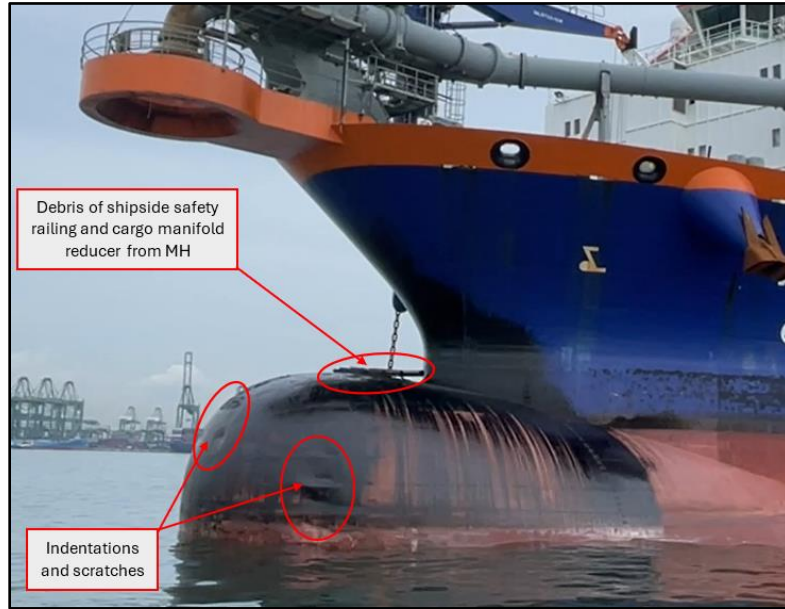
1.7.1.1 There was no injury reported after the allision. Minor indentations and scratches were noted on VM's bulbous bow (see **Figure 14**).

Figure 14 – View of VM's bulbous bow with damages and debris from MH
(Source: the TSIB)

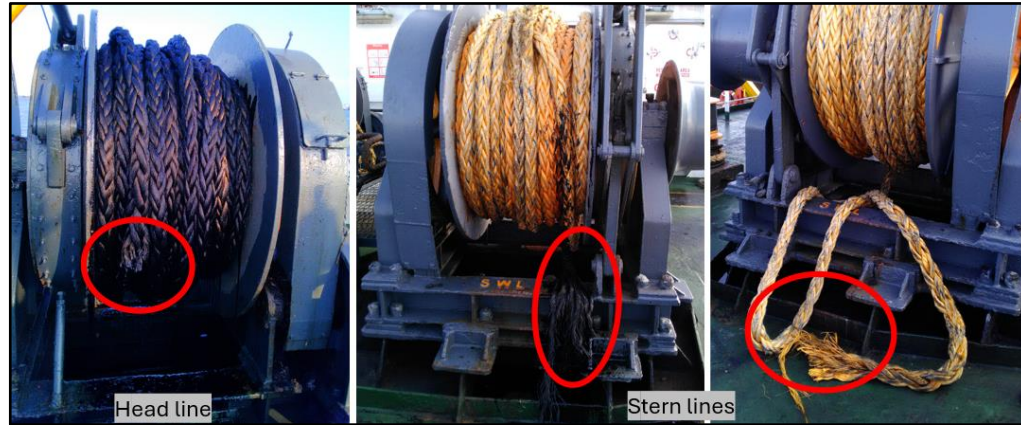
Figure 15 – View of mooring lines parted
(Source: the TSIB)

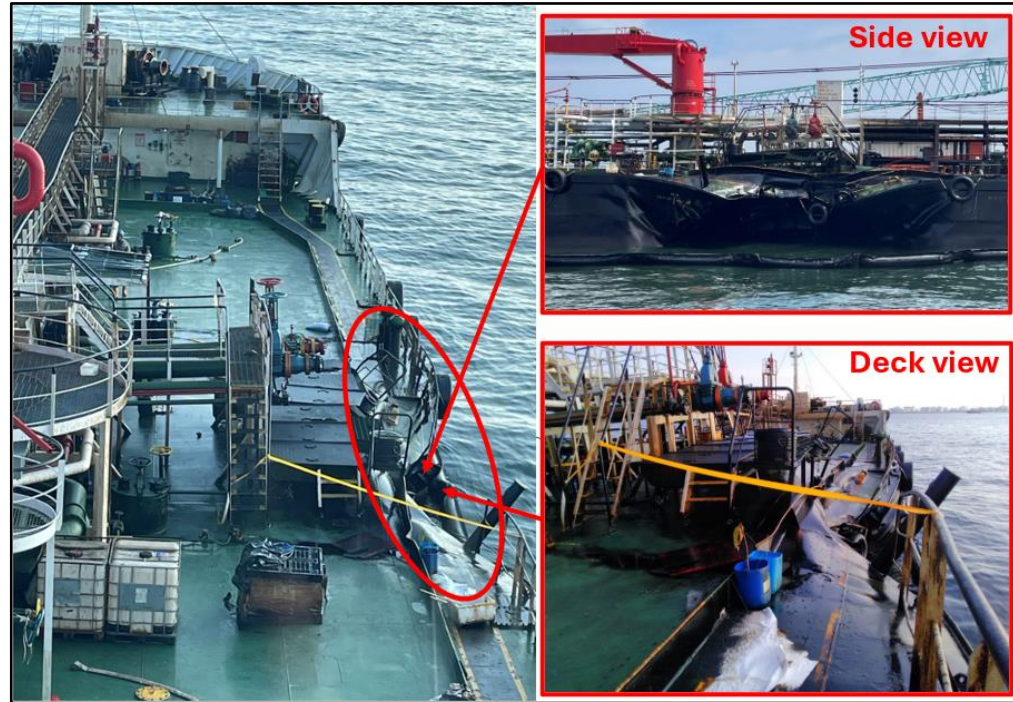
1.7.2.2 BV carried out the occasional survey on MH's hull from 15 June 2024 to 5 July 2024 while MH was anchored at the Western Petroleum Alpha Anchorage (AWPA). Preliminary assessment indicated that MH sustained the following hull damages (see **Figure 17**) from the allision:

- a) Starboard side of no.1 and no.2 water ballast tanks
- b) Starboard side of no.3 and no.4 COTs, in way of frames no. 72 – 97
- c) About 8m open crack in way of frame no.96 on the main deck starboard side
- d) Transverse bulkheads at frame no.75 (between no.3 COT and no.4 COT, starboard side)
- e) Transverse bulkheads at frame 95 (between no.2 COT and no.3 COT, starboard side)

Figure 17 – View of the damages on MH's starboard side
(Source: the TSIB)

- 1.7.2.3 Sea water ingressed into the starboard side of no. 2 water ballast tank, no. 3 and no.4 COTs.
- 1.7.2.4 Underwater hull damage was unable to be assessed at the time of survey due to restrictions. The attending class surveyor determined that MH was unfit for her operation and voyage. Towage was allowed for MH to be shifted from its current location to the AWP(A) with a list of conditions imposed by BV.

- 1.7.2.6 With approvals from the MPA and BV, MH was towed to a shipyard in Singapore on 5 July 2024 for permanent repairs.

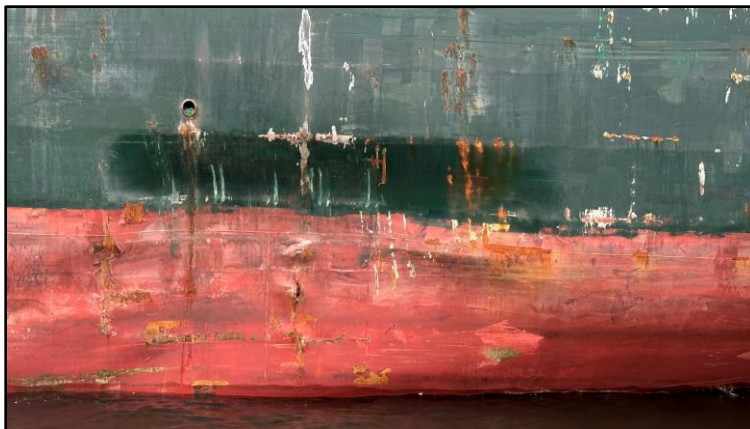
- 1.7.3.1 Resulting from the allision, EB suffered minor lube oil spill from its hull on the port side and a leakage inside the engine room. Multiple structural deformations were found on the port side ship hull at the locations of no.5 water ballast tank, freshwater tank (port), void space, grey water holding tank, cylinder oil storage tank (port) and purifier room, etc. (See **Figure 18** and **Figure 19**).

Figure 18 – Deformed shell plating between frames 28 and 35 and damaged into a hoe on port side (*Source: EB*)

- 1.7.3.2 An occasional survey of ship's hull was carried out by CR classification society (CR) on 16-18 June 2024, included temporary repairs and examinations to certify the technical fitness of EB. EB was allowed to continue the voyage with a list of conditional requirements and to carry out permanent repairs before 17 July 2024, which had been completed.

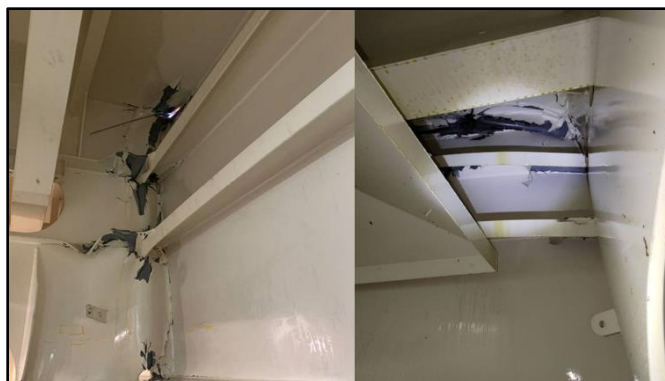
Figure 19 – Deformed shell plating between frames 45 and 52 on port side cylinder oil storage tank (*Source: EB*)

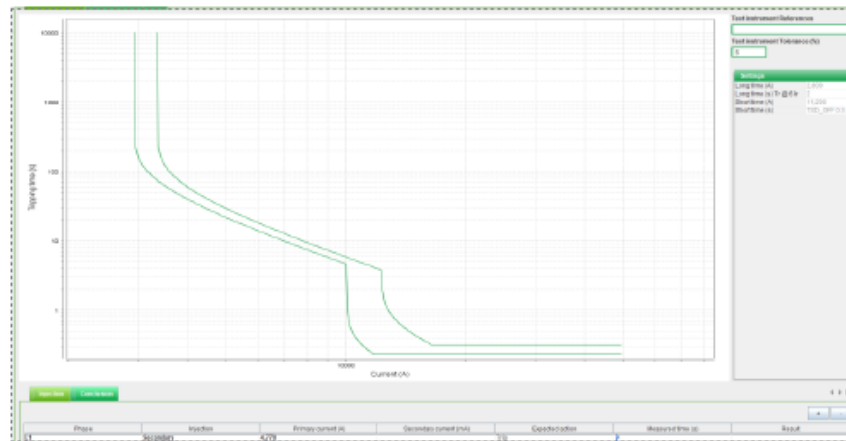
- In simulation test 1, test 2 and test 3, observed that I_r is picked up when pump A is started. But after pump A starting time (about 10 sec) is completed, total current is dropped below I_r trip threshold which is between 1.05 and 1.20 I_r . So trip time delay is reset at this point. Trip time delay started again when I_r is picked up by starting pump B and observed CB no trip. Starting duration of pump B is about 2 sec which is not long enough to reach time delay setting. For time delay setting, refer to software generated trip curve of Micrologic attached below.

Fig 9 : Trip Curve Generated By Software As Per Setting Of Incoming Feeder Aux Swbd AFT PS ACB

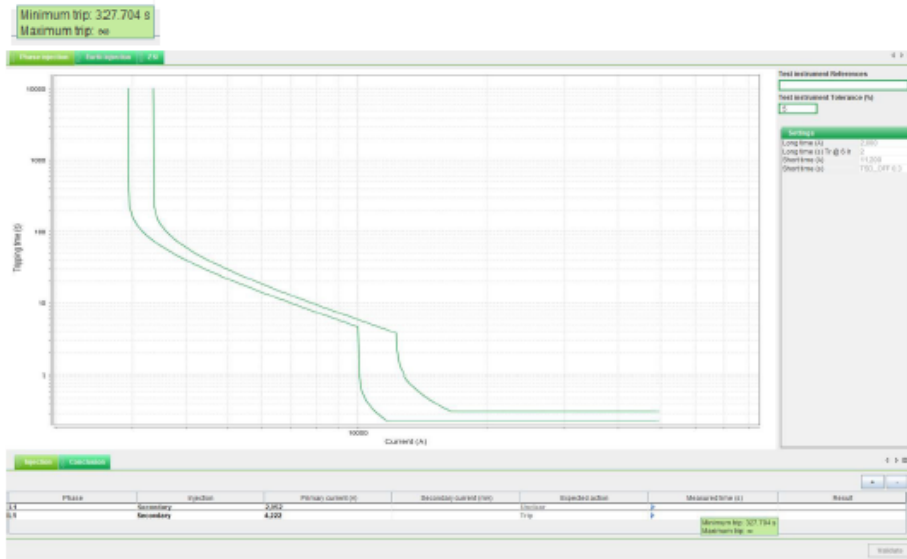
- As per generated trip curve, estimated trip time delay for current at I_r trip threshold is between 327.704s and infinity. Since the trip time delay range is too wide which is up to infinity, unable to determine the exact trip time delay if the load current is closed to I_r trip threshold.

Fig 7 : Trip Curve Generated By Software As Per Setting Of Incoming Feeder Aux Swbd AFT PS ACB
