# **Final Report**

## **EAST-WEST LINE FAULTY TRAIN INCIDENT**

**25 SEPTEMBER 2024**

TIB/RAI/CAS.014

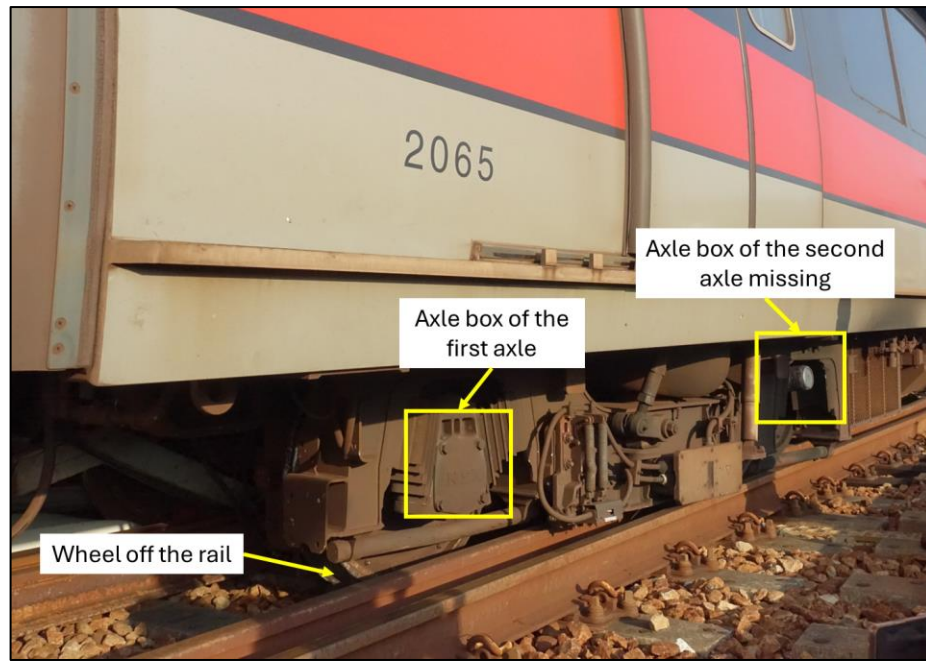
- 1.1.3 At 0928 hours, the OCC activated a recovery team to rescue T310. Four wheels of T310's Car 2065's front bogie were found to have come off the rails (see **Figure 1**). The axle box of the second axle was missing and later recovered near DVR (more on axle box in paragraph 1.5.2).

Figure 1: Axle box of the second axle was missing

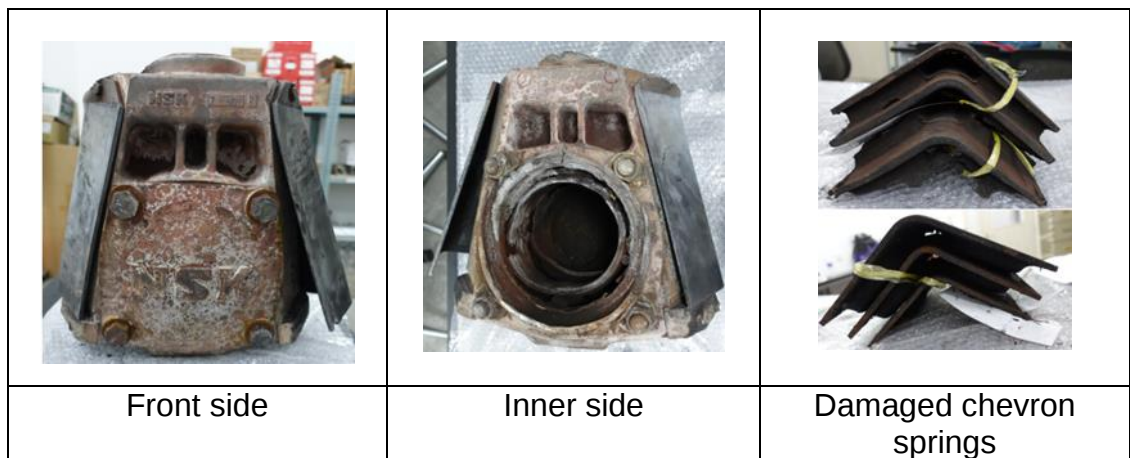
- 1.2 Injuries to persons
- 1.2.1 No one was injured in the incident.
- 1.3 Damage
- 1.3.1 The missing axle box from the second axle of Car 2065 was axle box 19 on T310 (more on axle box numbering in paragraph 1.5.1).
- 1.3.2 **Figure 2** shows a diagram of an axle box and its chevron springs (each made up of 5 metal plates, bonded together by rubber material) and **Figure 3** shows the damage to axle box 19 and its chevron springs. The temperature stickers on axle box 19 (more on temperature sticker in paragraph 1.5.2.2), as well as the grease in the bearings of axle box 19, were burnt off.

Figure 3: Damage to front/inner side of axle box 19 and its chevron springs

- 4.1 The rail operator overhauled all the axle boxes of the fleet of trains to which T310 belonged that had exceeded 500,000 km mileage before they were allowed to return to service. The overhaul was completed by 13 October 2024.

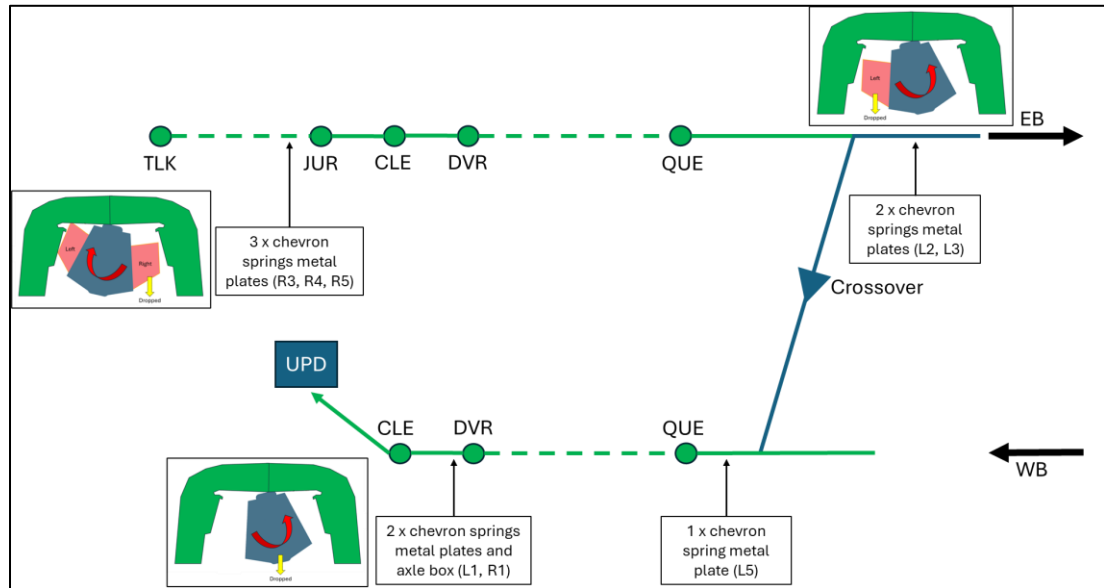
- 1.3.3 The track and trackside equipment (e.g. point machines, power cables, running rail fasteners and third rails) along a stretch of some 2,550 m of the WB track between Jurong East Station (JUR) and DVR were damaged in this incident. **Figure 4** shows the locations where the debris of the axle box and chevron springs were found. All the metal plates of axle box 19's chevron springs, except L4 on the left-side chevron spring and R2 on the right-side chevron spring (as shaded in **Figure 5**), were recovered.

Figure 4: Locations where the debris pieces were found

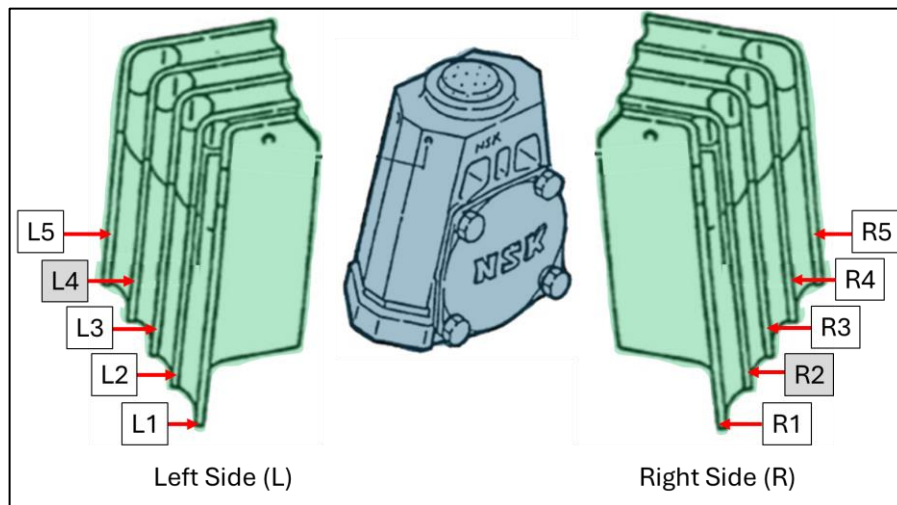
Figure 5: All metal plates of the chevron springs except L4 and R2 were recovered

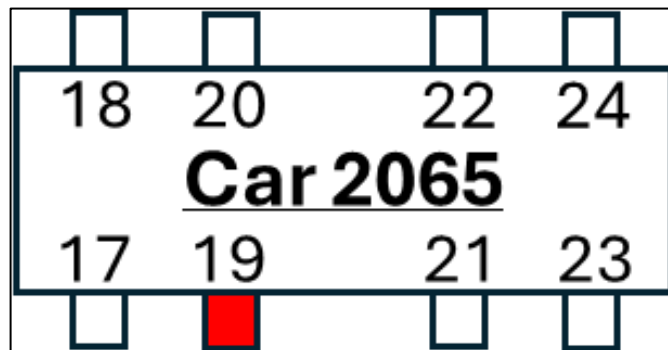
- 1.5.1 T310 belonged to a fleet of 66 trains that had been in use since 1987. Each of these trains has six cars. Car 2065 was one of the two cars in the middle of T310. The axle box that failed was axle box 19 on Car 2065 (see **Figure 6**).

Figure 6: Numbering of axle boxes on Car 2065

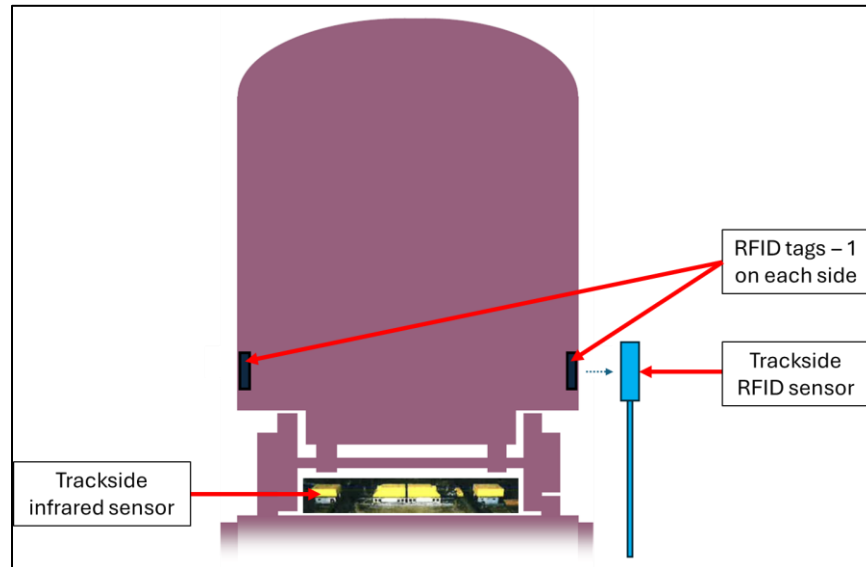
Figure 10: Hotbox system

- 1.6.5 On the incident day, the RSC saw the Level 1 warning. However, the train ID was not detected, and the Hotbox console displayed a Null ID. The RSC believed that the warning was a false warning and did not take any follow-up

1.6.6 The TSIB investigation team noted that there were instances of Null ID indications (i.e. train ID was not detected by the Hotbox system) as well as feedback from staff to the rail operator. However, the issue had not been resolved as Null ID indications were still being generated during operations.

- 4.2 The rail operator, with the assistance from the Hotbox manufacturer, rectified the Null ID indication issue. It has also required the MEC to share Level 1 warnings with the OCC via WhatsApp so that the OCC can take follow-up action if the RSC at the MEC misses the warning.

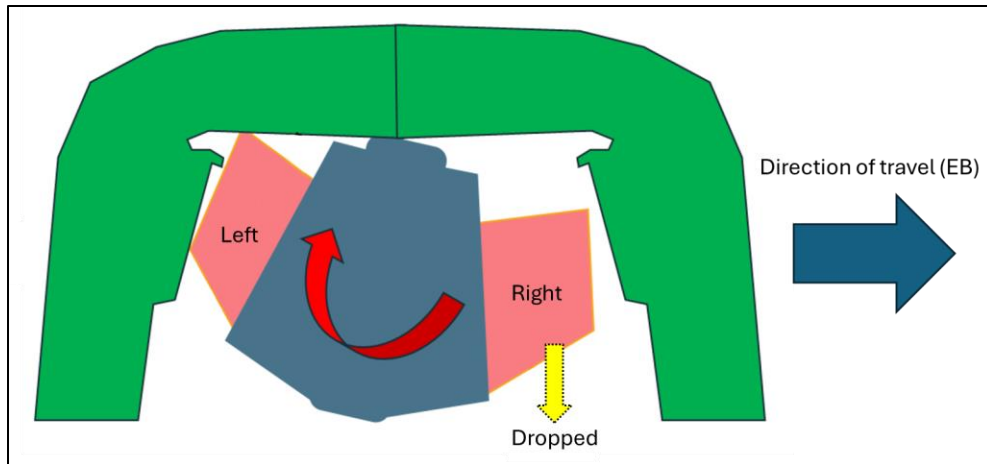
- (d) After T310's departure from TLK at 0825 hours for PSR, the intermittent or permanent bearing seizure, coupled with the train's EB movement (which entailed the axle box rotating clockwise), caused the chevron spring on the left-side of axle box 19 to be cornered against the bogie frame (see **Figure 12**). The metal plates R2 – R5 and the associated rubber material of the disintegrating chevron spring on the right-side progressively dropped on the EB track between JUR and QUE. (Metal plate R2 could not be found.)

Figure 12: Left-side chevron spring cornered against bogie frame and right-side chevron spring dropped onto track (*Diagram courtesy of SGS Testing & Control Services Singapore Pte Ltd*)

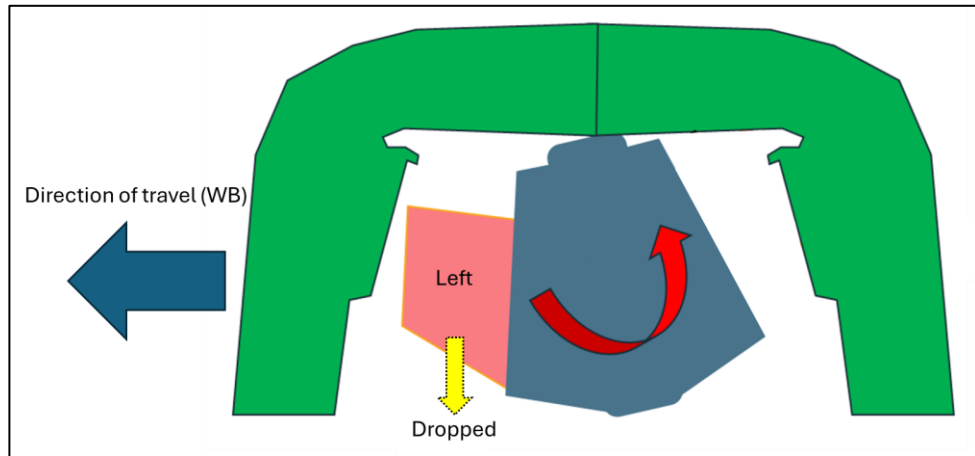
- (e) After T310 had changed direction at QUE-X, the train moved WB (which entailed the axle box rotating anti-clockwise). The chevron spring on the left-side was progressively released from being cornered against the bogie frame and the metal plates L2 – L5 and the associated rubber material of the disintegrating chevron spring on the left-side progressively dropped on the WB track around QUE-X and QUE (see **Figure 13**). (Metal plate L4 could not be found.)

Figure 13: Left-side chevron spring detached

- (f) Subsequently, axle box 19 became detached from the bogie and dropped on the WB track around DVR. Without the chevron springs and the axle box supporting the front bogie of Car 2065, the wheels of the front bogie eventually came off the rails.
