Final Report

HEXADRON TUNDRA 2 (URBAN) UNCONTROLLED FLYAWAY

TIB/AAI/CAS.234

Transport Safety Investigation Bureau
Ministry of Transport
Singapore

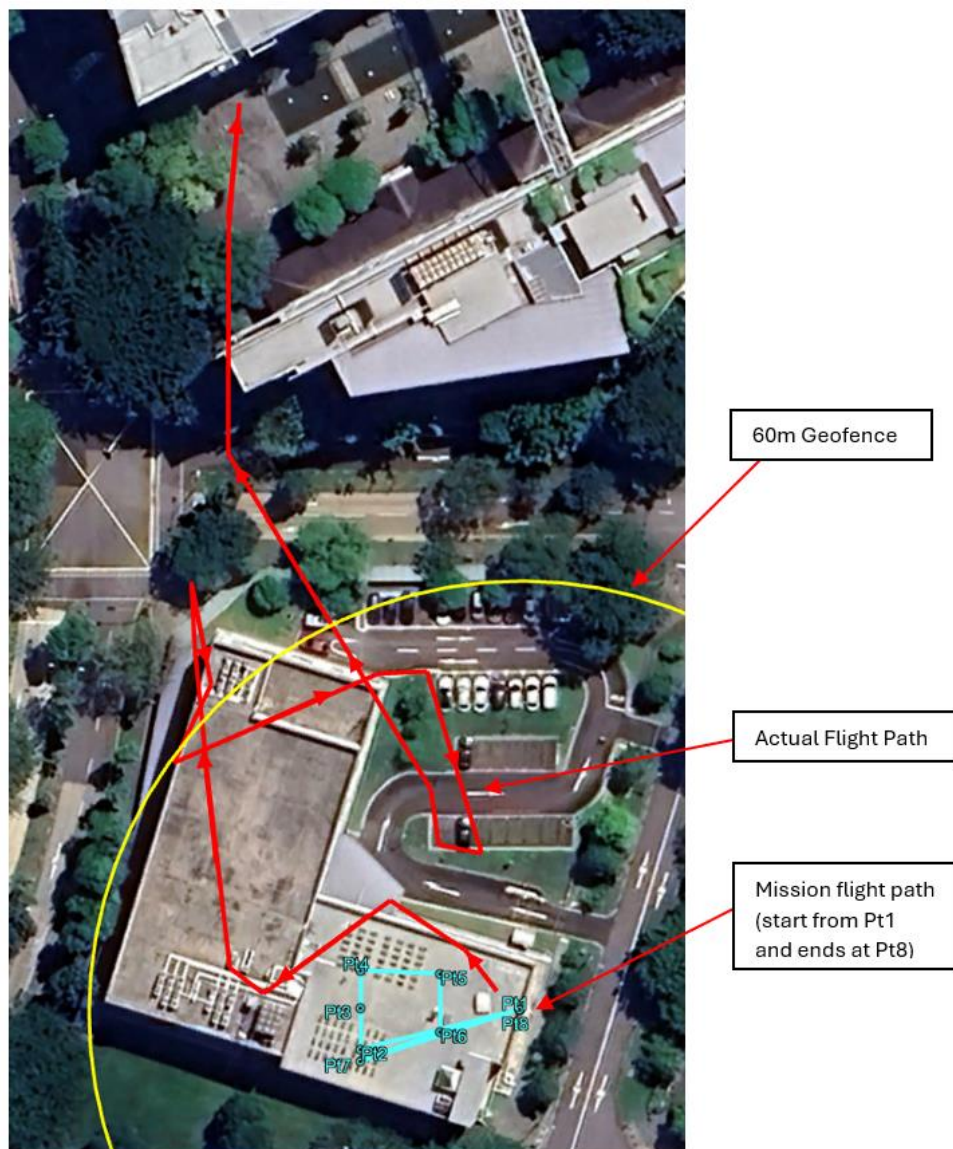
Figure 4: Mission flight path (cyan) and actual flight path (red)

- 1.1.6 At about 1757LT, OPT1 uploaded a mission⁶ for the eighth test flight (i.e. the incident flight)⁷. About two minutes later, the UA took off. However, instead of flying towards the first waypoint, the UA flew in an erratic manner (see **Figure 4**).

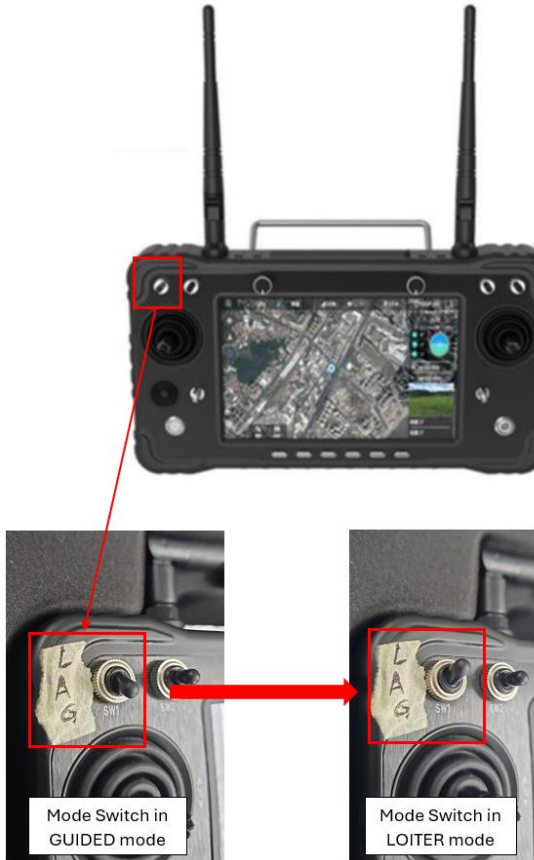
Figure 5: UA RC Mode Switch in three positions: “G” (GUIDED mode), “A” (ALT_HOLD mode) and “L” (LOITER mode)

- 1.1.7 UAP noticed the UA's erratic behaviour. To regain control of the UA, UAP used the RC to switch the FCC from GUIDED mode to LOITER mode (see **Figure 5**). This action was to hold the UA at its current position and altitude (i.e. hover) (see paragraph 1.5.1.2), but it did not work. The flight log of the C2 system server (hereinafter referred simply as the flight log) indicated that the FCC received LOITER mode command and there was no error message displayed on the C2 UI.

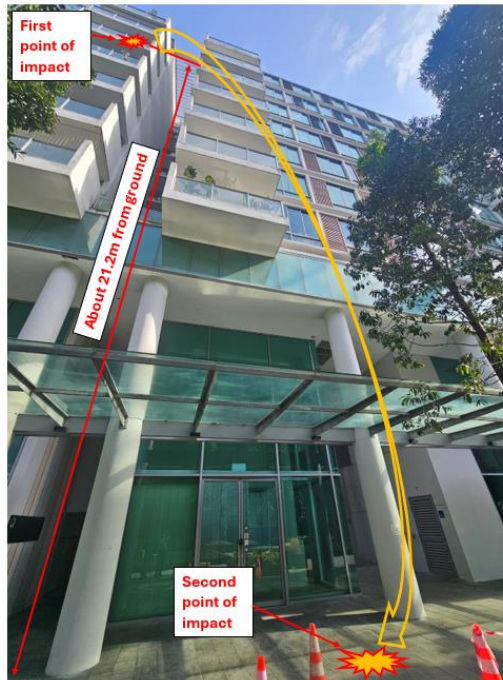
Figure 6: First and second point of impact

1.1.11 Eventually, at 85s after take-off, while the FCC was in RTL mode, the UA flew towards, and hit, a residential building about 200m from the flight test area (see **Figure 6**). It then dropped to the ground, about 1m from a person, and a fire ensued. **Figure 7** shows the crash site.

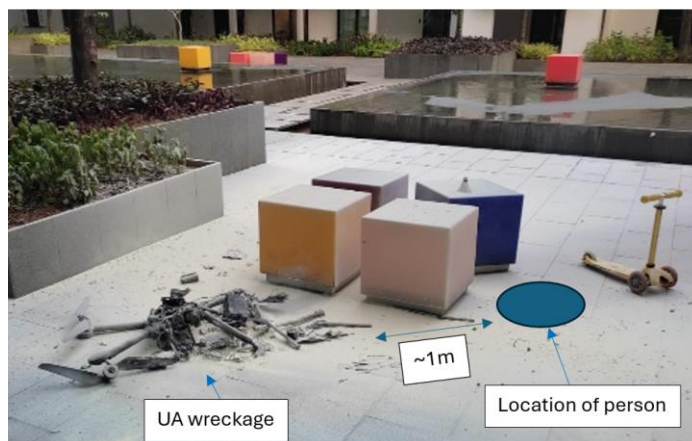
Figure 7: Crash site of the UA

1.3.1 The UA was destroyed by the post-crash fire.

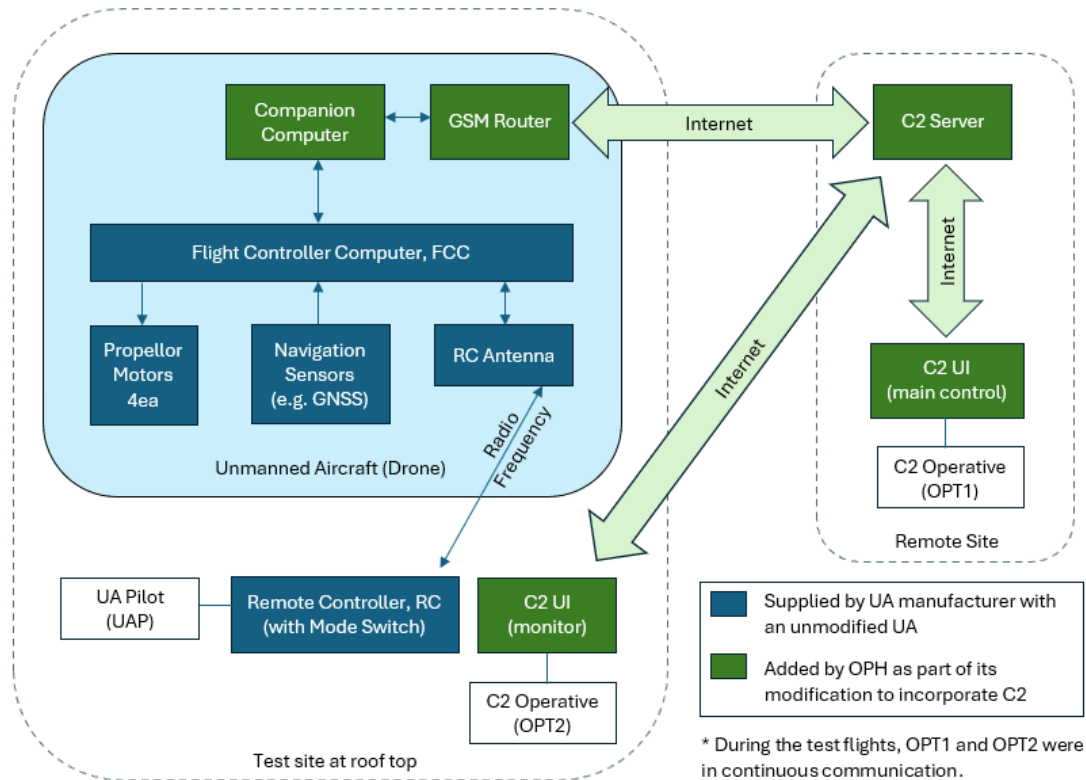
Figure 8: OPH's modification to the UA system

- 1.5.2.1 The OPH was developing the C2 system to remotely control and monitor the status of the UA via a laptop. The development of the C2 system required a Companion Computer⁹ to be integrated onboard the UA (see **Figure 8**). The Companion Computer was connected to the internet through the mobile cellular network so that it could receive commands from the C2 UI and relay them to the FCC. There can be more than one C2 UI being operated simultaneously to control/monitor the same UA.

1.5.2.6 According to the regulator, the development of the C2 system is considered a modification. The regulator required that “if a UA is customised or significantly

modified such that there is impact to its critical functions ... information should be provided to support the airworthiness of the UA". However, the OPH considered that its development of the C2 system was not a customised or significant modification that would have an impact to its critical functions, and hence did not submit additional information regarding the airworthiness of the modified UA.
