**FINAL REPORT**

**Garuda Airlines  
Boeing 737-300 Registration PK-GGG**

**Singapore Airlines Engineering Company  
Maintenance Jeep**

AIB/AAI/CAS.001

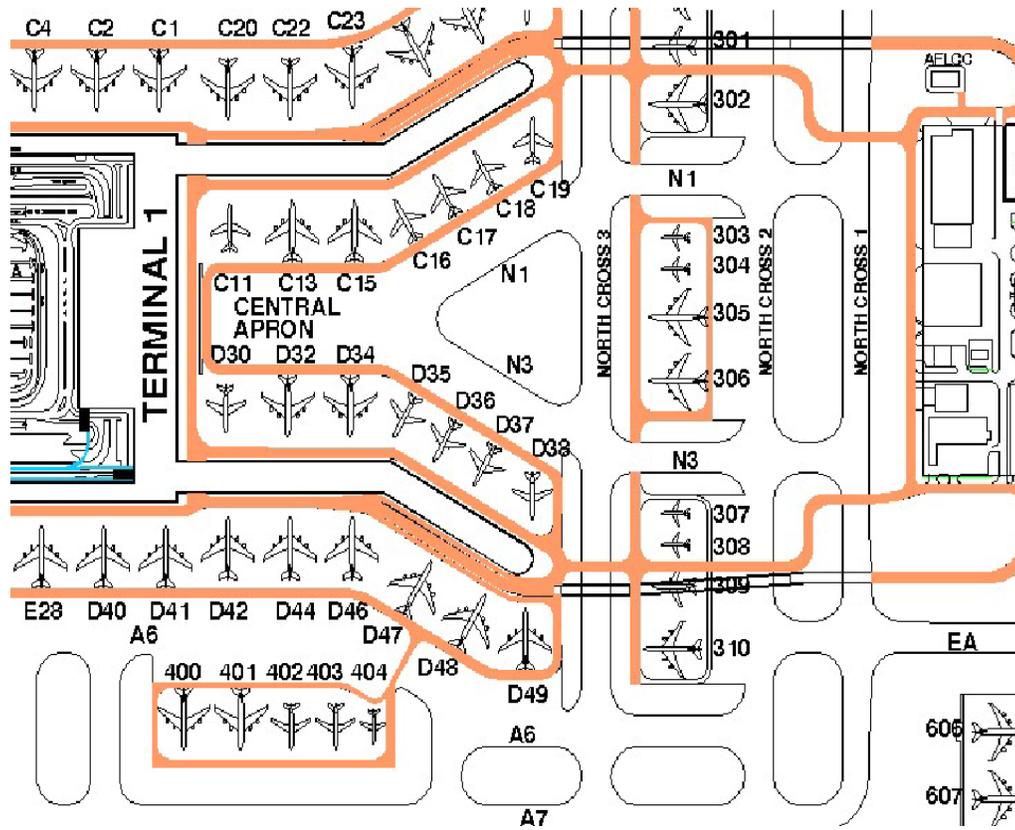
Chart showing layout of taxiways around the Central Apron

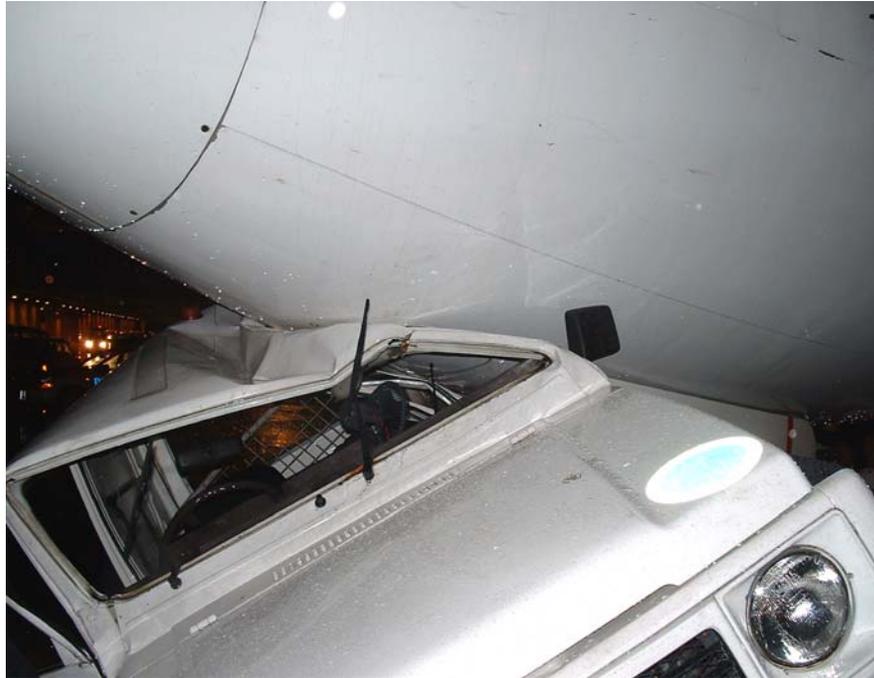
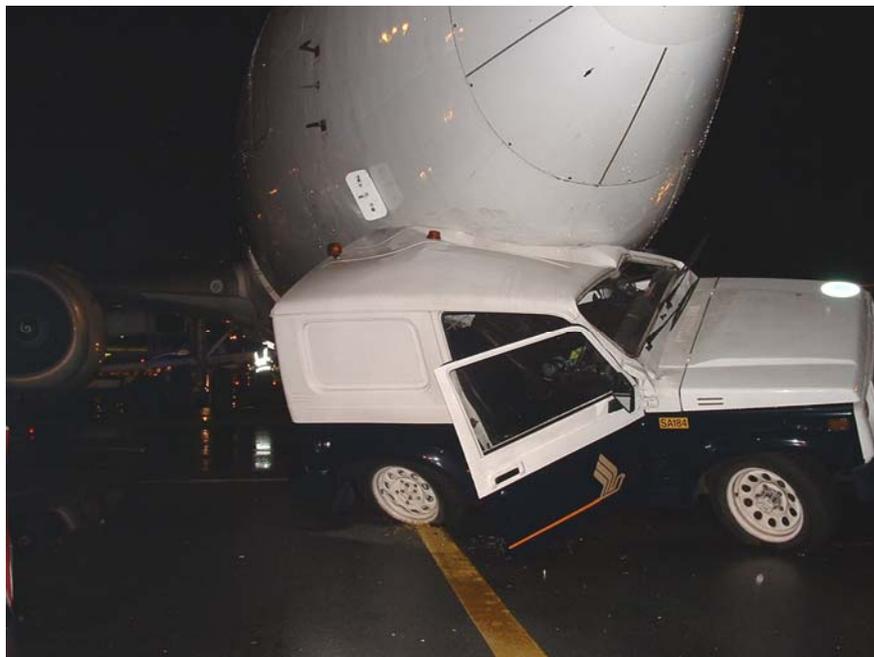
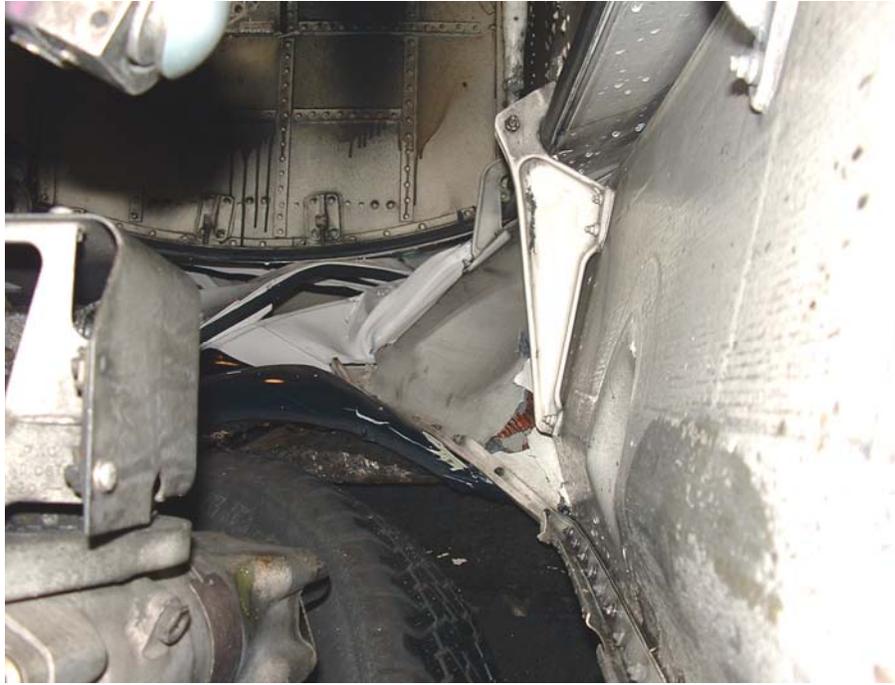
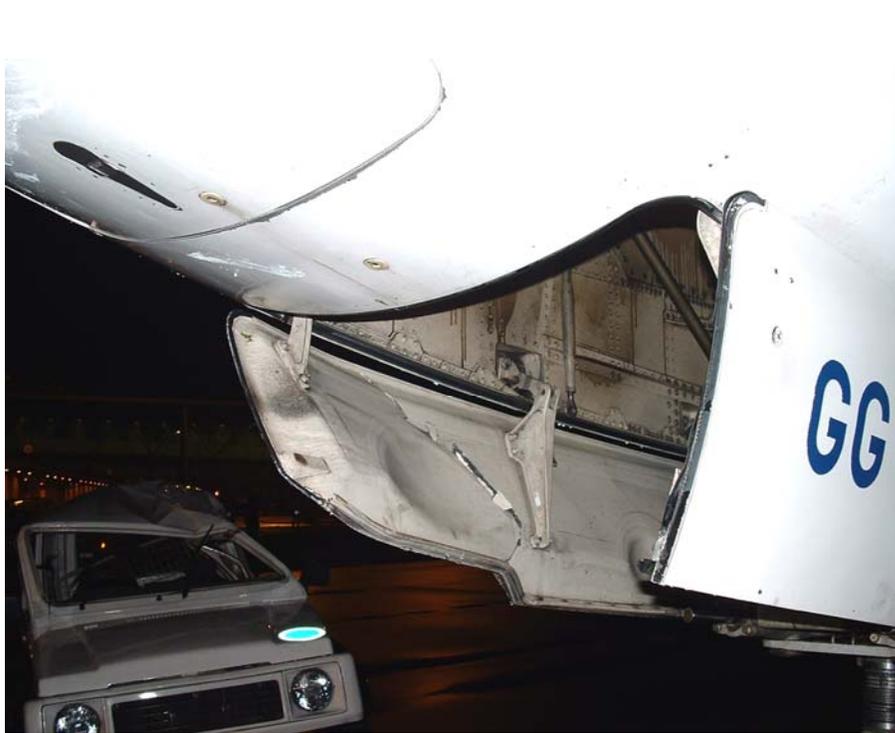
**Appendix 2**

1.3.1 The nose gear right hand door was buckled and broken. The nose gear left hand door was damaged through its penetration of the left hand door of the vehicle. (See **Appendix 2.**) There were three shallow dents on the right hand side of the fuselage forward of the nose gear well opening.

1.4.1 The vehicle involved in the collision with the aircraft belonged to the SIA Engineering Company Limited. The roof and the left hand door of the vehicle were crushed by the forward fuselage of the aircraft. The left hand door was also punctured by the nose gear left hand door.

1.4.2 There was a 2-metre long gouge on Taxiway NC3 caused by the rim of the right hand rear wheel of the vehicle when the vehicle was pinned under the aircraft forward fuselage.

Photographs showing damage to aircraft and vehicle

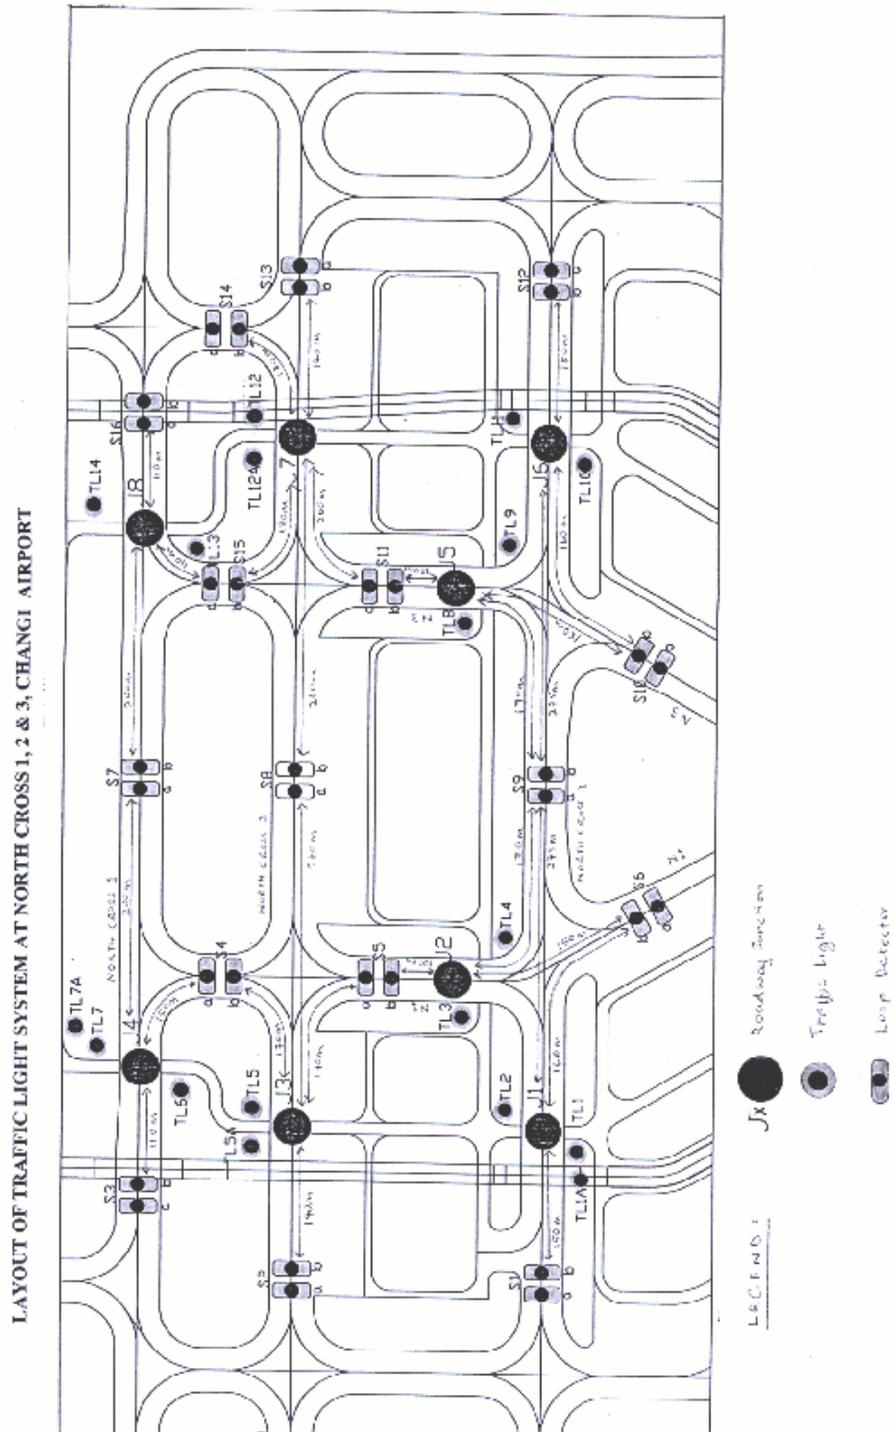
**Appendix 4**

- 1.10.6.7 On 13 December 2002 at around 11:00 hours, the red traffic light at the junction of Roadway R3N/North Cross Taxiway NC1 (traffic light No. 6 in Appendix 3) was observed not to have been activated by an Indian Airlines aircraft taxiing from west to east on Taxiway NC1. CAAS' maintenance contractor was called to check the system but could not find any fault with the system.

- 1.10.6.8 On 10 February 2003 between 16:20 and 17:00 hours, the traffic light at the junction of Roadway R5S/Taxiway NC3 (traffic light No.10<sup>1</sup> in Appendix 3) was observed to be activated when a truck travelling on Taxiway NC3 between the junction of Taxiway N1/Taxiway NC3 and the junction of Taxiway N3/Taxiway NC3. When a Garuda aircraft (registration PK-GWO) taxied from Terminal 1 Central Apron via Taxiway N3 to Taxiway NC3 (i.e. the same taxi route taken by flight GA 833 on the night of the collision incident), the red light did not activate. Several minutes later, when another Garuda aircraft (registration PK-GWK) taxied on the same route, the red light again did not activate.

not cause traffic light No.10 to activate. About ten minutes later a Royal Brunei Boeing 767-300 taxiing on the same taxiway activated the red light.

Chart showing layout and numbering of the traffic lights at the North Cross Taxiways area

CAAS has reviewed the reliability of the traffic light systems at the North Cross Taxiways area of Changi Airport and instituted a number of improvements.

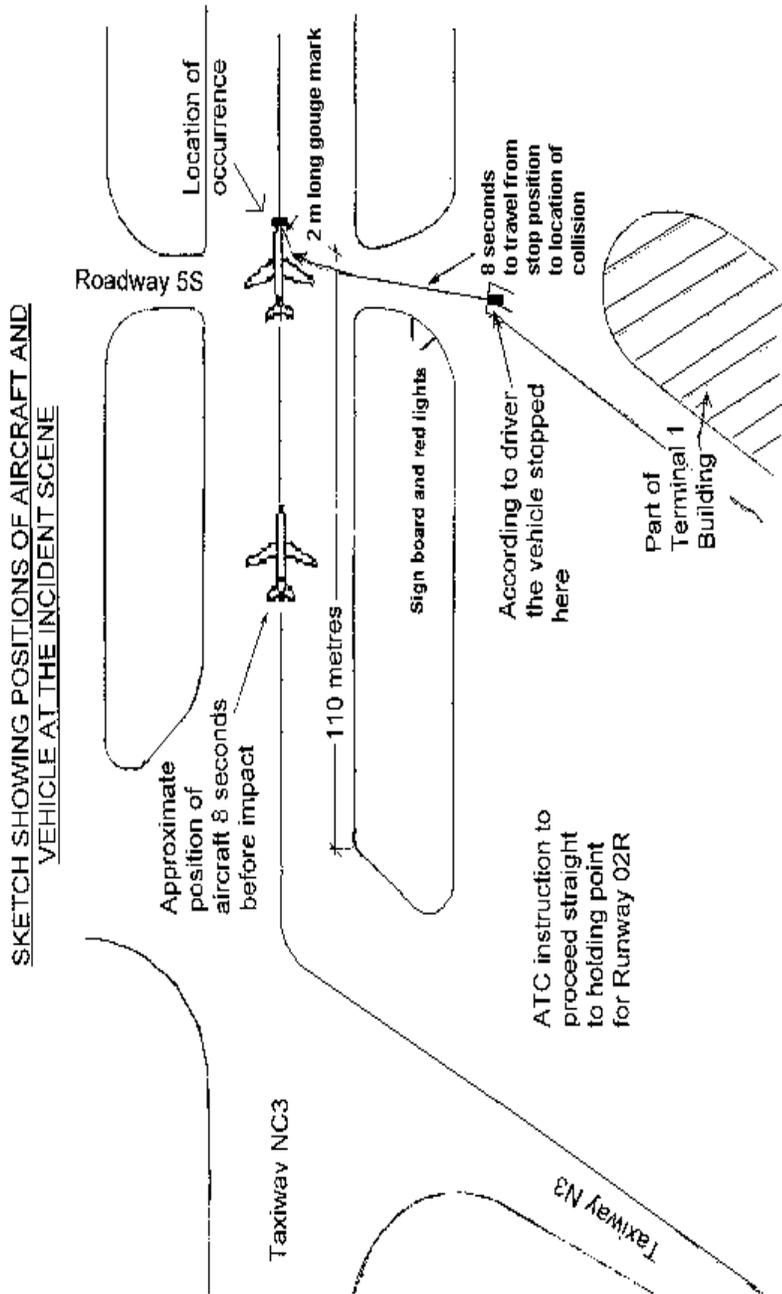
**Appendix 5**

Sketch showing positions of aircraft and vehicle at the incident scene
