# **FINAL REPORT**

**Runway Overrun Accident involving  
Arrow Air APWP5L  
McDonnell Douglas DC-8-62, N1804  
Singapore Changi Airport  
13 December 2002**

**AIB/AAI/CAS.002**

**Air Accident Investigation Bureau of Singapore  
Ministry of Transport  
Singapore**

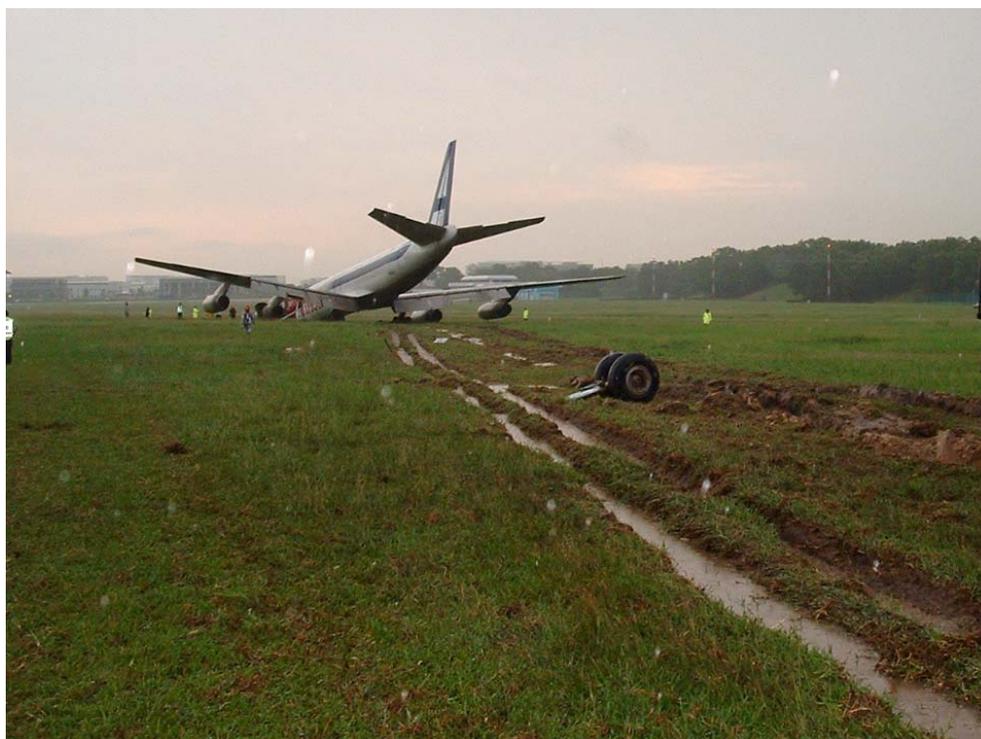
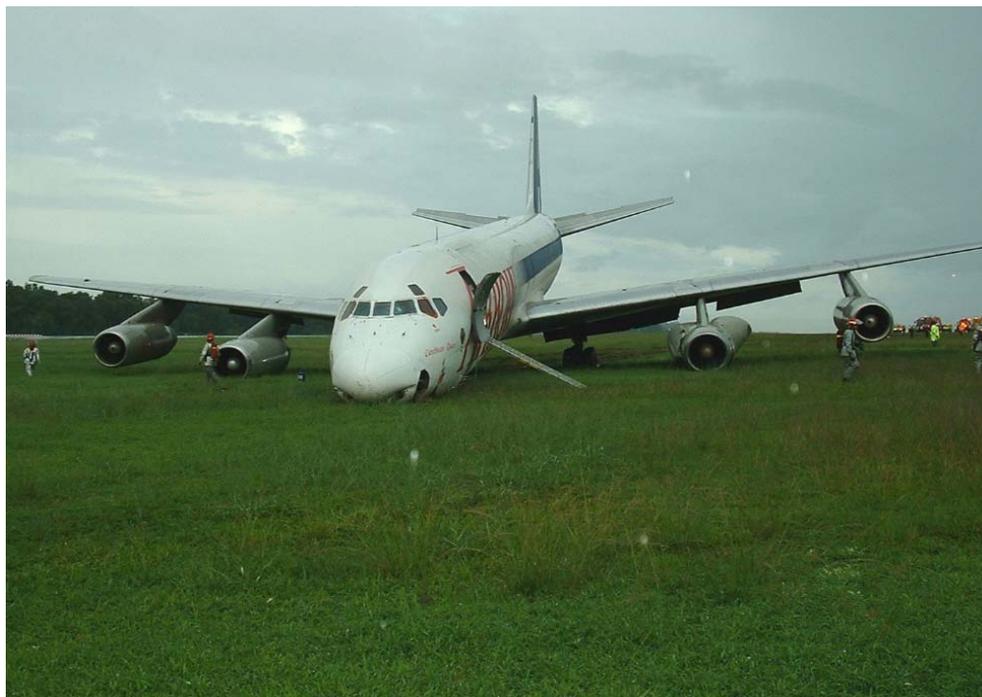
1.3.1 The aircraft's nose landing gear broke off halfway during the overrun. After the nose landing gear had broken off, the lower surface of the aircraft's front fuselage contacted the ground and ploughed through the grass and soggy area, and suffered serious damage as a result. Engines Nos. 2 and 3 (i.e. the two inboard engines) were also damaged.

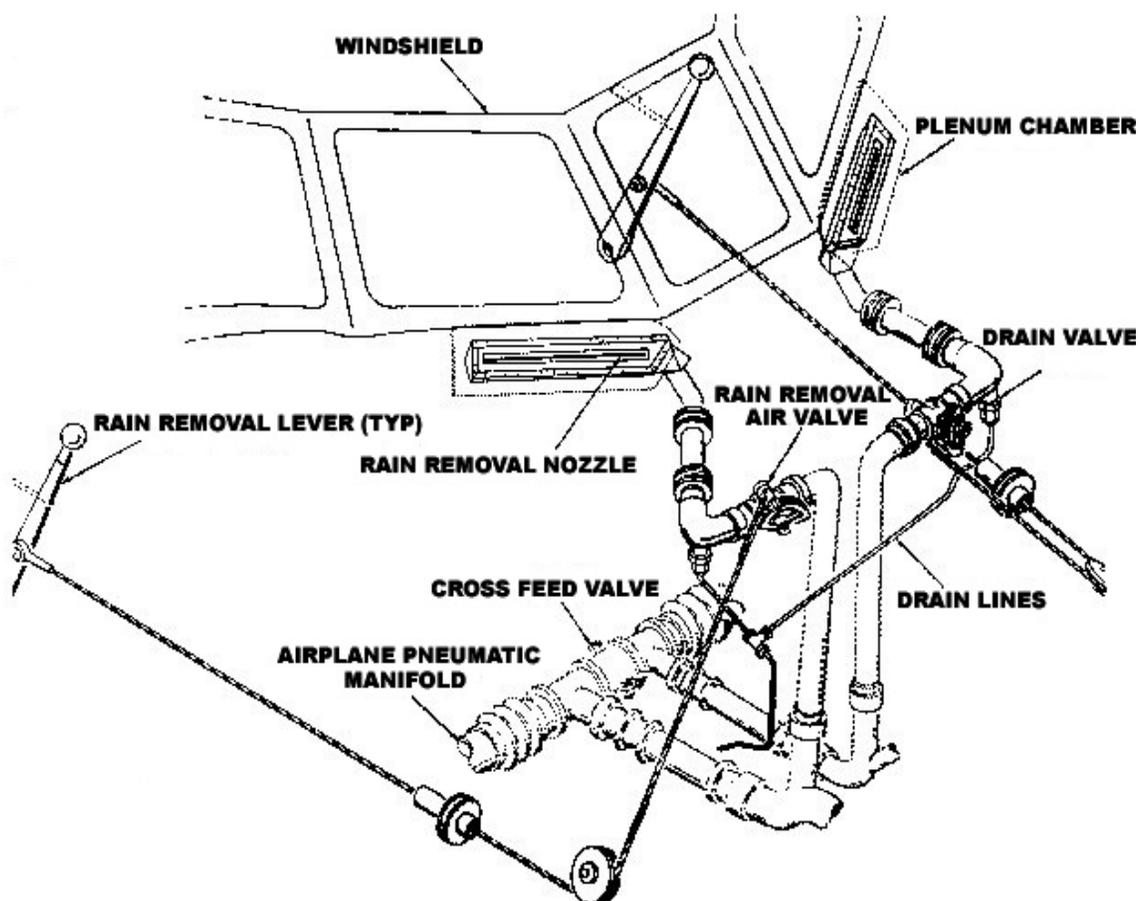
Figure 1. Windshield rain removal system

1.6.5.1 There were no windshield wipers used on the aircraft. The windshield rain removal system (see Figure 1) used hot air from the pneumatic system to blow away rain from the left and right windshields during flight.

- 2.4.1 At about 300 feet above ground, the PIC reported having the approach lights and runway lights in sight. However, the FO still could not see the lights as the windshield rain removal system on his side was not working effectively.
- 2.4.2 According to the PIC, the windshield rain removal system had not been used by the crew for several weeks and there were no reports of the system being inoperative. The cabling of the system was found to be intact after the accident and there was no indication of any mechanical failure of the system.
- 2.4.3 A reason for the ineffective rain removal from the FO’s windshield could be the heavy downpour and the direction of the rain.

- 4.6 The FAA review the effectiveness of DC-8's windshield rain removal system in very heavy rain. [AAIB Recommendation R-2004-020]
- 4.7 The International Civil Aviation Organization encourage research that could lead to the production of equipment that can accurately measure the braking action of runways under all conditions of surface contamination. [AAIB Recommendation R-2004-021]
