FINAL REPORT

BOEING B777-200 REGISTRATION OE-LPC COLLISION WITH AN AEROBRIDGE AT SINGAPORE CHANGI AIRPORT ON 17 JANUARY 2006

AIB/AAI/CAS.031

**Air Accident Investigation Bureau of Singapore
Ministry of Transport
Singapore**

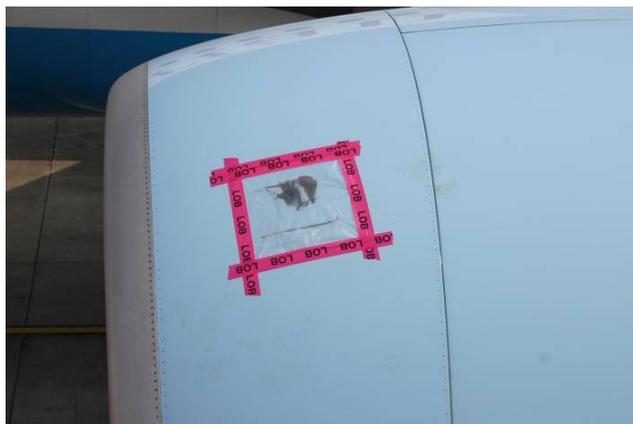
- 1.3.1 The left engine cowl suffered a puncture at the one o'clock position from making contact with the aerobridge (Figures 1 and 2).

Figure 1. Left engine cowling damage location at 1 o'clock position

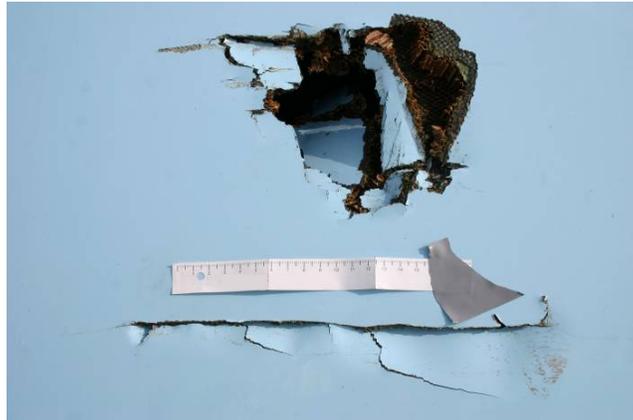
Figure 2. Damage to left engine cowling (close-up view)

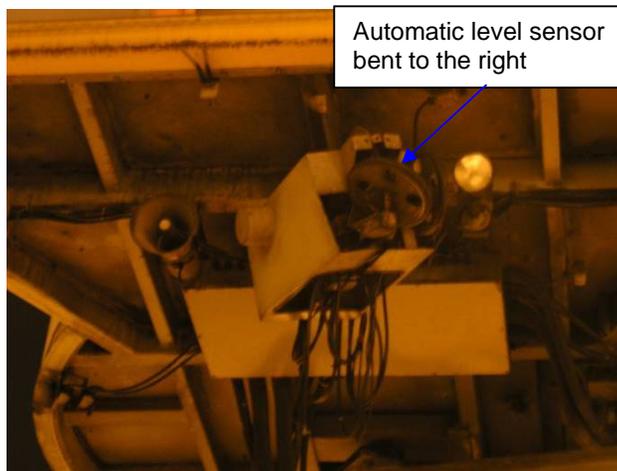
1.4.1 The aerobridge's automatic level sensor was damaged (Figure 3).

Figure 3. Damage to aerobridge automatic level sensor

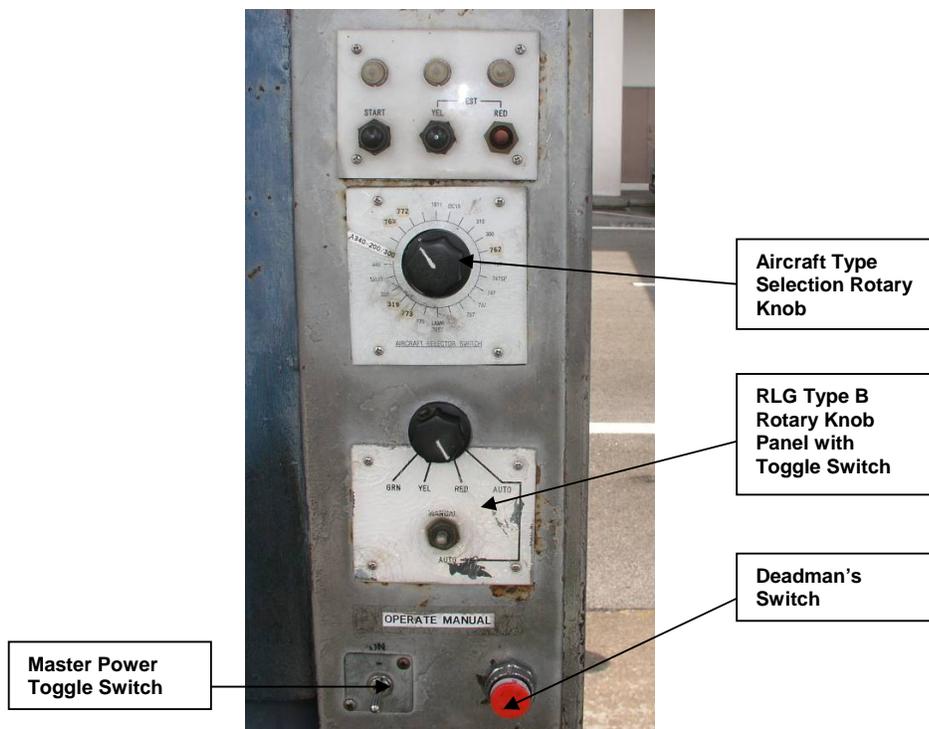
Figure 8. Bay F58 ADGS control panel

2.2.1 The position of the RLG Type B and Type C ADGS control panel was not conducive to the ADGS operator's task of monitoring the aircraft's taxi in and of ensuring that the correct indications were displayed on the ADGS. This was because the operator had to turn his body more than 90° to look at the aircraft and only half of the pairs of lights could be observed from the position of the ADGS control panel.

- 5.1 The airport operator has changed the Aircraft Docking and Guidance Systems (ADGS) at all the bays in Terminal 2 to a laser-based system similar to the one used in Terminal 1. The ADGS control panels have been standardised for all parking bays at Terminal 2. However, the position of the ADGS console remains the same (i.e. facing the terminal building). Nevertheless, the ADGS operators' workload is reduced. The operators' attention is predominantly on watching the aircraft as it taxis into the bay.

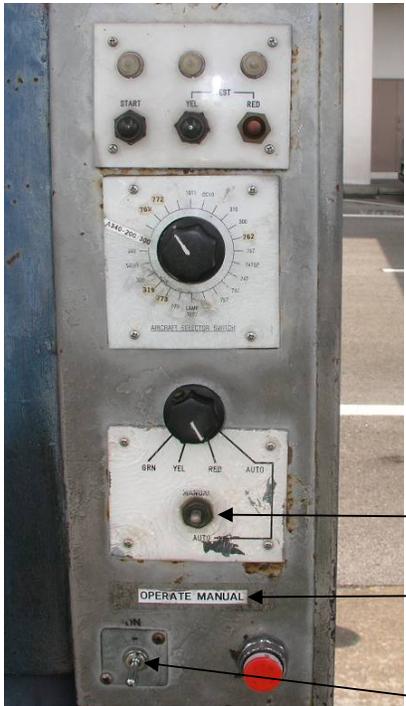
Figure 9. Bay F58 ADGS control panel

- 1.9.10 To ensure that the ADGS was kept in the manual position, an “Operate Manual” warning label was placed close to the toggle switch. The investigation team noted that at a number of bays, some of the “Operate Manual” labels as well as some other labels on the toggle switch section of the control panels were missing or partially painted over (Figures 9, 10 and 11).

Master Power 'Off'
label missing

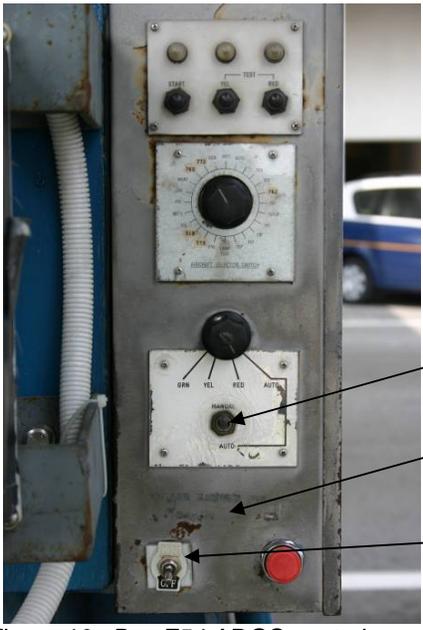
Figure 10. Bay F54 ADGS control panel

Operate Manual
label missing

Master Power 'On'
label missing
