## **FINAL REPORT**

Accident involving  
Philippines American Life Insurance Company Incorporated  
Beech Super King Air 300  
Registration RP-C1587  
at Seletar Airport, Singapore  
on 19 October 2000

**MOT/CA/RP-C1587**  
**Ministry of Transport**  
**Singapore**

**13 June 2003**

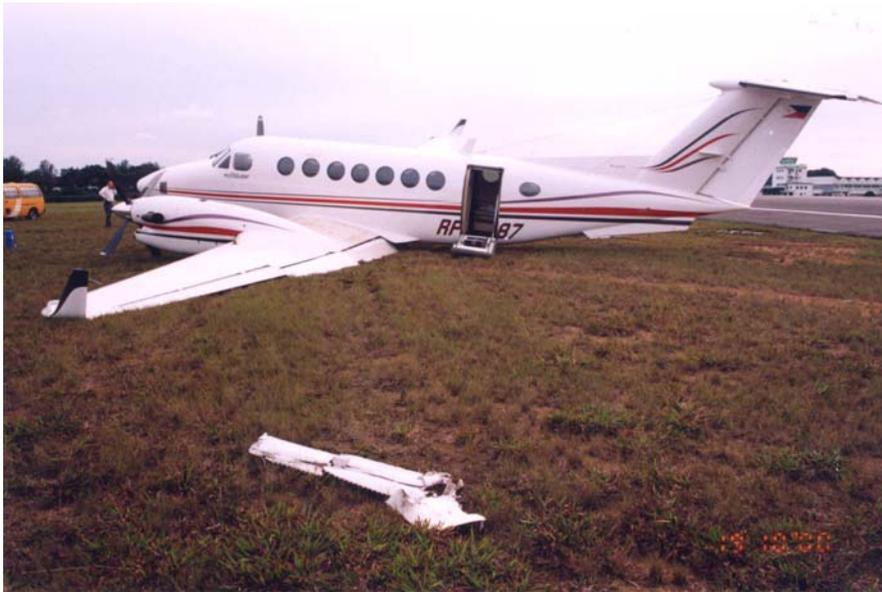
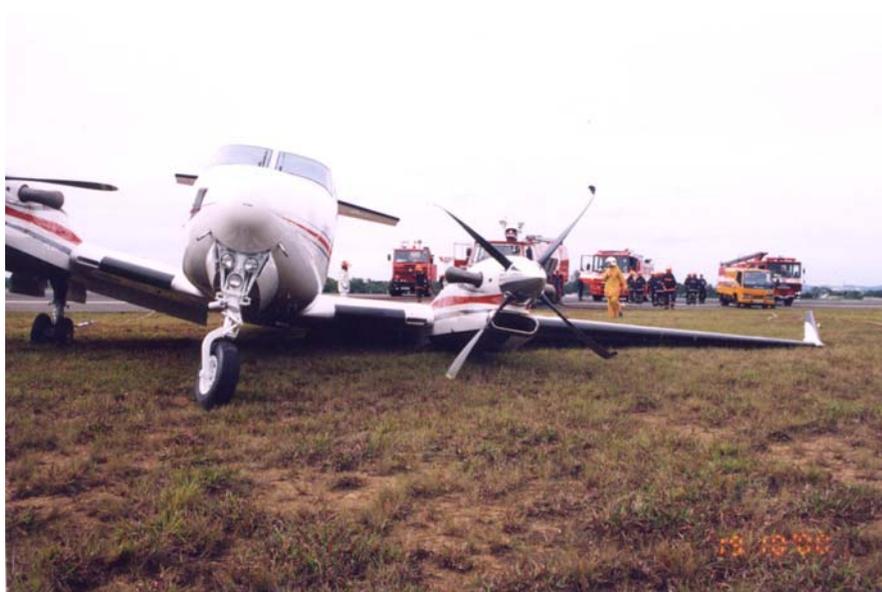
- 1.3.1 The aircraft sustained damage to the left main landing gear, left wing tip, left trailing edge flaps and left engine propeller blades during the landing.

- 1.12.1 The damage sustained by the aircraft was as follows:
- (a) Left main landing gear actuator was broken (landing gear collapsed).
  - (b) Left main landing gear bay area sustained damage on impact with the ground.
  - (c) Left wing tip had abrasion marks on the bottom surface.
  - (d) Left wing trailing edge flaps found with some parts dislodged, crumpled or bent.
  - (e) Left engine propeller blades were damaged and curled-up at all four blade tips.

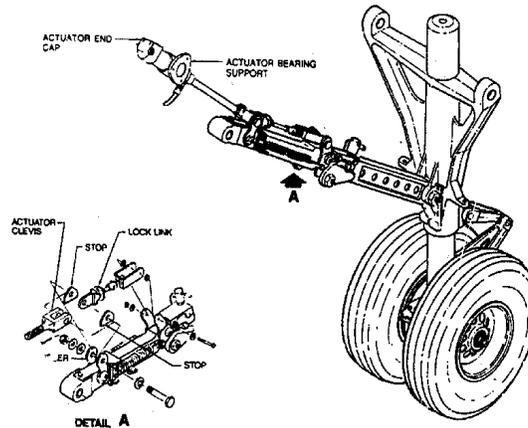
Left landing gear

1.16.1 The left main landing gear actuator clevis was found fractured. The fractured clevis and associated parts were initially sent to SETSCO Services Pte Ltd to conduct preliminary tests. Subsequently, these parts were sent to the ATSB for technical analysis to determine the nature and cause of the failure.

- 2.3.4 The above analysis indicated that the left main landing gear actuator rod had broken off at the threaded shank of the actuator clevis as a result of bending stresses causing overload fracture of an embrittled clevis.

- 4.1 The aircraft manufacturer should ascertain if there are other clevis that may have been hydrogen-embrittled during manufacture and if necessary review the heat treatment process for the clevis. [AAIB Recommendation R-2003-001]

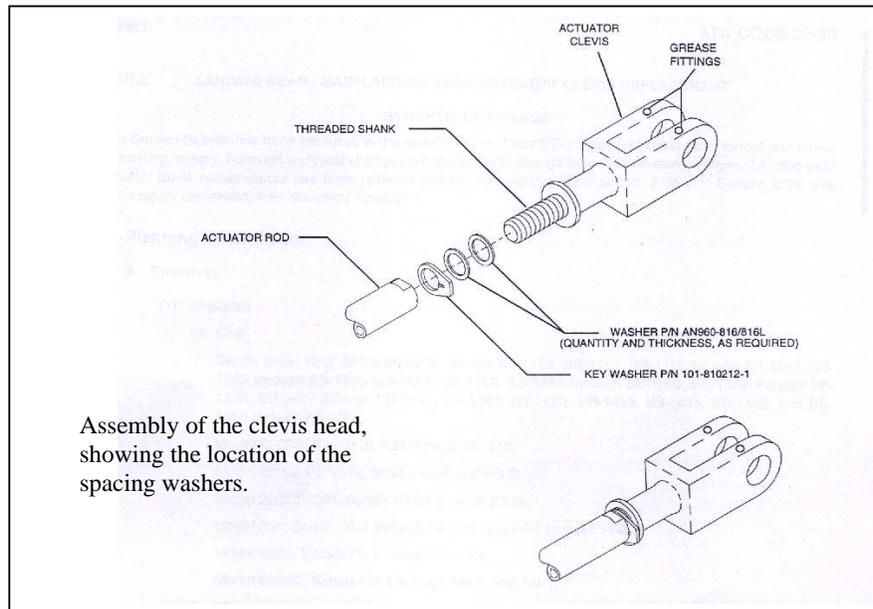
- 2.3.2 The results of the ATSB examination indicated that the clevis had failed through the base of the threaded shank as a result of intergranular fracture under bending loads. There was no evidence of pre-existing cracks or other physical defects that might have contributed to the clevis' failure. Such fracturing of the clevis is abnormal and is indicative of the material having been embrittled. Poor heat-treatment control of the steel would result in embrittlement. The hardness tests conducted showed that the material had an approximate tensile strength of 236,000 psi. The maximum specified strength of the component was 200,000 psi. The material would thus have a lower than intended resistance to shock or impact loads.

- 2.3.3 The ATSB examinations also found no evidence of contact between the clevis and the spacing washers. The contact faces of the clevis showed no indentations, scoring or other impressions on the paint that would be indicative of washer contact. It is probable that the clevis was installed without the prerequisite number of spacing washers between the clevis head and actuator rod. Without sufficient spacing washers, high bending stresses could be produced within the clevis shank. In the presence of material embrittlement, these bending stresses could result in the brittle overload fracture as experienced in this case.
