FINAL REPORT

**TAKE-OFF INCIDENT INVOLVING
BOEING 747-300, REGISTRATION HZ-AIT
SINGAPORE CHANGI AIRPORT
2 JUNE 2007**

AIB/AAI/CAS.040

**Air Accident Investigation Bureau of Singapore
Ministry of Transport
Singapore**

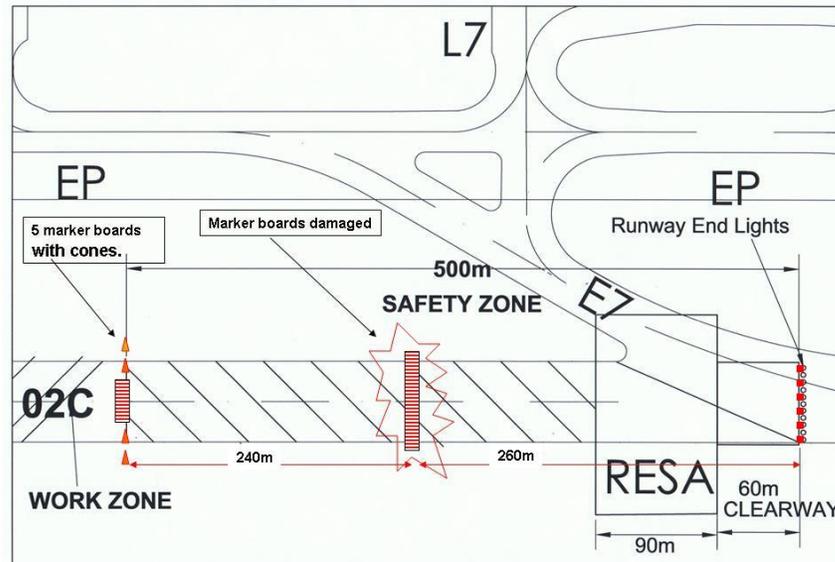
- 1.1.17 The work supervisor also observed that the first row of marker board lights located in the safety zone at 260 m from the temporary runway end lights went off after the aircraft took off. He went to check them and found that the first row of 13 marker boards was badly damaged. The second row of five marker boards remained intact but the red cones that were positioned on both sides of the five marker boards were blown off.

FIGURE 1 - Position of the first row and second row of marker boards

1.10.3 A row of 13 marker boards with lights was positioned across the runway about half way within the safety zone (260 m from the temporary runway end lights). The second row of 5 marker boards and rubber cones marking the start of the work zone were positioned 500m from the end of the temporary runway end lights (240 m from the first row of marker boards) (**Figure 1**).

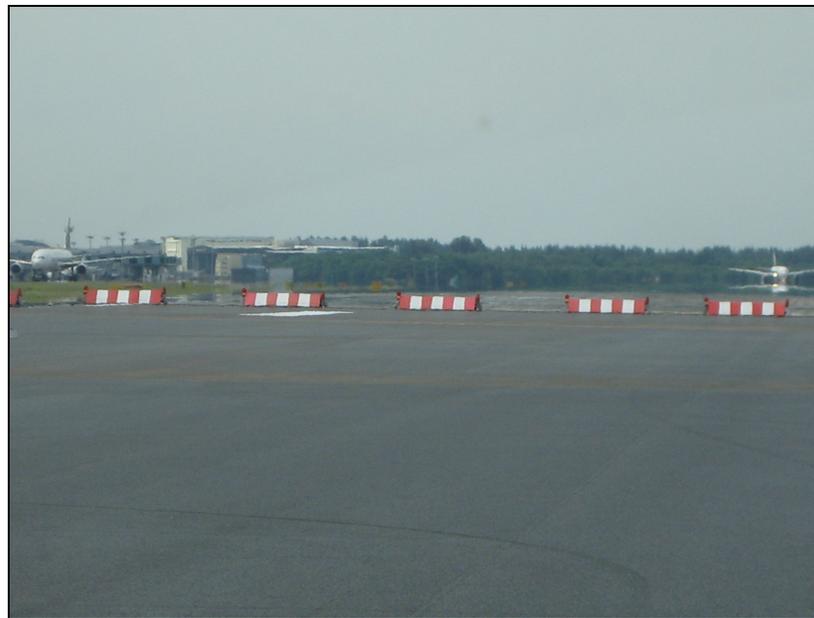
FIGURE 2 – A typical row of marker boards and lights, as placed at 260 m from the temporary runway end lights

1.10.2 A temporary row of runway end lights were positioned to indicate the end of runway at 2,500 m (**Figure 1** and **Figure 2**) with a row of blue edge lights indicating the edge of the last taxiway (E7) out of the runway. A safety zone of 500 m was established after the temporary runway end lights before the work zone started.

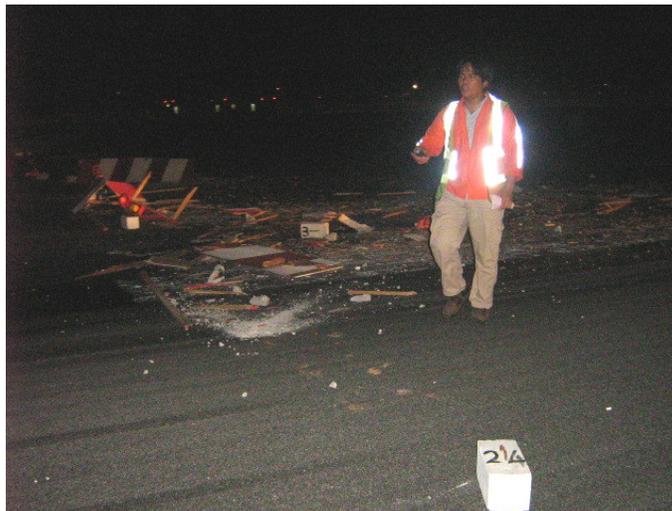
1.4.1 The runway end marker boards and light assemblies were damaged. Of the 13 triangular marker boards that were laid across the runway at 260m from the runway end, 11 were destroyed and some⁵ of the concrete blocks used to weigh down the boards were also damaged (See **Figure 3** and **Figure 4**).

FIGURE 3 - Damaged marker boards and concrete blocks

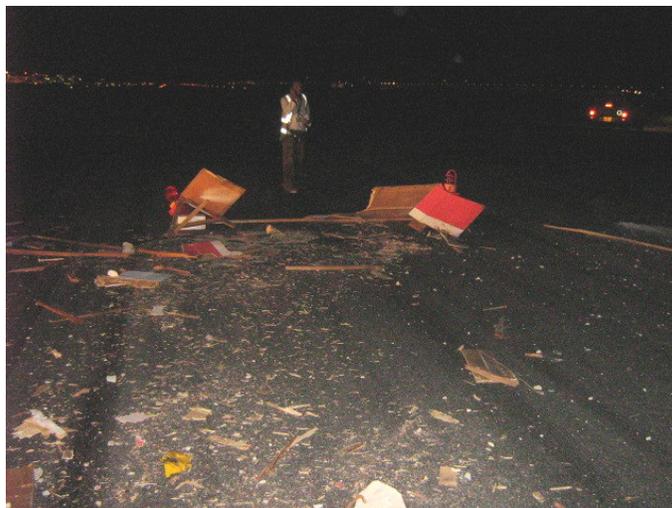
FIGURE 4 - Debris spread (photo taken against direction of take-off)

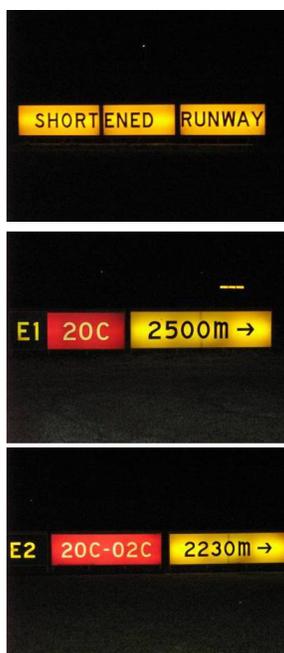
1.10.4 Along Taxiways E1 and E2, lighted signs were in operation to remind flight crew of the shortened runway (**Figure 5**).

FIGURE 5 - Lighted sign at taxiway intersections
