FINAL REPORT

AIRBUS A330-343, REGISTRATION B-HLM ENGINE FIRE EVENT

16 MAY 2011

AIB/AAI/CAS.074

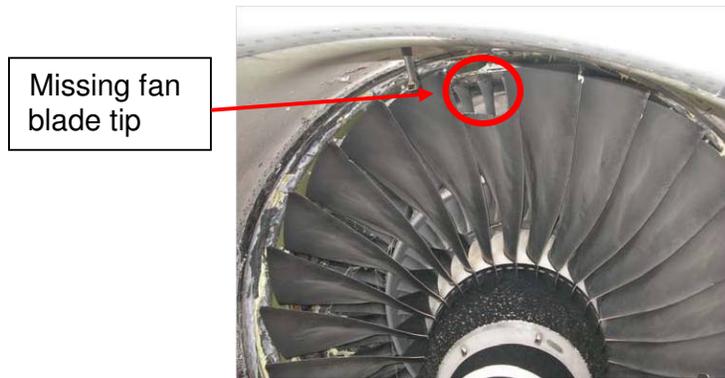
1.3.1.1 All the fan blade tips of the No.2 engine were damaged, with one of the blades having its tip missing (see **Figure 2**). The missing part was about 130 mm long.

Figure 2: One fan blade had a missing tip section (front view)

- 2.1.1 The No.2 engine vibration was a result of the engine's rotating assembly becoming unbalanced following the loss of a 130 mm tip section of one of the engine fan blades. The failure of the fan blade could be attributed to its mechanical strength having been compromised as a result of the use of an incorrect gas during the manufacturing process.

4.1.1 All in-service fan blades manufactured in the same batch as the failed fan blade in this incident have been recalled and inspected by the engine manufacturer. There was no similar manufacturing defect found in the recalled blades.

4.1.3 The engine manufacturer has included in its blade manufacturing process an additional laboratory inspection to ensure an acceptable microstructure is present on each fan blade.

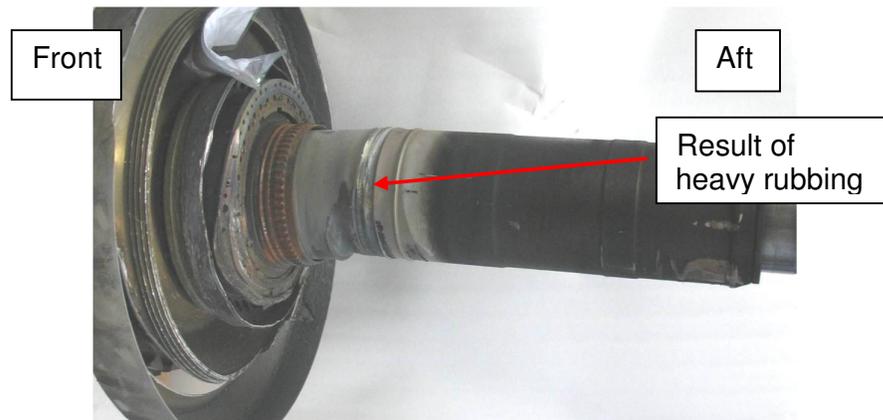
- 1.3.1.2 The LP shaft showed evidence of severe contact with the IP front stub shaft with heavy rubbing approximately 40 mm wide and extending 180° circumferentially. The LP shaft was deformed locally and had a significant bend coincident with the heavy rub (see **Figure 3**).

Figure 3: Damaged LP shaft

- 2.1.3 Since the second fuse did not function, the LP shaft came into contact with the IP stub shaft. Less severe secondary damage, caused by the release of a smaller section of blade, contributed to a slower decay in rotational speed of the LP and IP spools than those occurred in other fan blade loss events. This resulted in higher differential speeds between the contacting shafts for a greater duration, leading to increased localised heating and more severe bending of the LP shaft than had been seen with previous events.

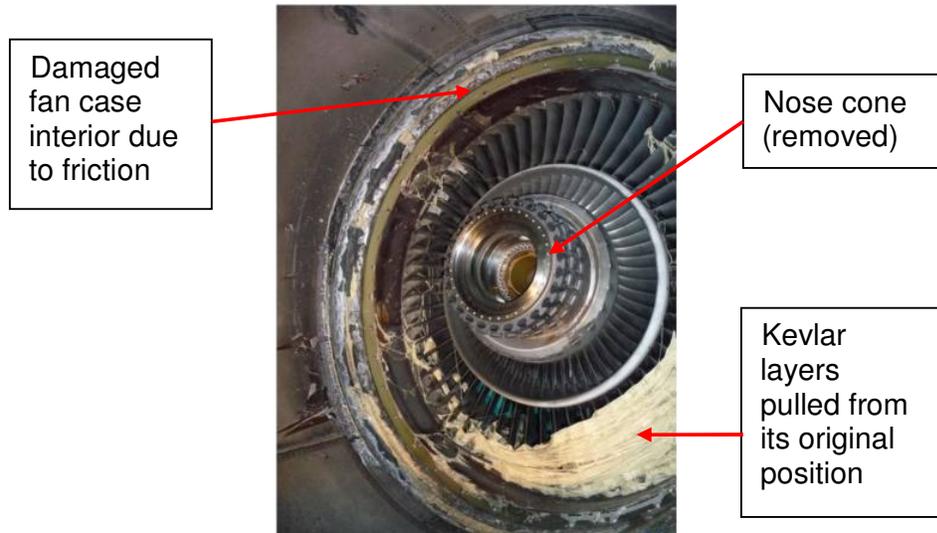
- 1.3.1.3 There was significant damage to the interior of the fan case (see **Figure 4**). The centre sections on all but two of the fan case retention panels were worn through by rubbing of the fan blades and some of the Kevlar layers were pulled out.

Figure 4: Damaged interior of fan case and Kevlar layers

- 2.1.4 The greater than normal bend in the LP shaft seen in this event, resulted in a heavier rub between the tips of the fan blades and the fan case interior around its full circumference, causing damage to the fan case and most of the fan case retention panels.

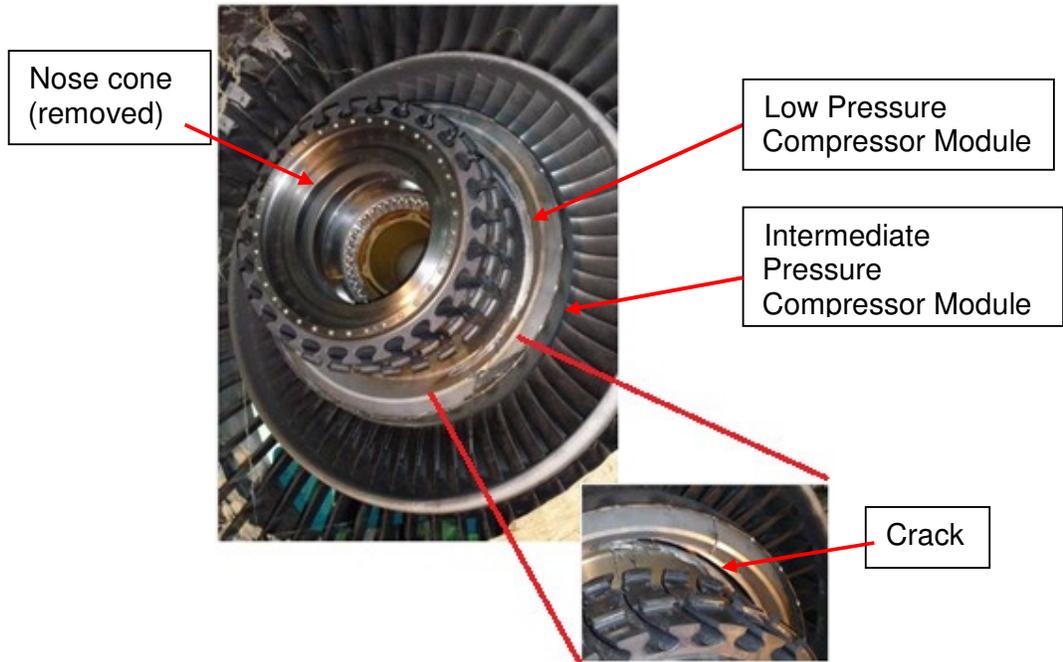
Figure 5: Hole in Low Pressure Compressor rear seal

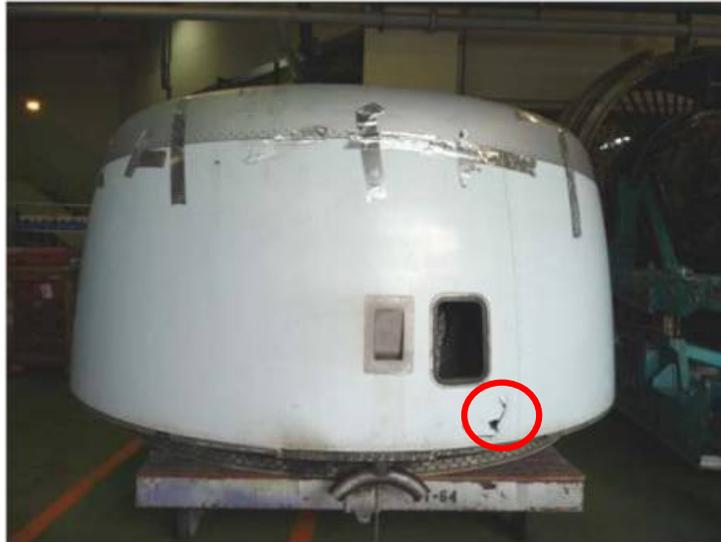
- 1.3.1.4 The front section of the engine (i.e. the fan case, engine intake and fan cowl door) had shifted forward and left a 30 mm gap between the front section and the thrust reverser unit.
- 1.3.1.5 A crack was found at the boundary of the Low Pressure Compressor Module and the Intermediate Pressure Compressor Module near the nose cone (see **Figure 5**).
- 1.3.1.6 Some nicks and tears were also found on the engine intake cowl acoustic panels (see **Figure 6**). The engine inlet cowl acoustic panel adjacent to the P20/T20 probe had a puncture through the inner and outer skin (see **Figure 7**).

Figure 7: Puncture on engine inlet cowl outer skin (top view)

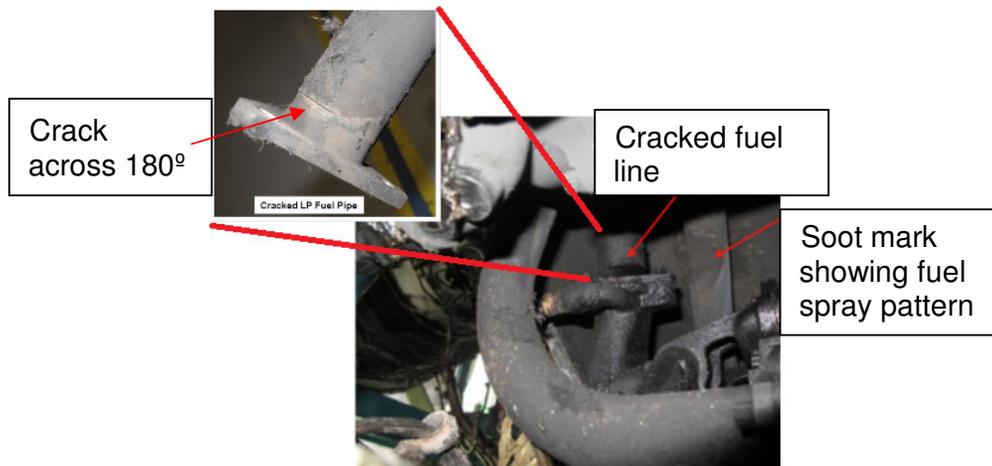
1.3.2.1 The No.2 engine fuel line next to the engine fuel pump (which supplied fuel from the wing fuel tank to the fuel pump) was found to have a 180° crack around the edge of the tube end-fitting weld (see **Figure 8**). There were signs of fuel spraying onto the surface of a nearby pipe.

Figure 8: Cracked fuel pump supply line with fuel spray marks in the vicinity

1.3.2.2 Examination of the fracture surfaces of the crack by the engine manufacturer indicated high stress fatigue initiating from multiple sites around the inner surface of the tube towards the outer surface.

- 3.1.4 The fuel pump supply line cracked due to high vibrations, resulting in fuel leak. It was likely that the heat from the burning Kevlar layers ignited the leaked fuel.

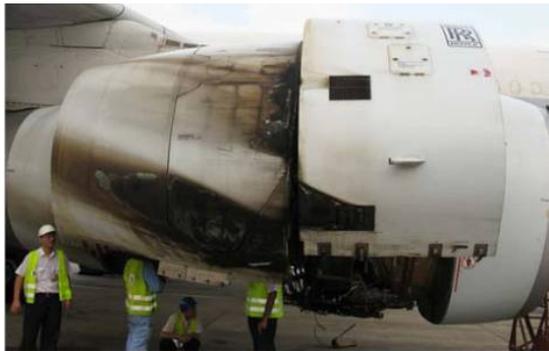
1.8.1 There was soot on the right side of the No.2 engine (see **Figure 9**) exterior surface, and on the interior surface of the right fan cowl door (see **Figure 10**).

Figure 9: Right side of No.2 engine

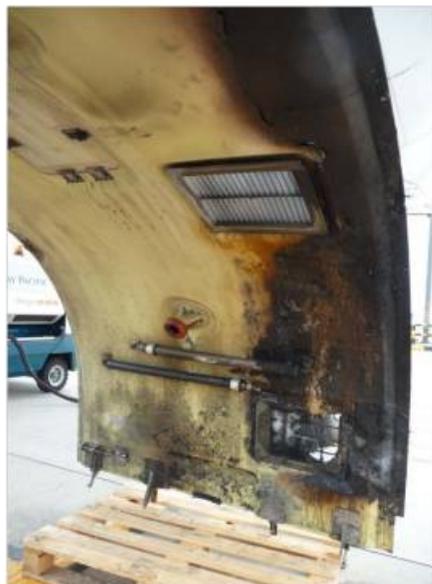
Figure 10: Interior of No.2 engine right fan cowl door

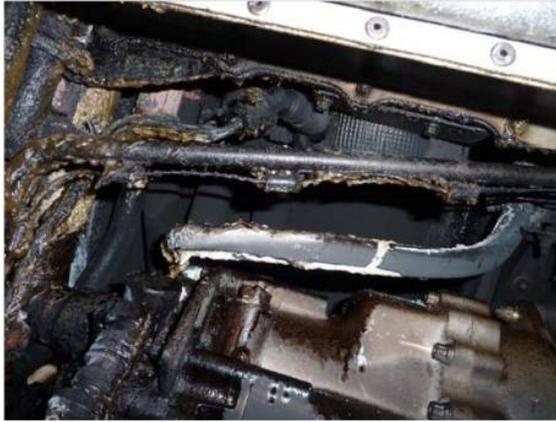
1.8.2 There was fire damage to the accessories located on the right side of the engine, such as pipes, electrical harness under the air oil heat exchanger (AOHE) and the fuel pump, electrical harness near the fuel flow transmitter, and the underside of the fan case (see **Figure 11** to **Figure 14**).

Figure 11: Fire damage to the AOHE

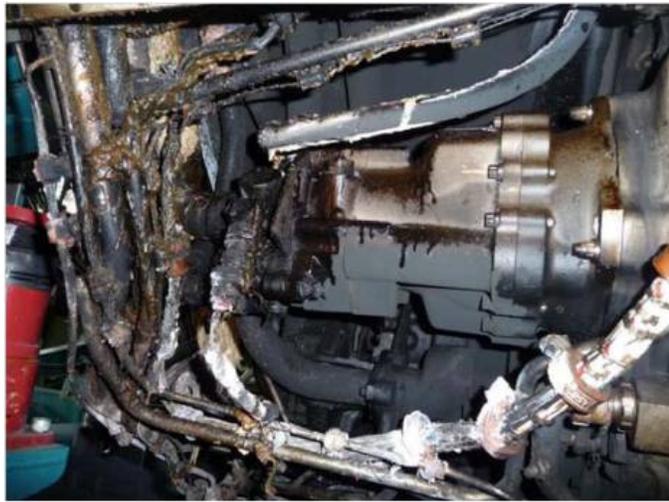
Figure 12: Fire damage to the fuel pump

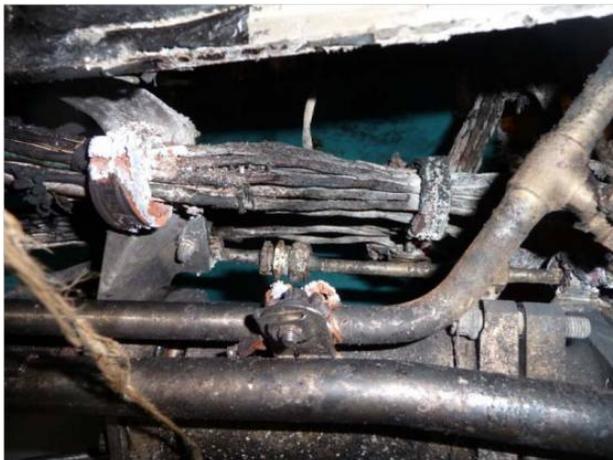
Figure 13: Fire damage to electrical harness near fuel flow transmitter

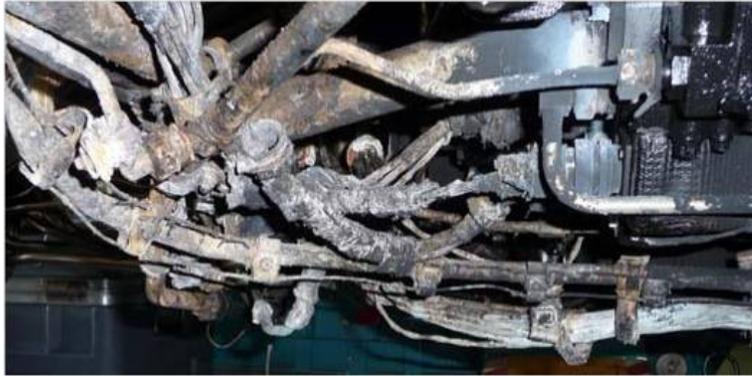
Figure 14: Fire damage to underside of fan case

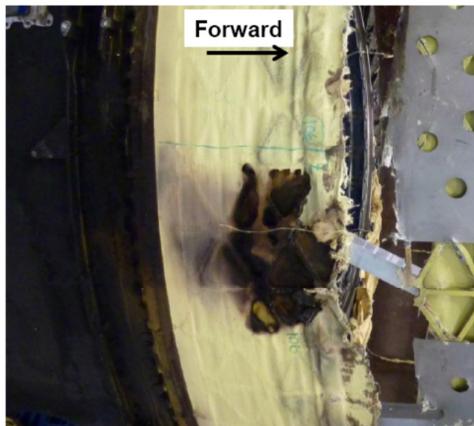
- 1.8.3 The Kevlar layers at the bottom of the engine were burnt (see **Figure 15**). The burnt pattern indicated that the burning had started from the inner layers.

Figure 15: Burnt Kevlar at bottom of engine

2.2.1 The rubbing of the fan blade tips against the interior of the fan case generated a lot of heat, as evidenced by the burnt Kevlar layers.

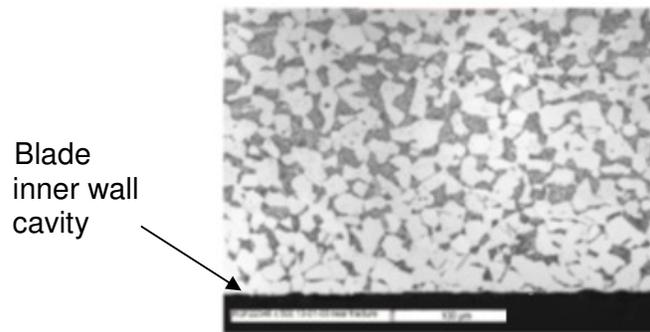
- 1.9.3.3 The examination by the engine manufacturer revealed that the material at the surface of the blade's cavity had less beta phase microstructure compared with a normal blade material sample (see **Figure 17**). This phenomenon is known as 'diffused beta-denuded layer' and would weaken the mechanical strength of the material.

Figure 17: Microstructure at the inner cavity wall of the failed fan blade

1.9.3.4 Investigation by the engine manufacturer revealed that an incorrect gas was used in the manufacture of the failed fan blade. This resulted from the installation of an incorrect gas cylinder during a routine gas cylinder replacement. This gas cylinder was meant for maintenance welding operations and not for fan blade manufacturing. Tests have shown that blades manufactured with this gas resulted in a similar material microstructure to that observed on the failed fan blade.

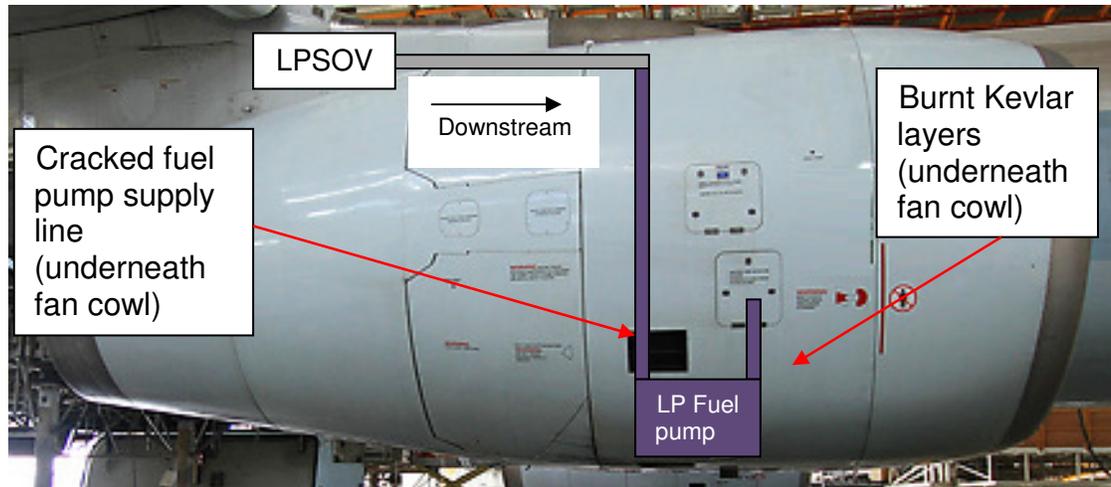
2.2.2 The fan blade failure caused severe vibration of the No.2 engine. It was likely that this vibration generated loads in the fuel line supplying the No.2 engine which resulted in a crack forming and subsequently fuel spraying out from the opening in the fuel line (see **Figure 19**).

Figure 19: Relative location of cracked fuel line and heat source (block diagram of fuel line from LPSOV viewed from engine exterior, not drawn to scale)

2.2.3 As the rotating fan blades rubbed against the inner circumference of the fan case, the heat generated was high enough to burn through the Kevlar. It was likely that the heat from the burning Kevlar ignited the fuel from the cracked fuel supply line and the burning fuel then caused further fire damage to the engine.
