FINAL REPORT

LEARJET 35A, REGISTRATION RP-C5354 RUNWAY OVERRUN ACCIDENT AT SINGAPORE SELETAR AIRPORT ON 21 AUGUST 2007

AIB/AAI/CAS.043

**Air Accident Investigation Bureau of Singapore
Ministry of Transport
Singapore**

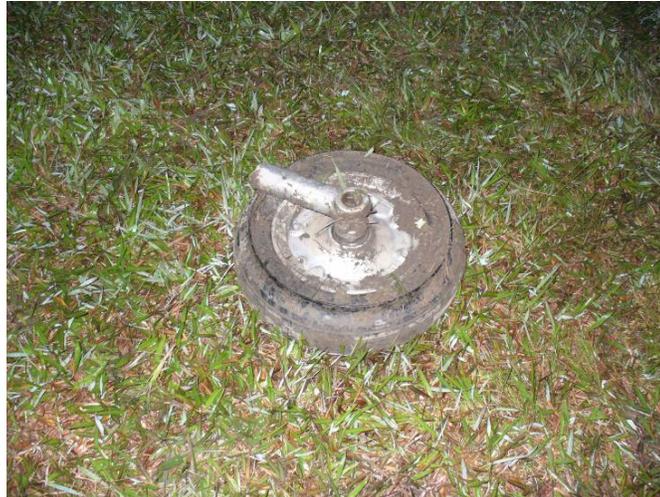
1.1.8 The nose wheel was found on the grass in close proximity to the aircraft. There were no gouges or markings on the paved runway surface. This suggests that the nose gear broke after the aircraft had left the paved runway surface (see **Figure 1**).

Figure 1. Aircraft nose wheel broken from its axle

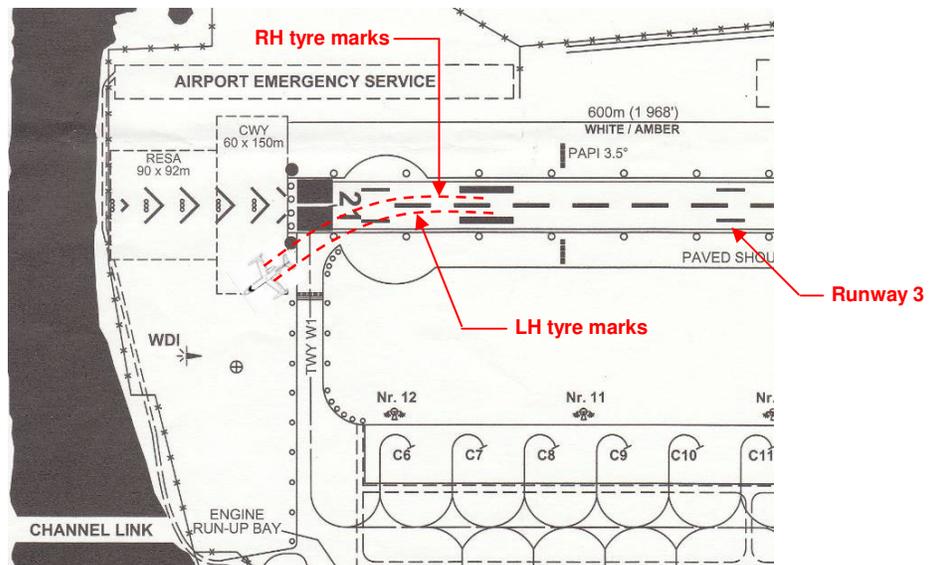
1.1.7 The aircraft was approaching the runway end and the flight crew decided to veer the aircraft to the left towards the grass area and tried to stop the aircraft on the grass area as they were aware of a water channel beyond the end of Runway 03.

1.1.9 The aircraft came to a stop at the intersection of Runway 03 and Taxiway W1 (see **Figures 2 and 3**).

Figure 2. Aircraft path off Runway 3 to the grass verge

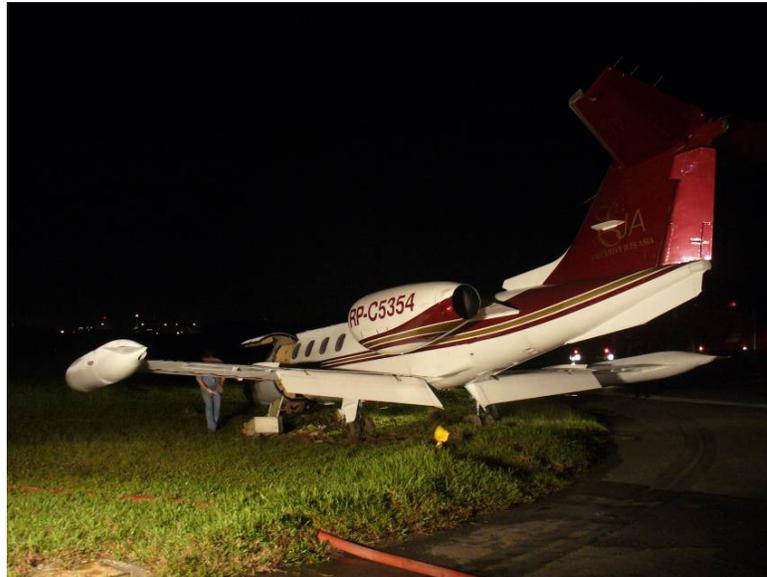
Figure 3. Aircraft on grass verge

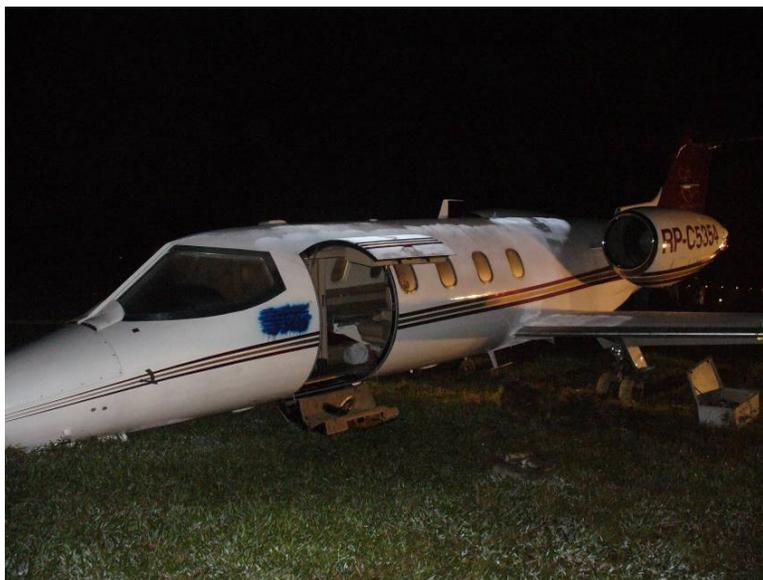
- 1.3.1 There was no fire. The aircraft suffered damage to the nose gear, nose gear doors, radome, nose lower structure, pilots' windshield. The nose, forward and aft fuselage of the aircraft had signs of wrinkled deformation. There were also crack marks on the ventral fin and the vertical stabiliser (see **Figure 4**).

Figure 4. Nose gear collapsed
