INCIDENT REPORT

Runway Excursion Incident

Boeing 777-200 Registration 9V-SRG

AIB/AAI/CAS.016

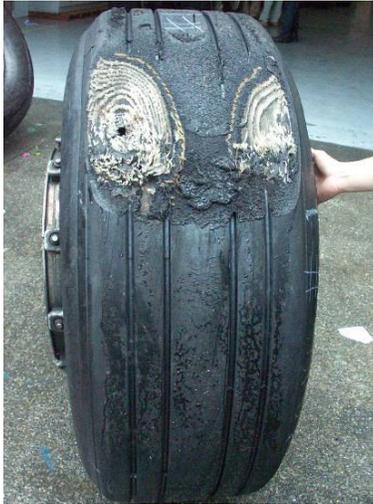
Tyre No. 1

- 1.18.2 Two tyres fitted at the No.1 and No.9 positions were sent to the tyre manufacturer, by the operator, for examination and analysis. The report from the tyre manufacturer indicated that both tyres had severe flat spotting and exposed belt plies. The damage appeared to have been initiated by reverted-rubber aquaplaning. The level of abrasion on the tyres also indicates that the tyres were blocked from rolling for some period, while in contact with the runway surface.

- 1.18.3 The report also indicated that the tread wear pattern of No.1 tyre showed an overload condition or partial or full loss of pressure, which resulted in the shoulder areas abrading more than the centre tread area. This tyre was apparently blocked from rolling for a greater distance than the No.9 tyre as the amount of tread rubber abrasion was much more.
