FINAL REPORT

**AIRBUS A320-231, REGISTRATION VT-ESF
LEFT HAND MAIN LANDING GEAR
BOGIE BEAM FRACTURE
AT SINGAPORE CHANGI AIRPORT
26 NOVEMBER 2005**

AIB/AAI/CAS.029

**Air Accident Investigation Bureau of Singapore
Ministry of Transport
Singapore**

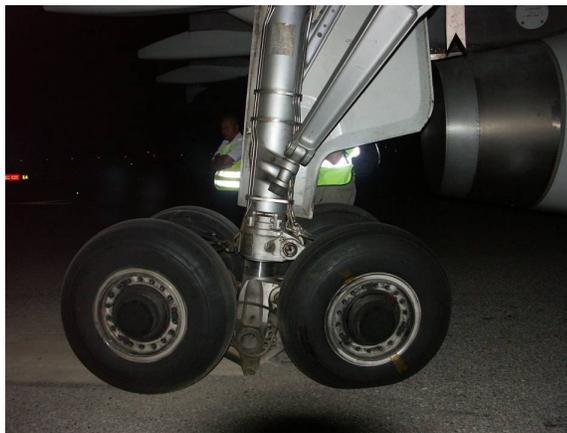
- 1.1.1 At 10.20 p.m. on 26 November 2005, an Airbus 320 departing from Singapore Changi Airport to Chennai suffered a fracture to the left hand main landing gear (MLG) bogie beam while taxiing on Taxiway EP. The aircraft came to a stop between taxiways B2 and B3 (see **Figure 1**). There were no injuries in this incident.

Figure 1: Left hand MLG bogie beam failure

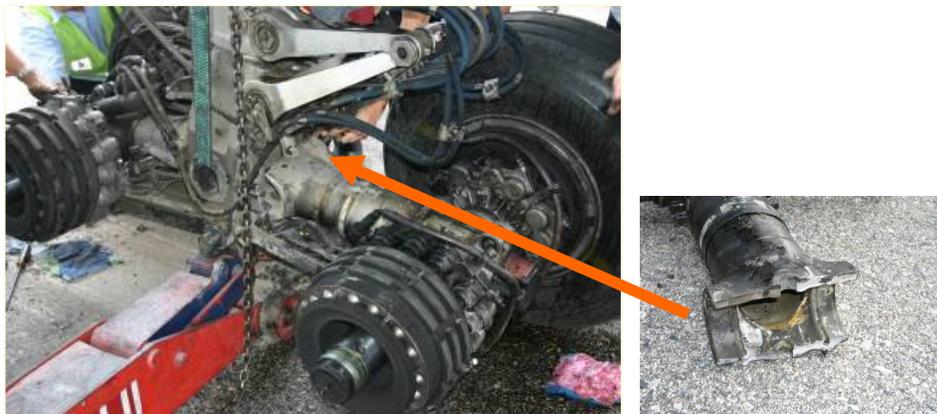
- 1.2.1 The left hand MLG bogie beam fractured into two parts at the pivot pin attachment hole (see **Figures 2 and 3**).

Figure 2: The bogie beam fractured into two parts at the level of the bogie pivot pin attachment hole.

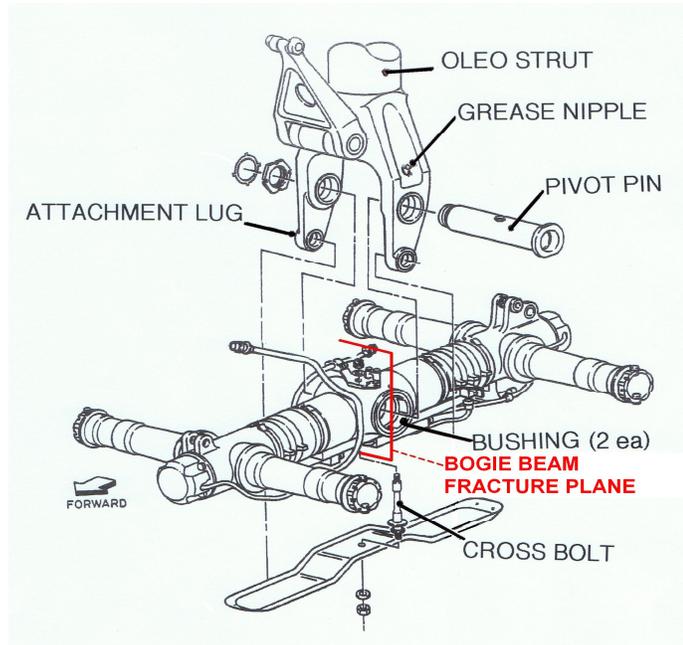
Figure 3: Bogie beam fracture plane

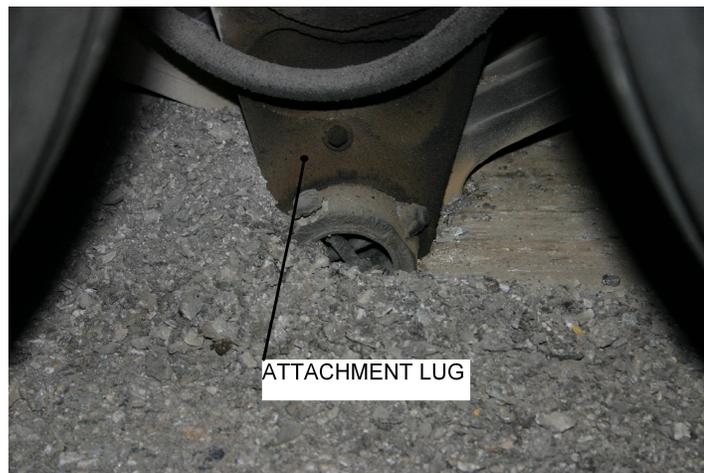
1.2.2 The left MLG oleo strut attachment lugs suffered scuffing from being dragged on the ground for about 50 metres before the aircraft came to a stop. The attachment lugs were found dug into the asphalt due to the weight of the aircraft (see **Figure 4**).

Figure 4: The left MLG oleo strut attachment lugs dug into the asphalt

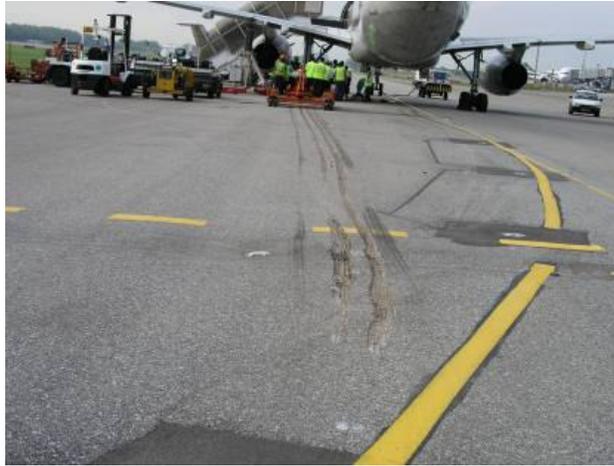
1.2.4 The taxiway surface suffered gouges (over a distance of about 50 metres, with varying depths of between 1 and 2 cm) from Taxiway B2 to where the aircraft stopped (see **Figure 5**).

Figure 5: Gouging on Taxiway (about 50 metres)

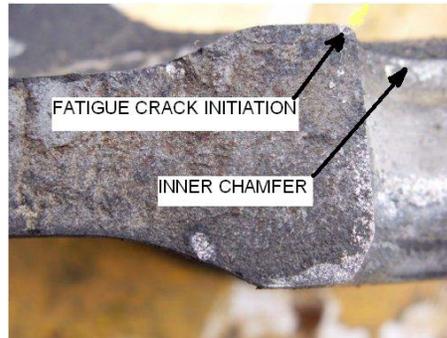
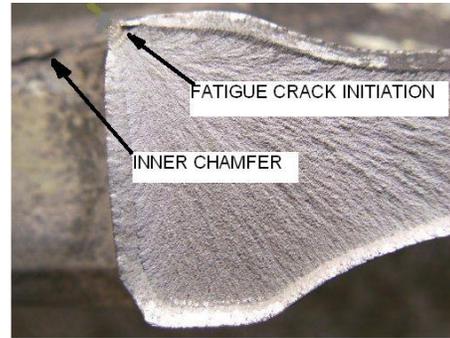
- There were corrosion pits underneath the cadmium plating.
- The cause of the bogie beam fracture was the corrosion pits that had developed at the radius intersection of the bogie pivot pin bore and the cross bolt hole. At two locations at the bogie radius

intersection, fatigue cracks initiated and propagated from these corrosion pits (see **Figures 6 and 7**). Stress corrosion cracking finally led to the bogie fracture.

AFT-1 and AFT-2 surfaces showing evidence of fatigue crack initiation. (See paragraph 2.1 in Appendix A for the locations of AFT-1 and AFT-2.)

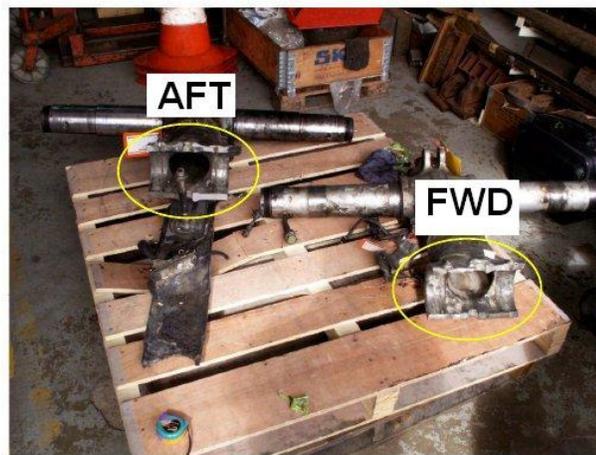
Figure A1: FWD and AFT bogie beam sections

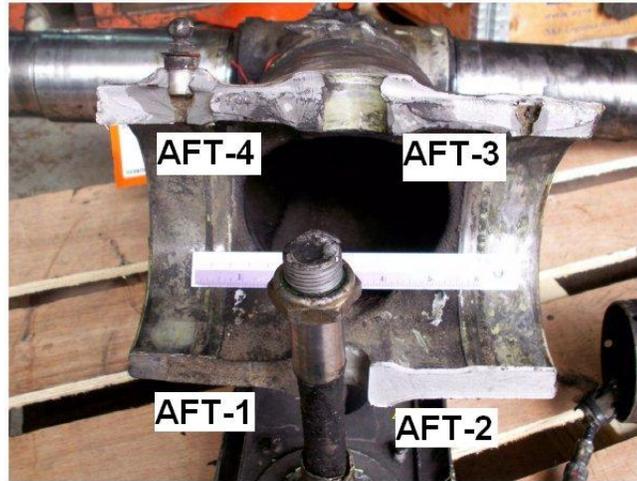
Figure A2: Designation of the aft fractured surfaces

- The chemical composition and hardness values were within the material specifications.
- Visual inspection of the fracture surface on the bogie beam found that AFT-1 was dull in appearance with signs of rusting. AFT-2, AFT-3 and AFT-4 appeared bright and fresh, with chevron marks and shear lips on the fracture surfaces. This indicates that delayed fracture might have occurred on AFT-1, whereas the rest were probably due to fast fracture. Fatigue fracture had originated from the chamfer of the bottom cross bolt hole.

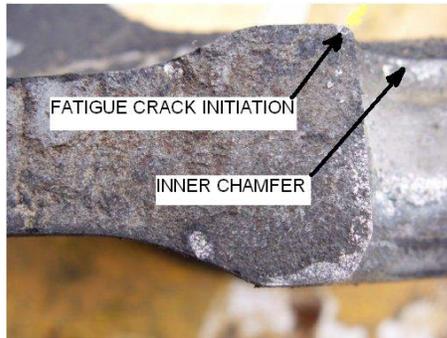
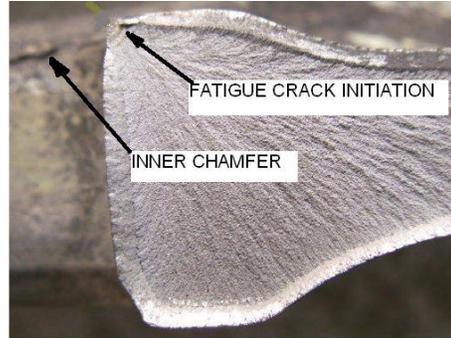
- Although AFT-2 appeared bright and fresh, evidence of fatigue cracking was observed at the inner chamfer. Fatigue fracture had initiated from some corrosion pits (see **Figures A3** and **A4**).

AFT-1 and AFT-2 surfaces showed evidence of fracture initiation.

- (1) Corrosion pits initiated at the inner chamfer. These corrosion pits date back to the overhaul period or sooner as they were covered by the protection layers at part refurbishing. They are due to lack of or defective cadmium protection layers.
- (2) Fatigue crack initiated and propagated from these corrosion pits. No initiation date can be given for this crack. The surface smoothness could indicate that it started a little bit sooner than AFT-2.
- (3) Crack growth mechanism changed from fatigue cracking to a stress corrosion cracking process (SCC) after about 1 mm of fatigue propagation.
- (4) Final ductile rupture occurred when the fracture toughness was reached after about 80 mm of SCC crack propagation.

- (1) Corrosion pits initiated at the inner chamfer.
- (2) Fatigue crack initiated and propagated from these corrosion pits at a time close to (a)(2) above.
- (3) Final ductile rupture occurred when the fracture toughness was reached after about 2 mm of fatigue crack propagation.

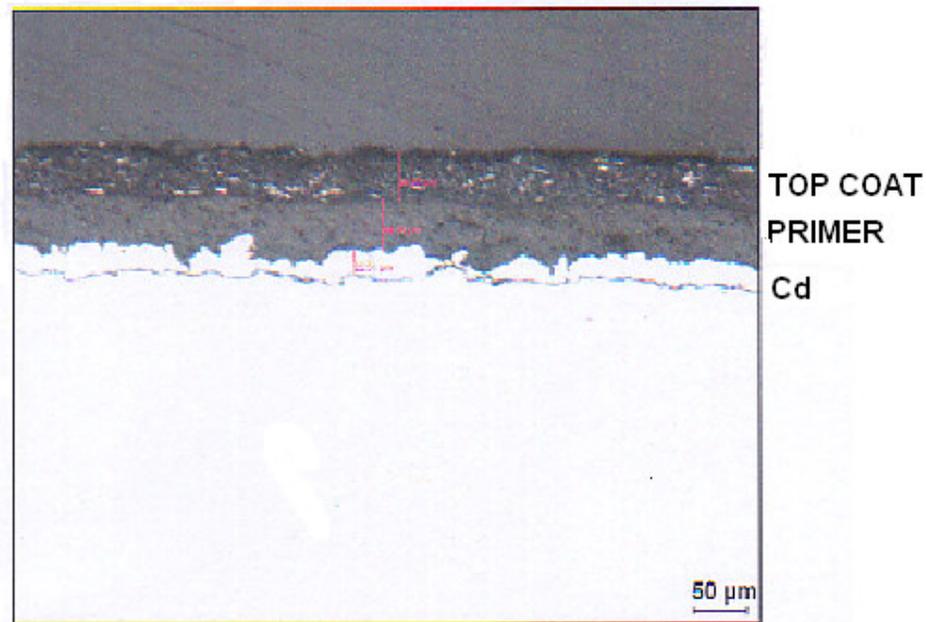
- The thickness of the top coat (paint) and cadmium plating on the outer surface of the bogie beam were within the specifications (see **Figure A5**). But examination of the inner chamfer of the cross bolt bore revealed that thickness of the primer and cadmium plating were out of the specifications. Corrosion pits were observed on the inner chamfer. This may be due to moisture condensing on the surface.

Figure A5: Micrograph showing the top coat, primer and cadmium plating.

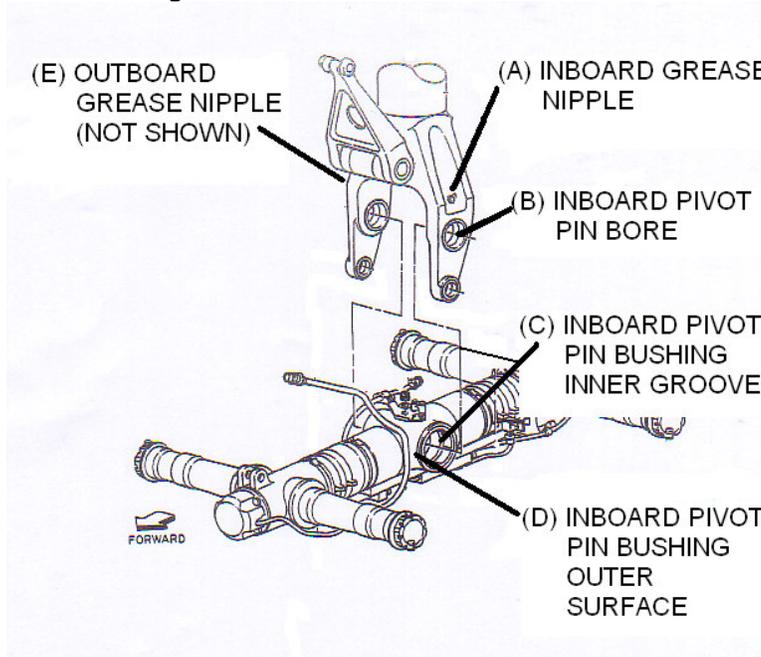
2.4 Preliminary visual inspection revealed that the grease around the pivot pin bushings and on the bogie beam appeared to have dried up and was black in colour. Five grease samples were examined. The grease samples were taken from the following locations on the left hand MLG (see **Figure A6**):

The examination revealed a high level of chromium in the grease from the inboard pivot pin bushing inner groove. This indicates considerable wear in the bushing contact area.

Figure A6: Bogie beam grease sample locations

- 5.1 Although the lack of lubrication at the pivot pin bushing contact area may not have contributed to the bogie beam fracture, it is recommended that the operator should review its lubrication procedure for the bogie beam to ensure that the bushing contact area is adequately lubricated. (R-2009-006)

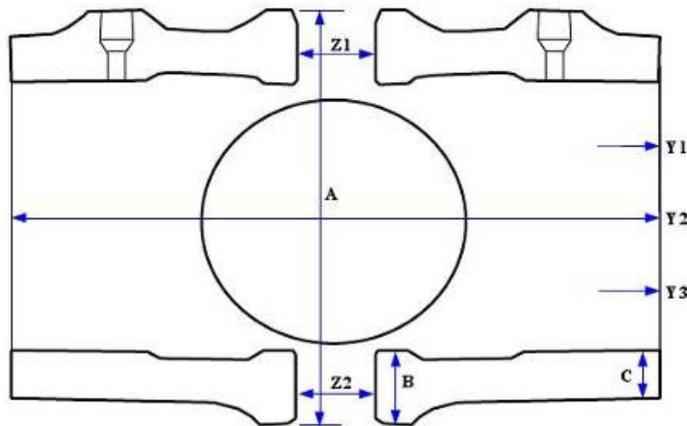
Figure A7: Bogie beam dimension values

2.5 The bogie beam dimension values were close to the specified values (see **Figure A7**).
