FINAL REPORT

CESSNA 172R, REGISTRATION 9V-FCI

AIRCRAFT VEERING OFF RUNWAY

AIB/AAI/CAS.076

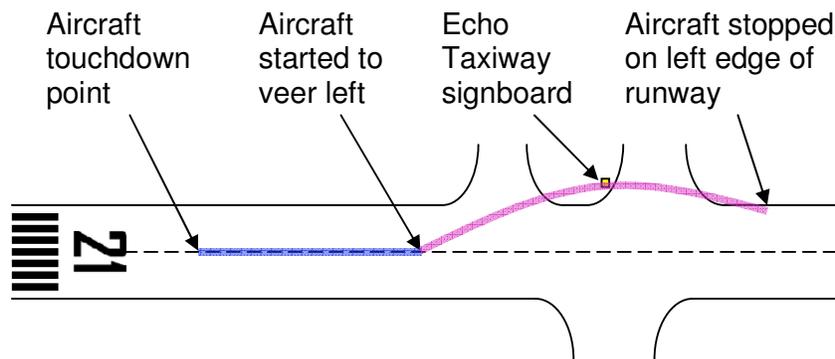
Figure 1: Ground path of the aircraft *(Not drawn to scale)*

- 1.1.1 At 11.50 a.m. on 27 June 2011, a Cessna 172R aircraft from a local flying college, piloted by a student pilot, momentarily veered off the left edge of the runway after landing on Runway 21 in Seletar Airport. The aircraft went onto the grass patch and hit the Echo Taxiway signboard before returning to and stopping on the runway. **Figure 1** is a sketch of the aircraft's ground path.

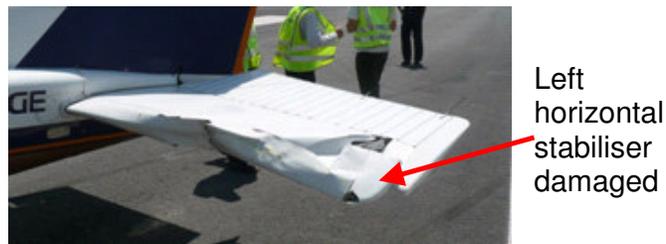
Figure 2: Damage of horizontal stabiliser

1.3.1 The aircraft's left horizontal stabiliser hit the Echo Taxiway signboard and was damaged (see **Figure 2**). The right aft of the fuselage was also damaged (see **Figure 3**).

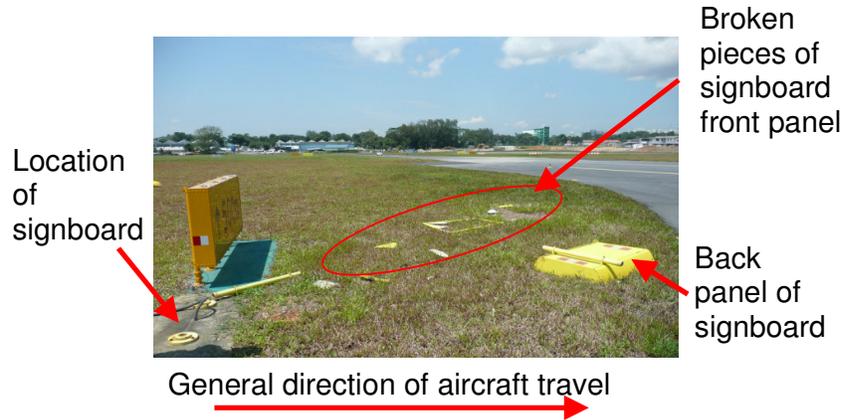
Figure 4: Echo Taxiway signboard damage

1.4.1 The Echo Taxiway signboard was dislodged from the stand (see **Figure 4**). **Figure 5** shows the repaired Echo Taxiway signboard.
