FINAL REPORT

Taxiing Accident involving

**McDonnell Douglas DC8-62
Registration Mark: N1808E at**

AIB/AAI/CAS.004

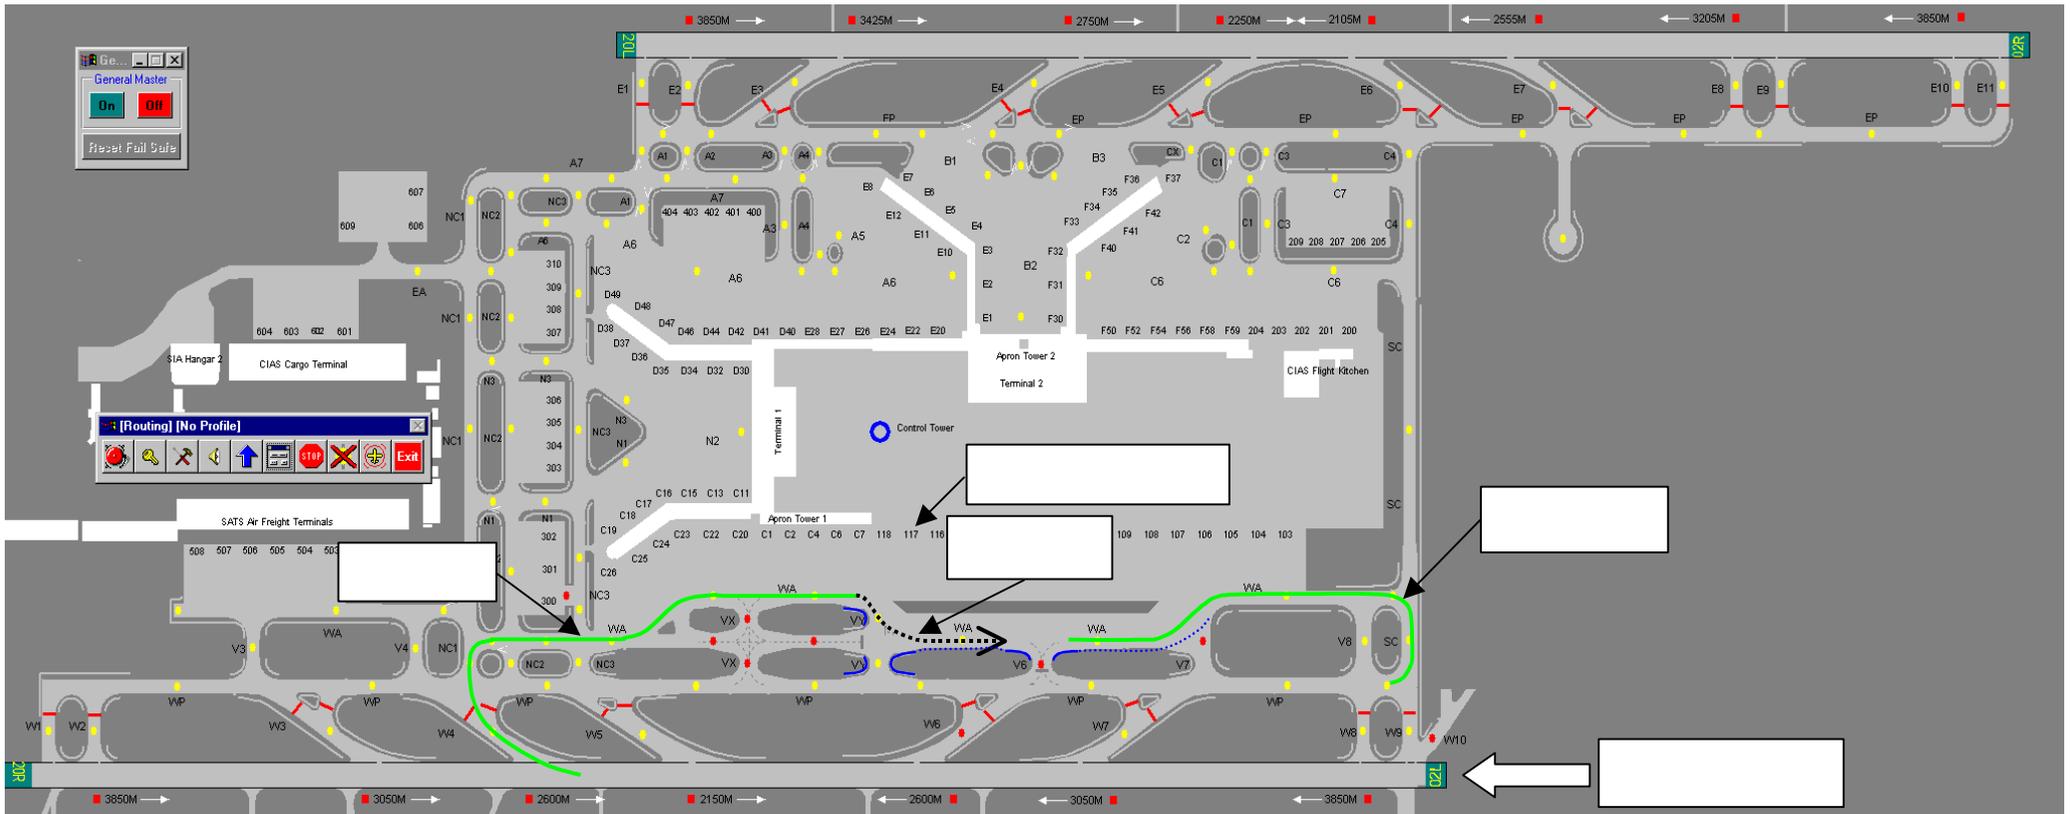
FLIGHT APWP6L TAXI ROUTE (PART 1)

1.1.4 The aircraft exited the runway via rapid exit Taxiway W4. The ground movement planner at Changi Tower selected the taxiway centre line lights to guide the aircraft from Taxiway W4 onto Taxiway NC1, Taxiway WA and to Bay C7 (Bay 117 is the second parking bay after Bay C7). (See taxi route 'I' in the airfield layout shown in Appendix 1A.)

- 1.1.5 Due to airside construction works, there was no taxiway centre line lighting guidance on the short segment of taxi route from Taxiway WA from abeam Bay C7 to the adjacent parking Bays 117 and 118. There was a NOTAM in force that stipulated that during hours of darkness, aircraft could only be towed in to Bays 117 and 118. On reaching Bay C7, the flight crew of APWP6L did not stop but continued taxiing past Bay C7 onto a diverted portion of Taxiway WA. The taxiway centre line lights for this diverted portion of Taxiway WA were not switched on by ATC as it was not the intended route for the aircraft. (See taxi route marked 'II' in the airfield layout shown in Appendix 1A.)

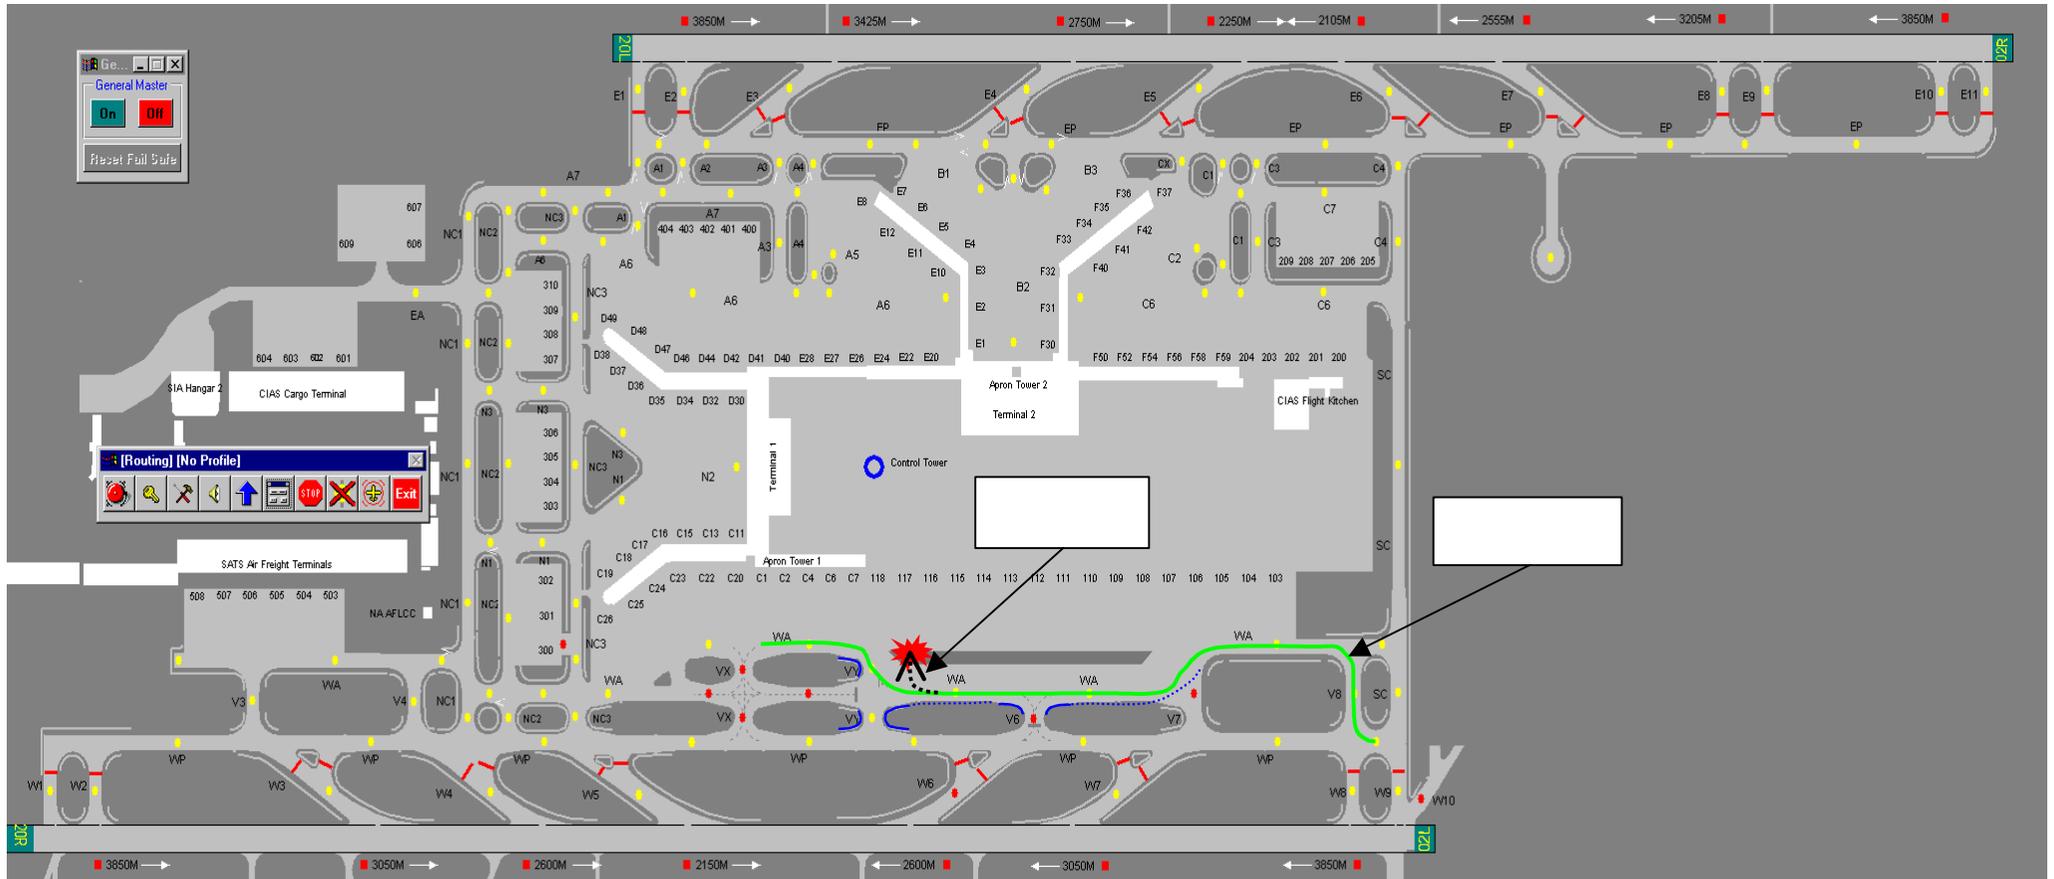
FLIGHT APWP6L TAXI ROUTE (PART 2)

- 1.1.6 At about 0037 hours, flight APWP6L called Changi Tower to indicate its position near Bay 106. Realising that flight APWP6L had missed its allocated parking position, the ground movement planner at Changi Tower routed the aircraft back to Bay 117 via Taxiways WA, SC, WP, V8 and Taxiway WA. (See taxi route marked 'III' in the airfield layout shown in Appendix 1A and taxi route marked 'IV' in the airfield layout shown in Appendix 1B.)

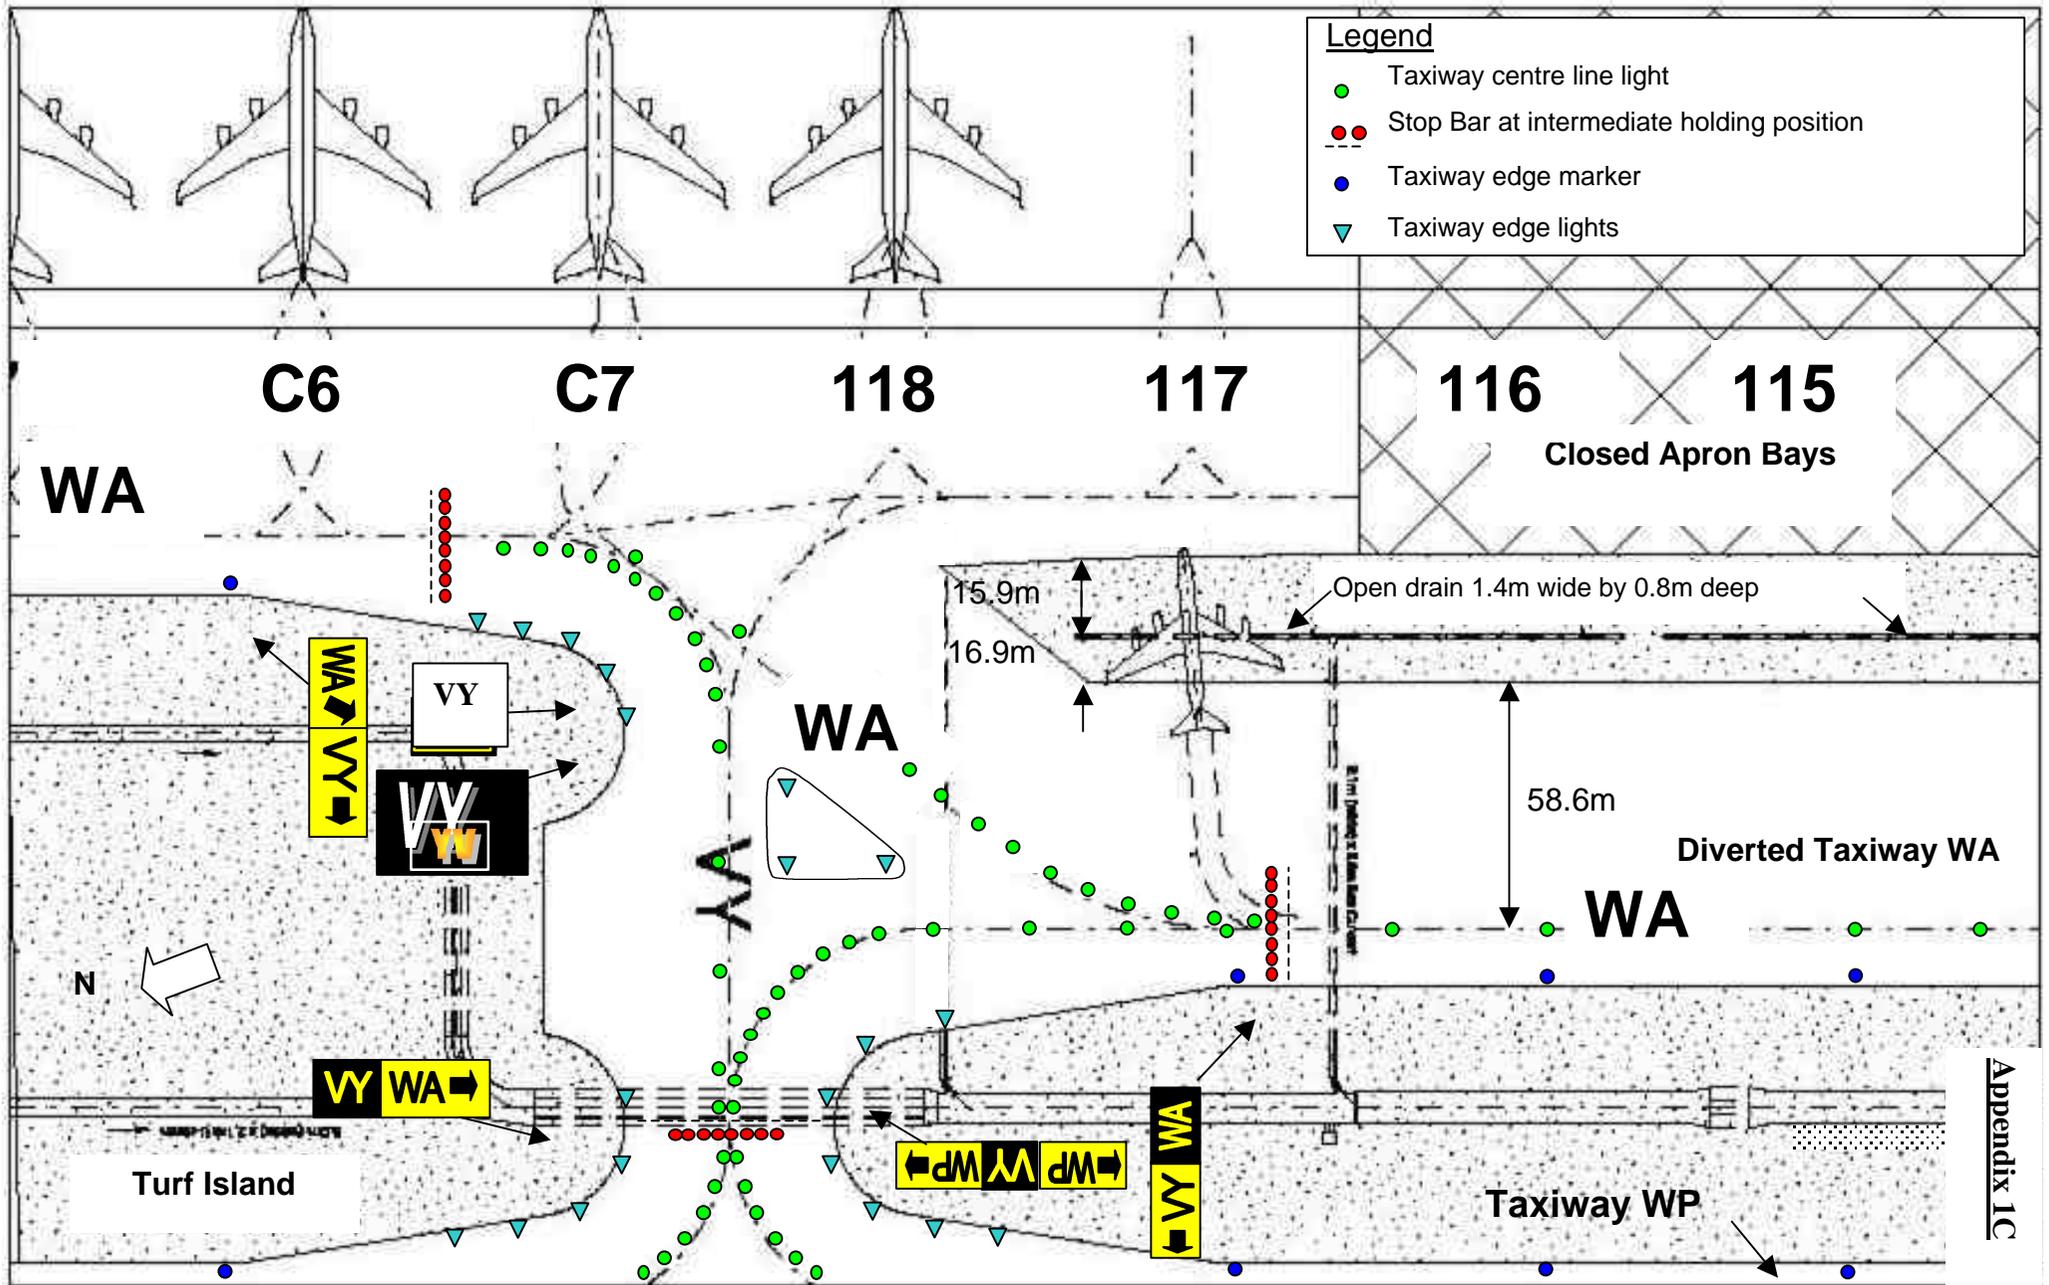
SITE LAYOUT DRAWING

- 1.1.7 Flight APWP6L followed the return route until it was abeam Bay 117 on the straight section of the diverted portion of Taxiway WA, just before Taxiway VY. At that location, the pilot saw the ground marshaller at Bay 117 on the aircraft's right side. Instead of continuing to follow the assigned taxi route, the aircraft turned right. In doing so, it left the WA taxiway centre line and went onto a grass area between Taxiway WA and the parking apron. The nose gear of the aircraft went across an open drain of about 1.4 m wide and 0.8 m deep within the grass area. The aircraft came to a halt when its main landing gears went into the drain at about 0044 hours. See Appendix 1C for accident site layout.

- 4.4 CAAS should consider installing taxiway edge lights or reflective markers along the edge of Taxiway WA next to the unmarked paved area to provide an additional cue to pilots to stay within the taxiway. [AAIB Recommendation R-2004-008]

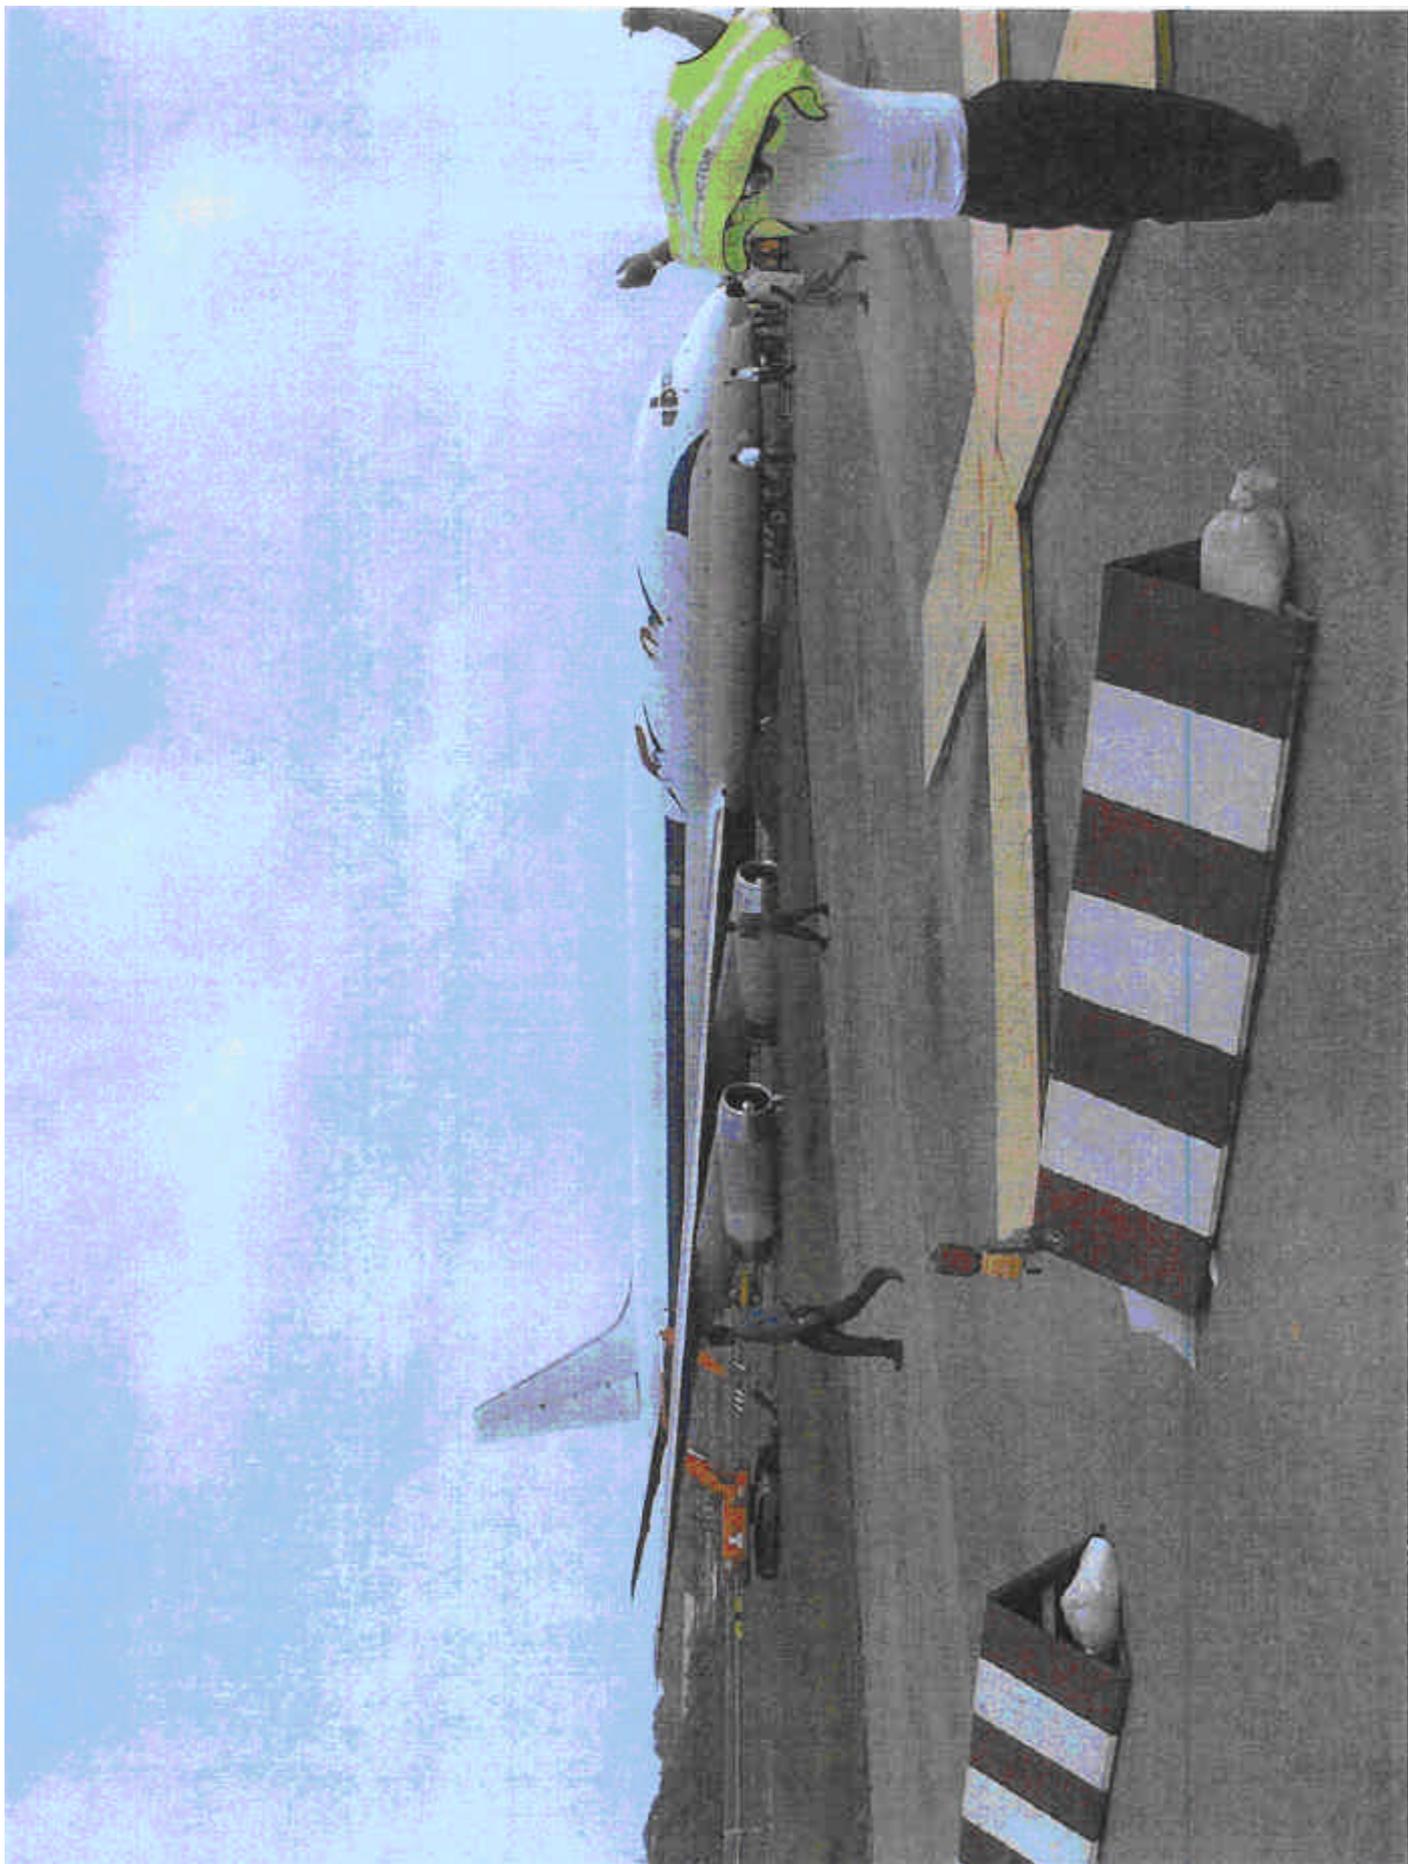
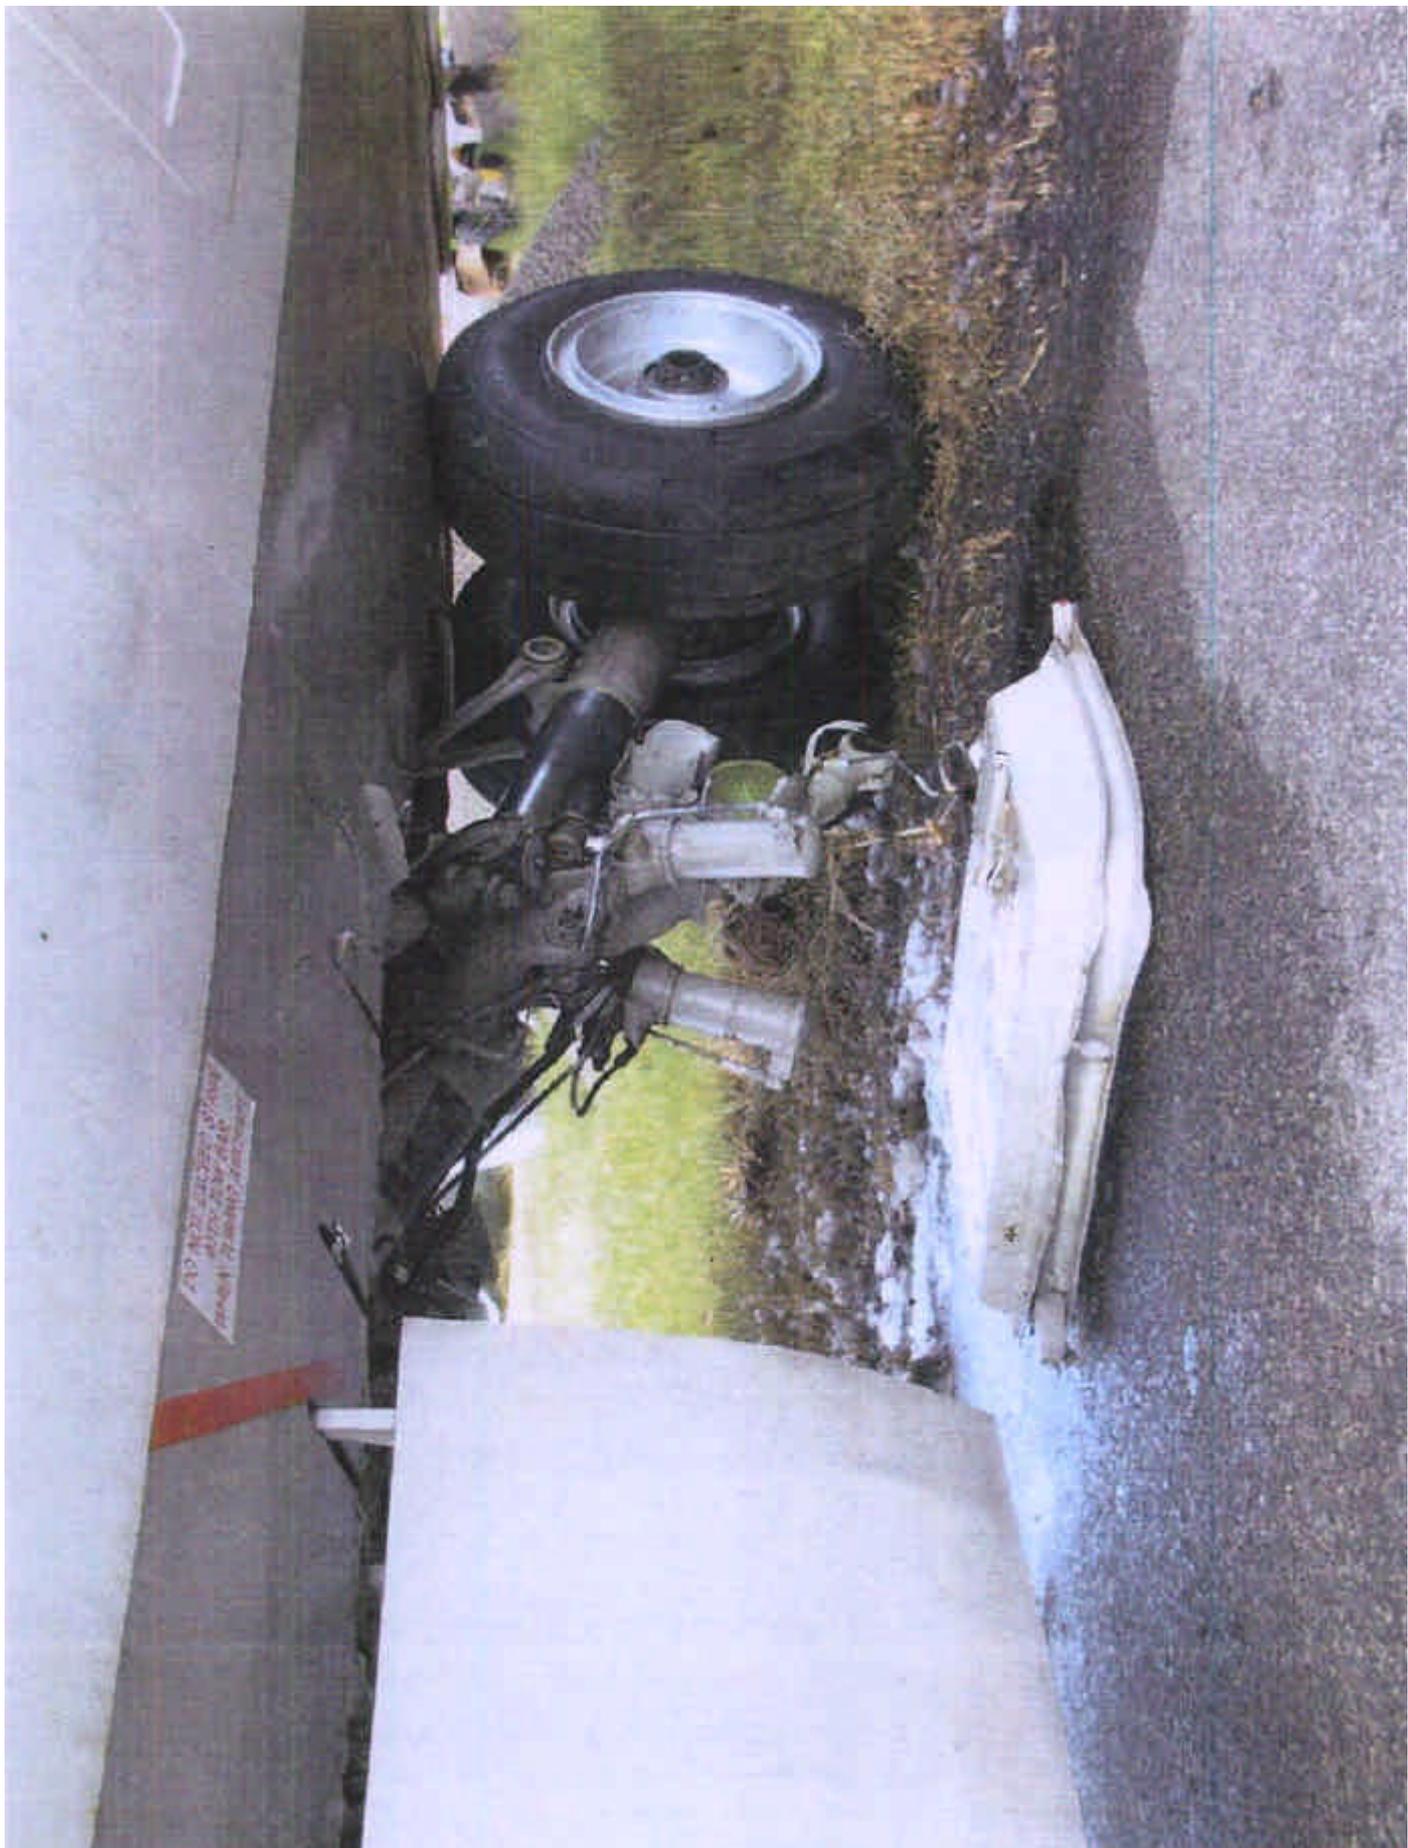
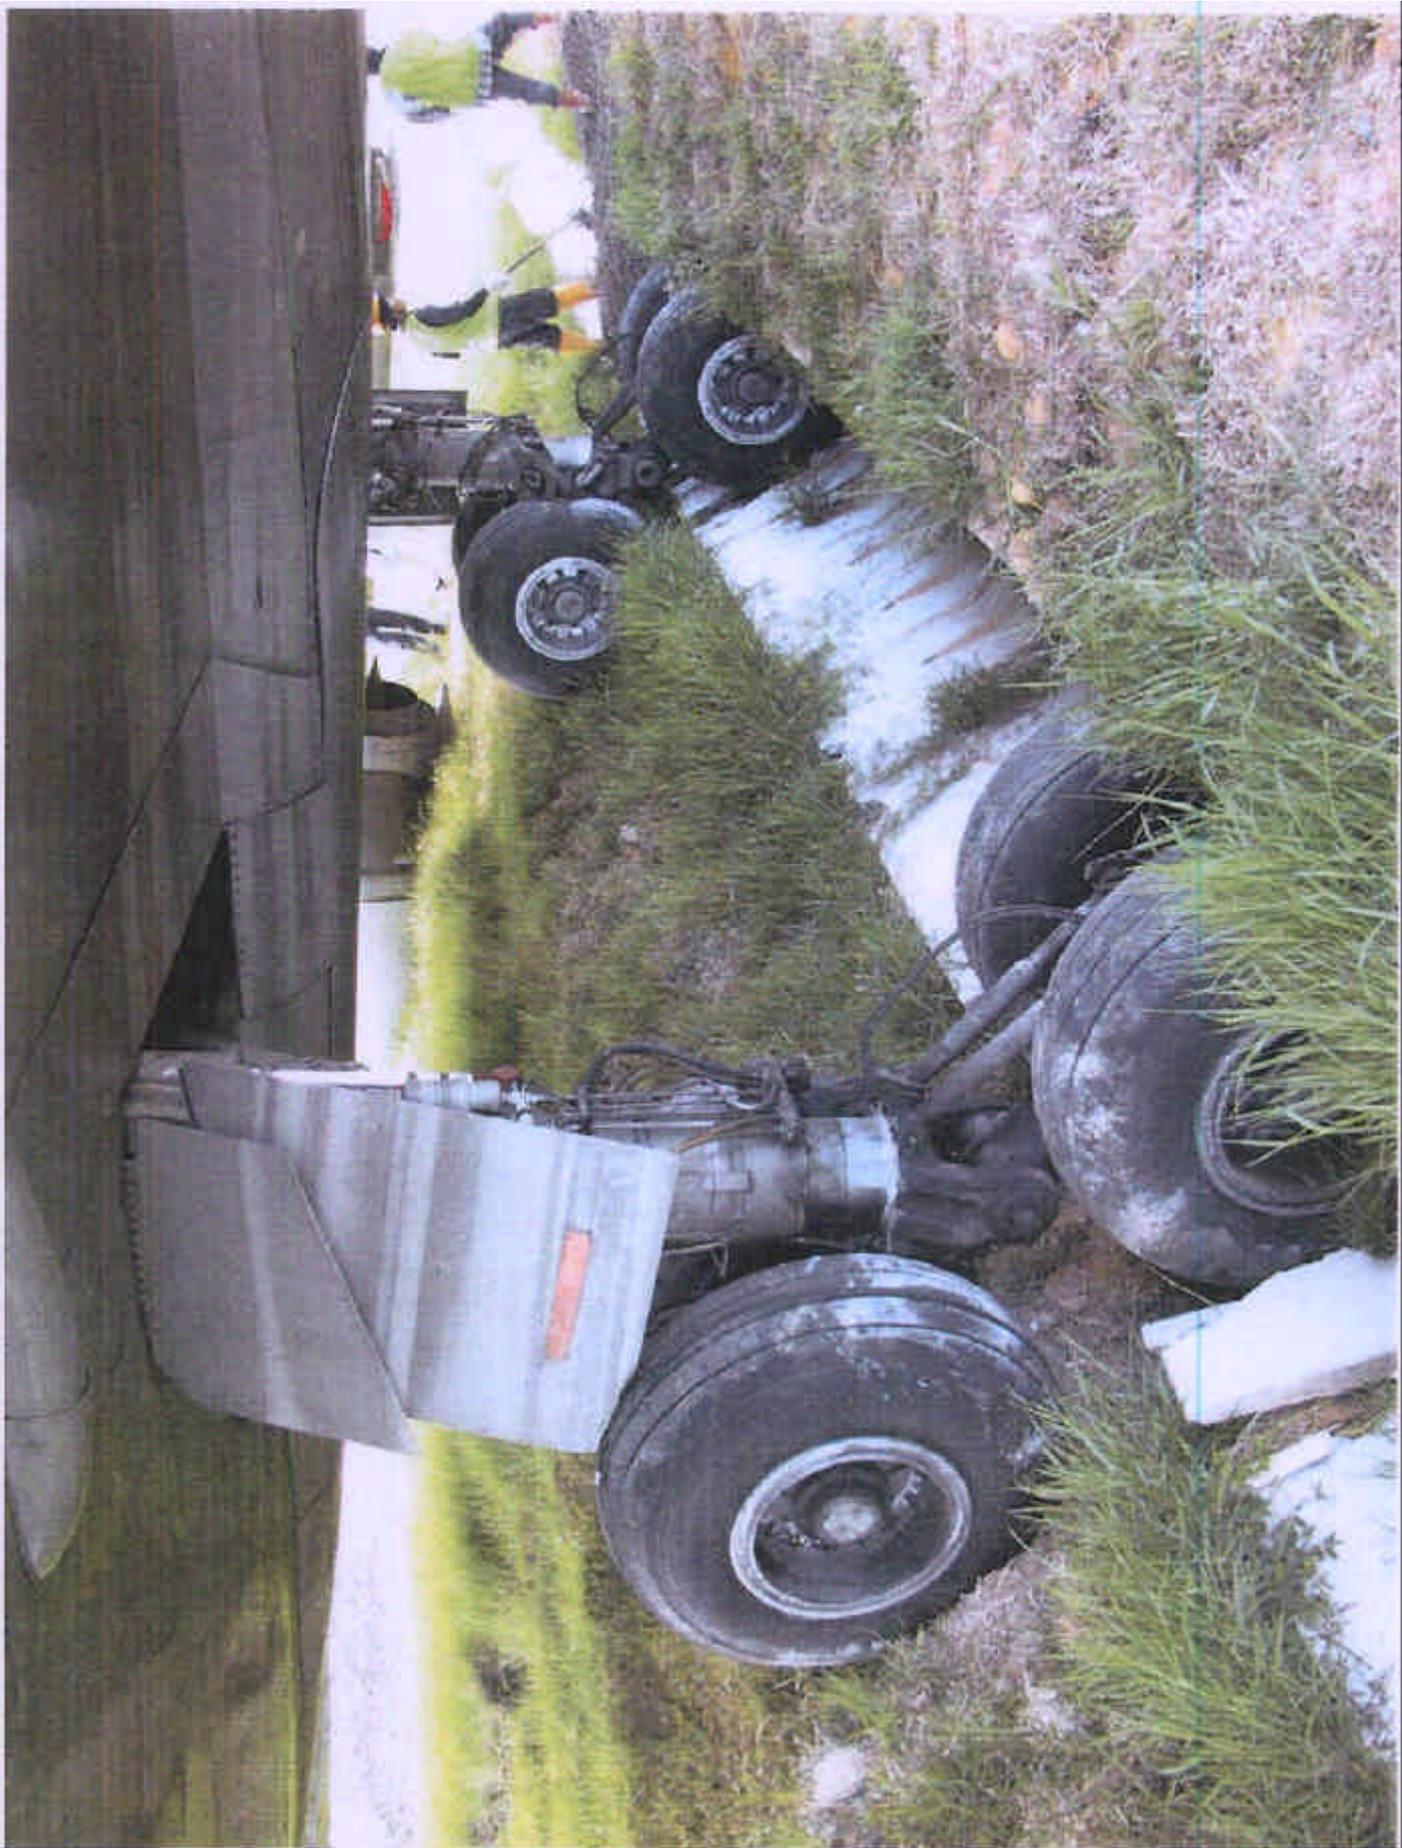
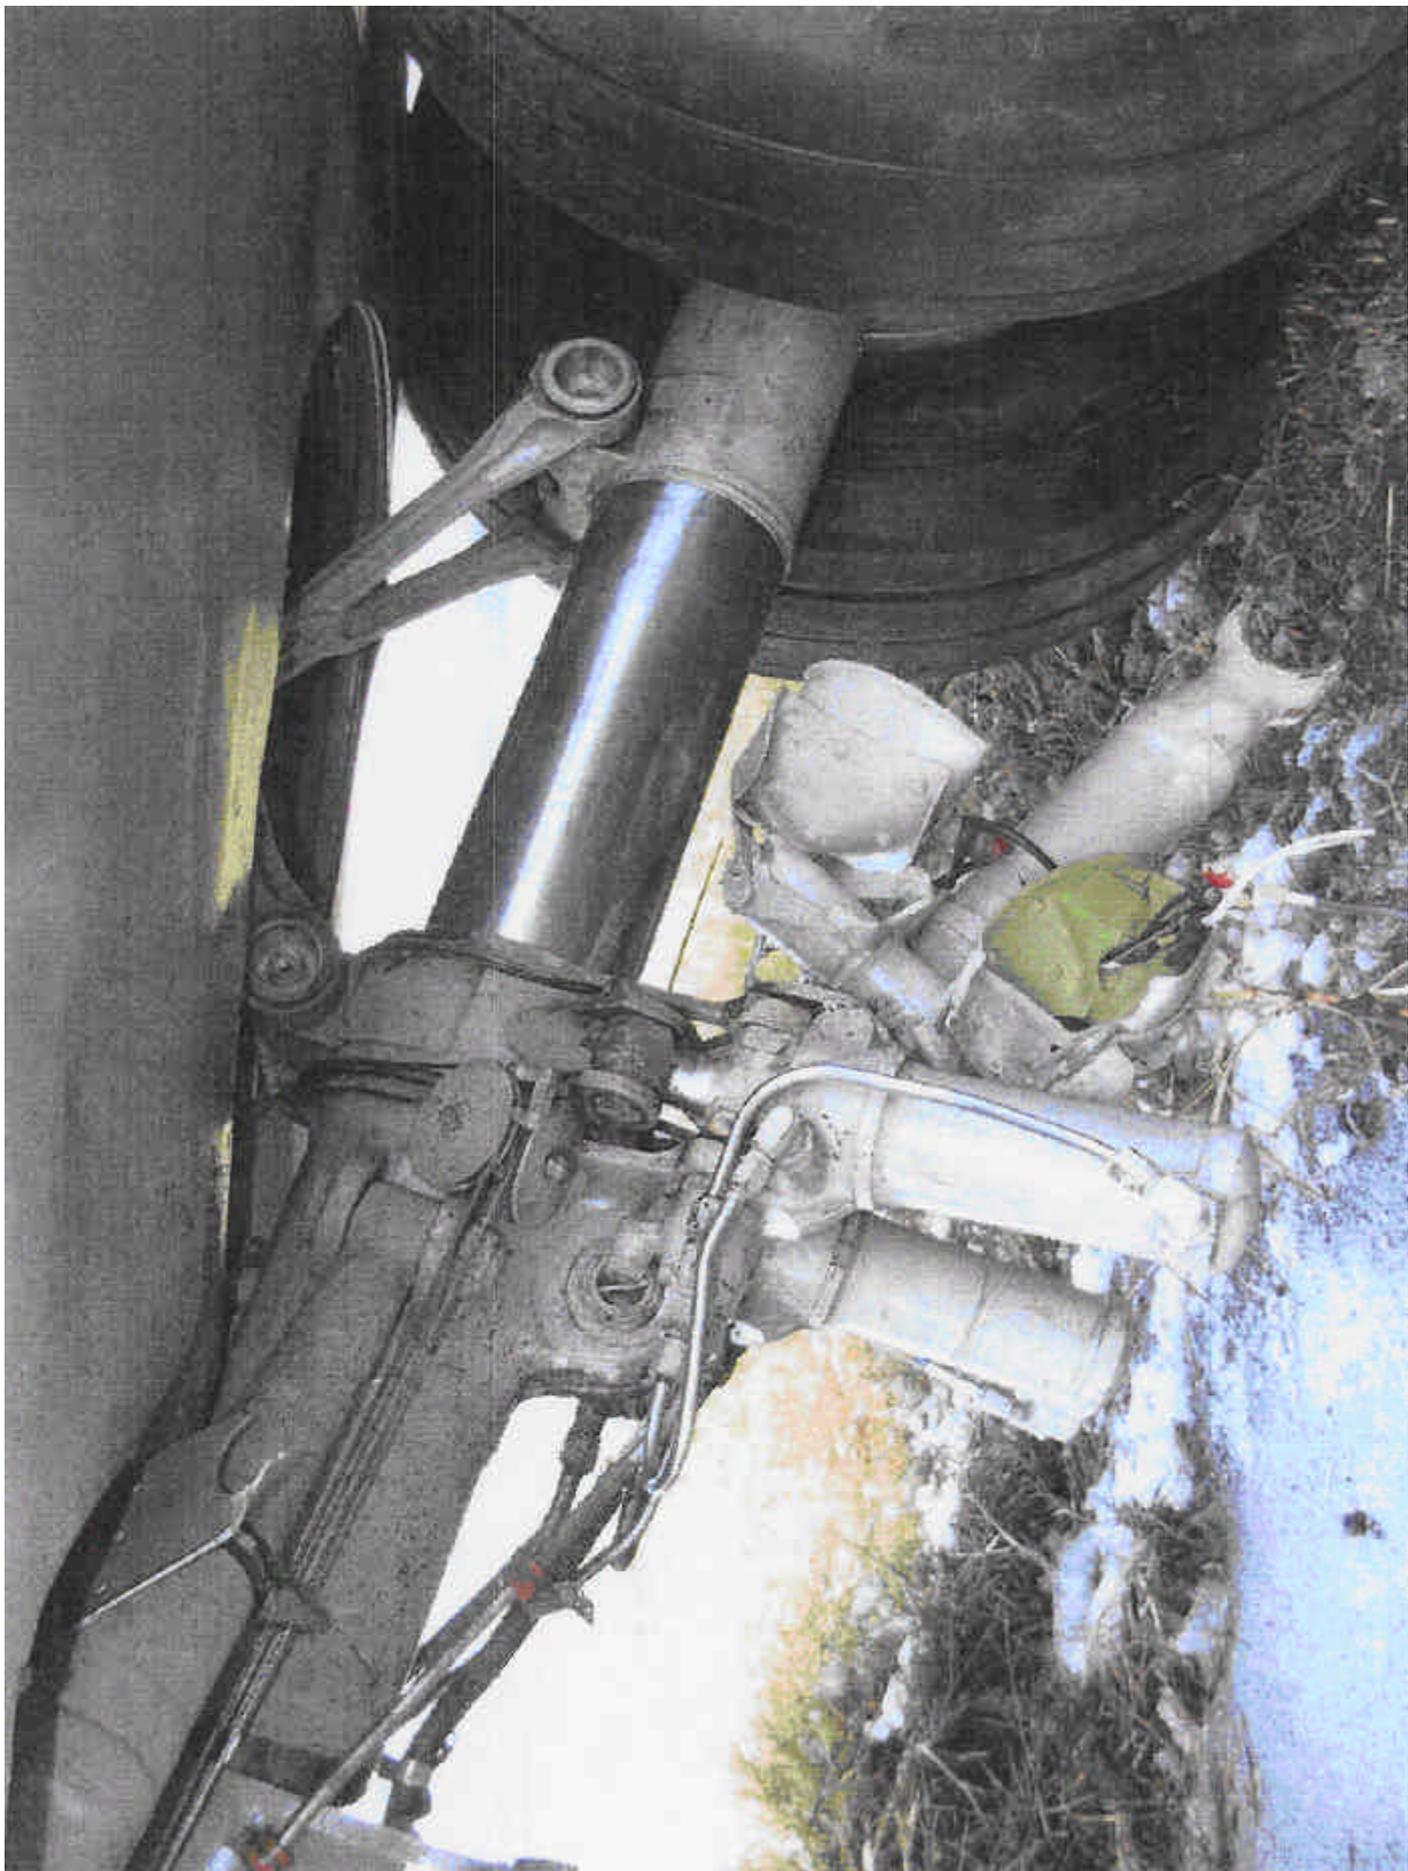
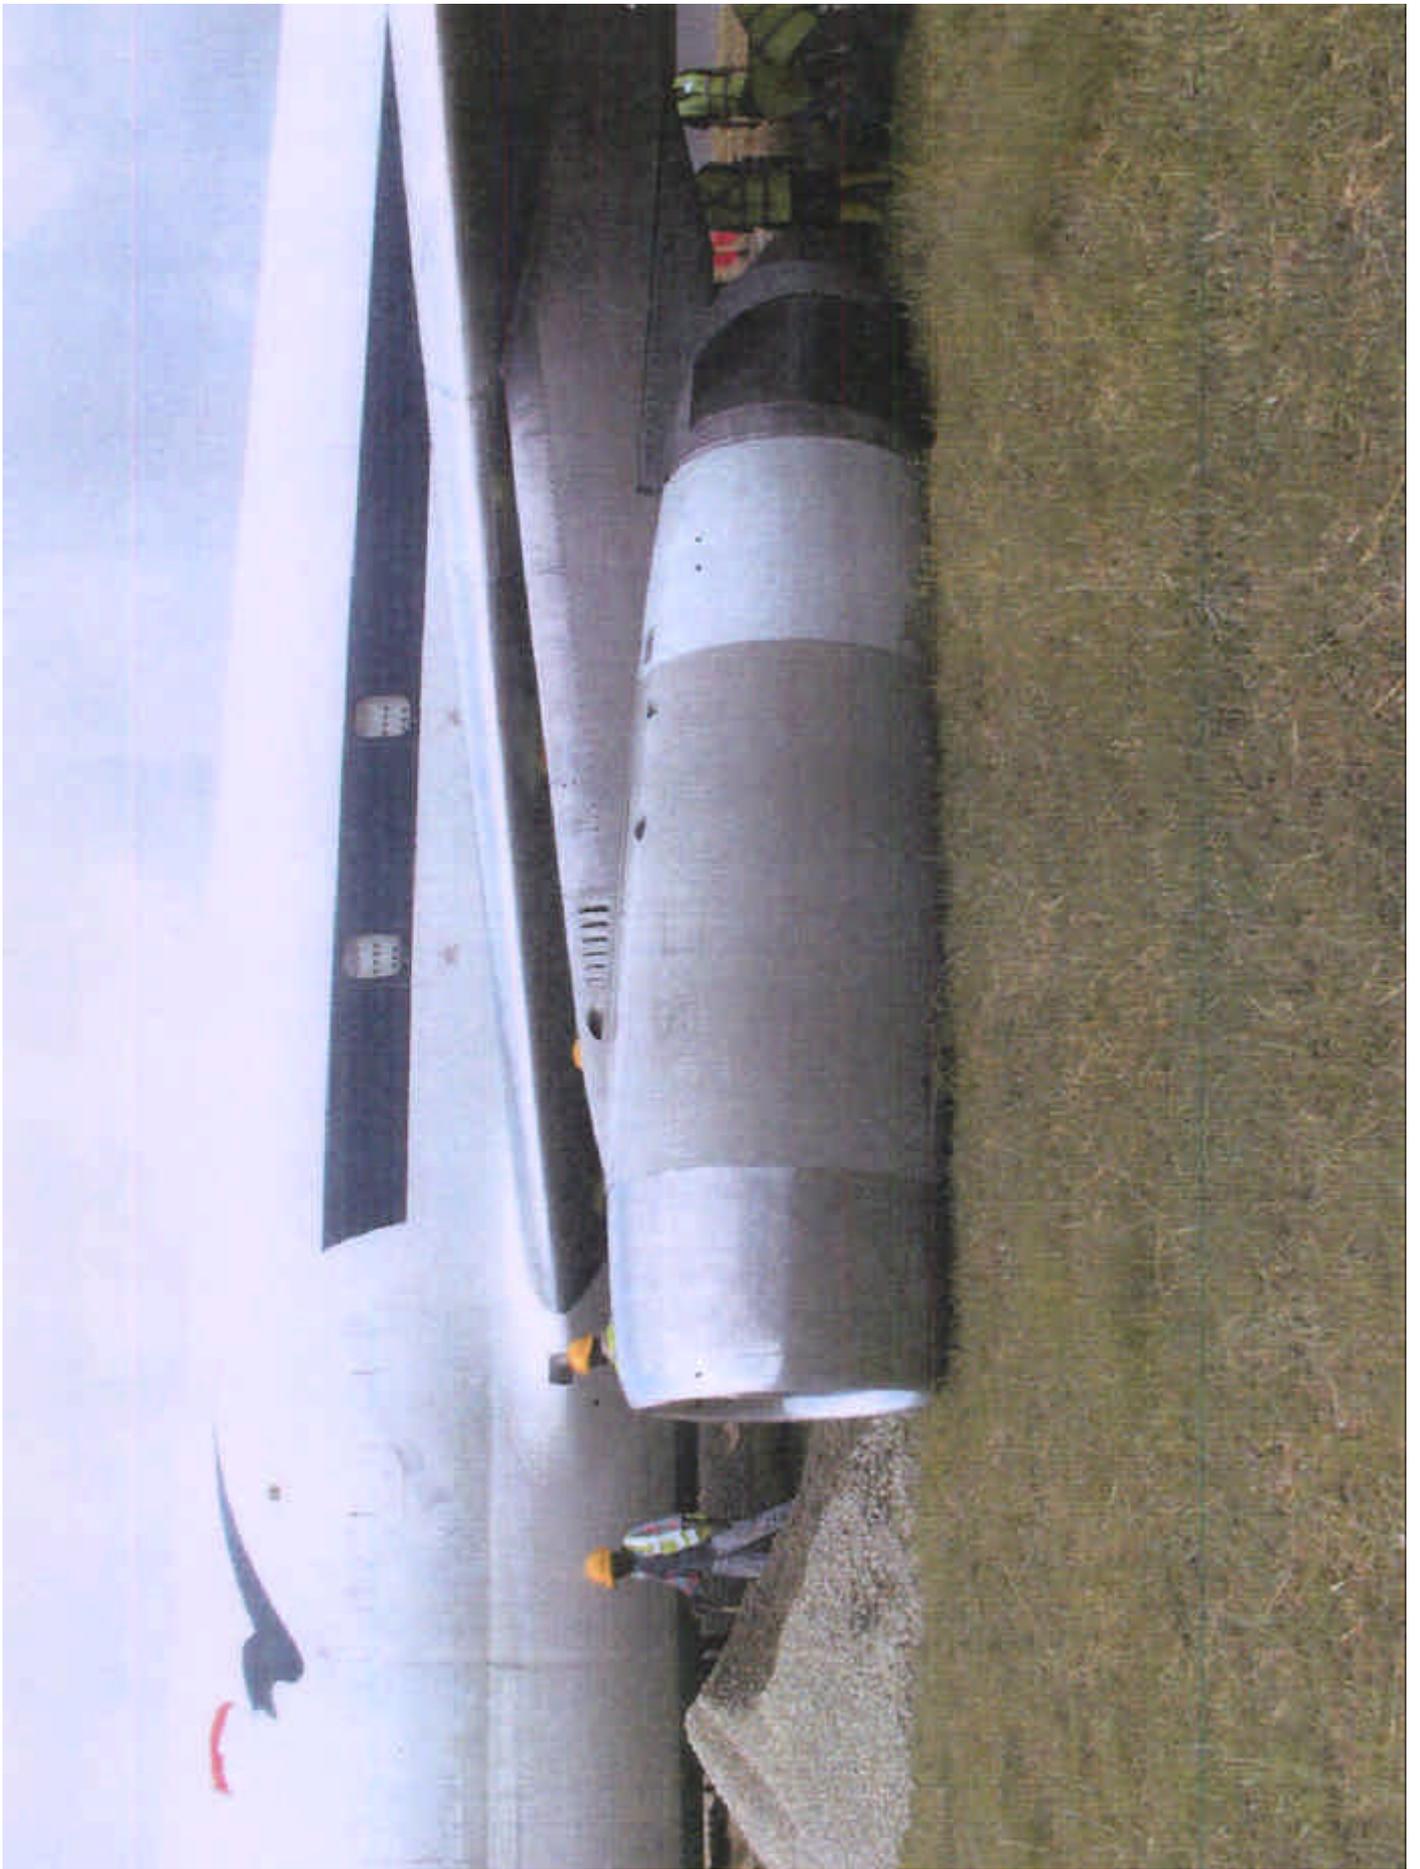
PHOTOGRAPHS OF AIRCRAFT'S DAMAGE

- 1.3.1 The aircraft's nose landing gear was broken and the fuselage around it was damaged. The main landing gears were also damaged as a result of being lodged in the drain.
