FINAL REPORT

**RUNWAY TAKE-OFF INCIDENT INVOLVING
AIRBUS A340, REGISTRATION A40-LH
SINGAPORE CHANGI AIRPORT
30 MAY 2007**

AIB/AAI/CAS.039

**Air Accident Investigation Bureau of Singapore
Ministry of Transport
Singapore**

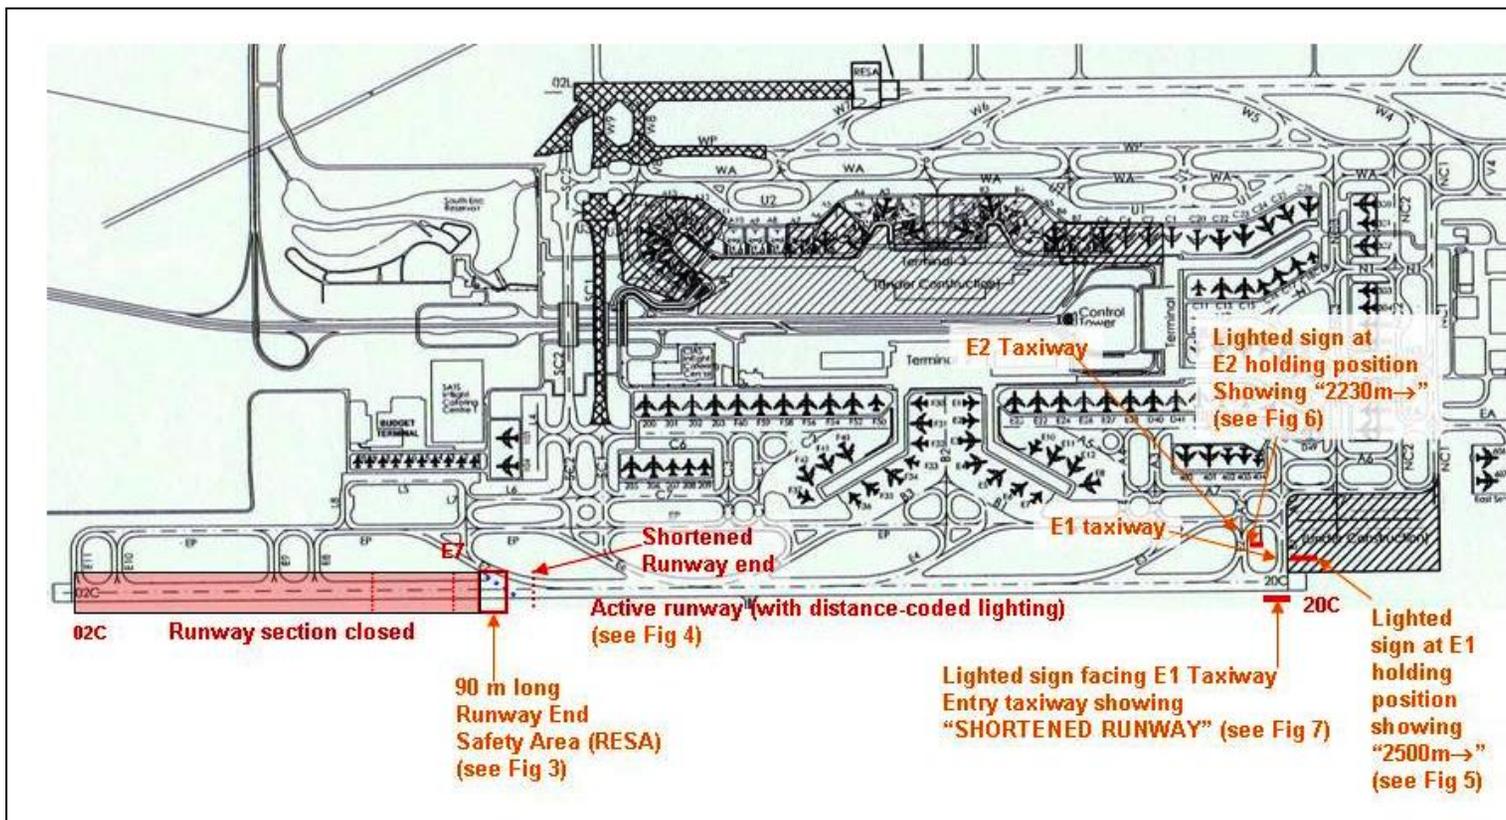
Figure 2. Layout of the shortened 20C showing the closed section and location of the movement guidance signs

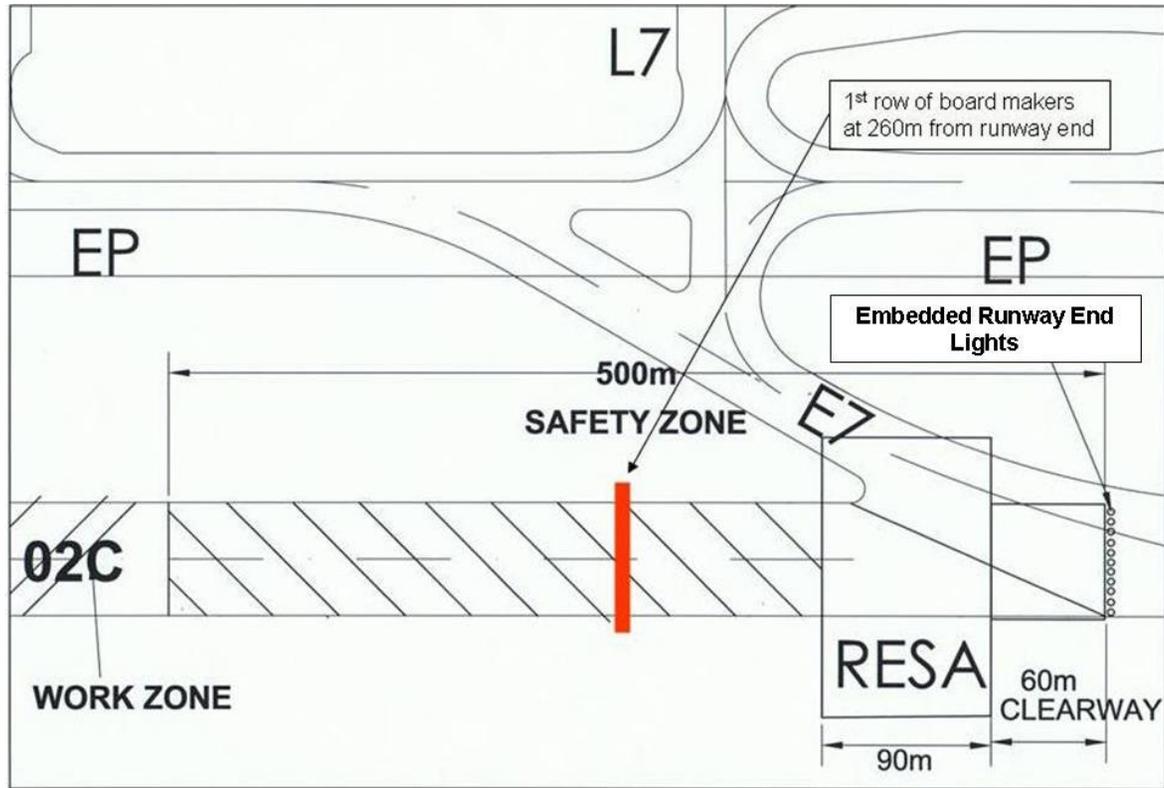
- Establishing a 500 m safety zone from the temporary runway end before the start of the work area
 - Placing marker boards with red lights at 260 m from temporary runway end to demarcate boundaries of closed runway

Figure 3. Safety zone at the end of shortened Runway 20C

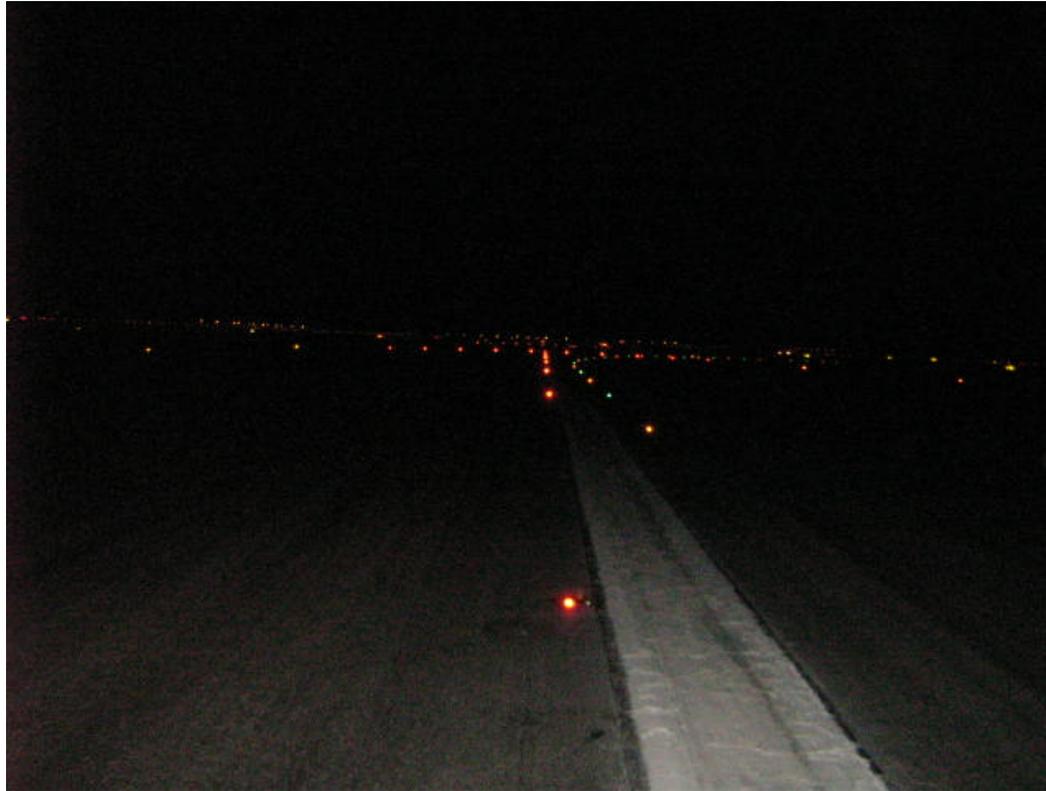
- 1.1.27 During the take-off roll at about 120 knots, the PIC noticed that the centreline lights changed from white to alternate red and white⁵. The PIC subsequently applied Take-off Go Around (TOGA) power and abruptly made a higher than normal rate of rotation to avoid overrunning the runway. Both the PIC and FO reported that they saw the red runway centre lights upon rotation. Data from the flight recorder indicated that TOGA was applied at 125 knots with positive lift-off at 141 knots.

- The lights were white from threshold to the point 900 m from runway end.
- The lights were alternate red and white from 900 to 300 m.
- The lights were red from 300m to runway end.

Figure 4. Distance-coded runway centre line lights and runway end lights near the shortened end of Runway 20C

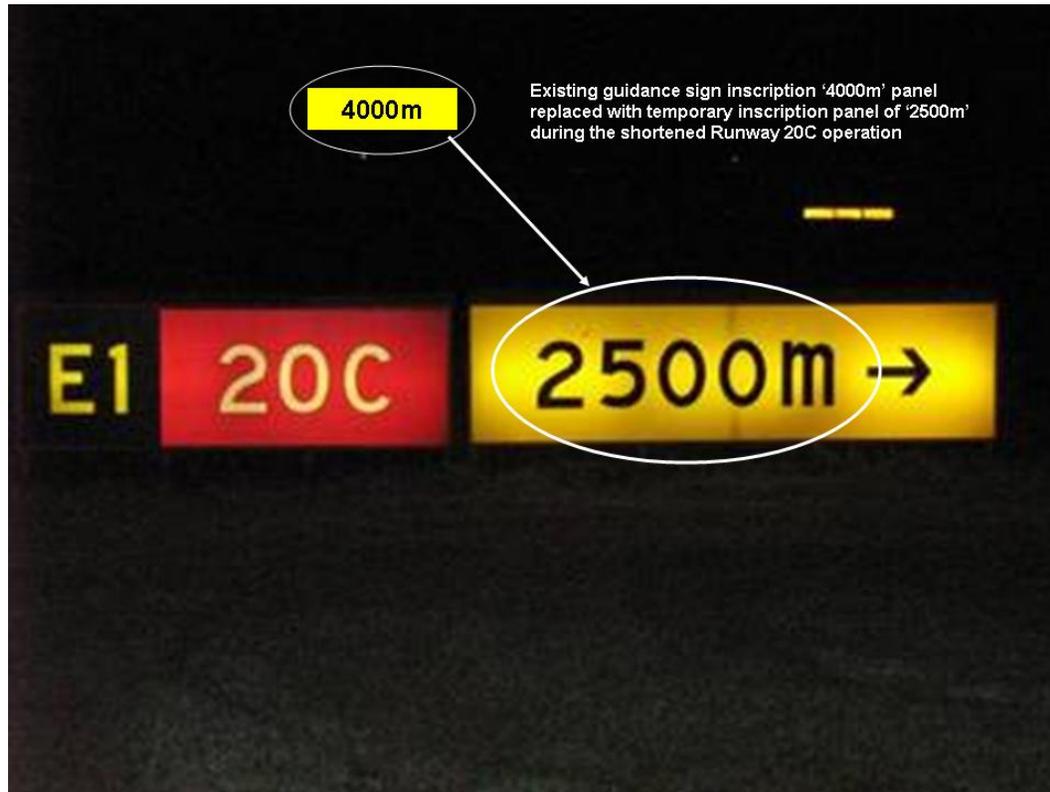
1.10.3 All the existing aircraft movement guidance signs affected by the shortening of Runway 20C were updated by the airport operator accordingly (See **Figure 5** and **Figure 6**). A new guidance sign (**Figure 7**) that indicated 'Shortened Runway' was put up facing taxiway E1, on the left side of Runway 20C, as a last reminder to flight crews before they move onto the runway. All these guidance signs were illuminated.

1.10.4 The guidance signs indicated in **Figure 5** and **Figure 6** conformed to the requirement in Annex 14 to the Convention on International Civil Aviation (Chicago Convention). The 'Shortened Runway' sign put up by the airport operator was not required by ICAO, but was placed there as an additional precaution.

- 2.4.1 The crew did not notice the sign shown in **Figure 5** when they were at the Runway 20C holding point on Taxiway E1. The inscription panel on the guidance sign was replaced with a temporary inscription panel of the same size, font and colour indicating the shortened distance. The investigation team understands that the sign meets the requirements in Annex 14 to the Chicago Convention for normal operations. However, for abnormal operations such as taking off from a shortened runway, the sign did not contain any attention getter to draw the crew's attention to the reduced TORA shown on the guidance sign.

- 3.1.4 The FO did not check the ATIS again even though he told the ATCO he would do so when seeking clearance from Clearance Delivery.
- 3.1.5 The guidance signs pertaining to the shortened Runway 20C positioned along the taxi route to the runway failed to draw the attention of the flight crew to its information.

Figure 5. Guidance sign at E1 taxiway holding position after the original inscription panel showing 4000 m was replaced with one showing 2500 m

- 5.1 The airport operator review the way important information is indicated on movement area guidance signs concerning any temporary runway length changes so that the signs can be effective in drawing flight crews' attention. [AAIB Recommendation R-2008-006]
- 5.2 The airline review its procedure and training of the pilots to improve flight crews' awareness of movement area guidance signs around airports. [AAIB Recommendation R-2008-007]
- 5.3 The airline require its flight crews to report any significant incident which they are aware of to the local air traffic control unit. [AAIB Recommendation R-2008-008]

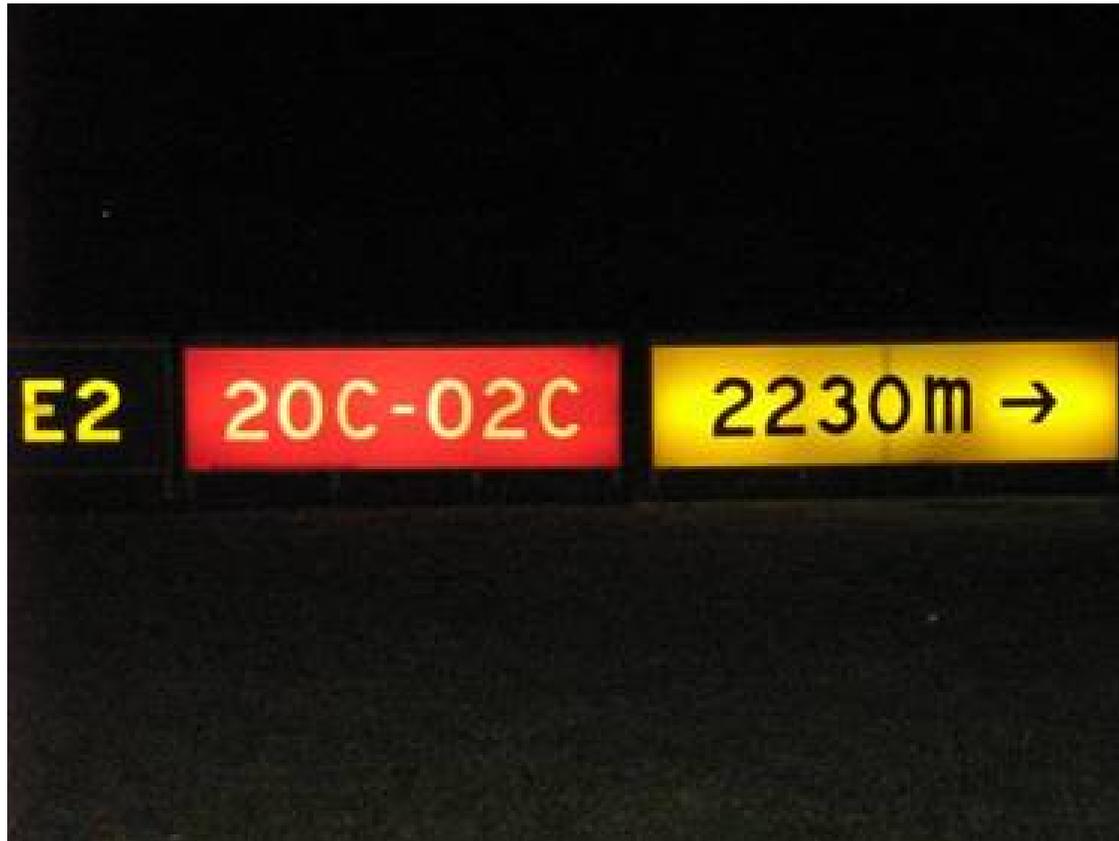
Figure 6. Guidance sign at E2 taxiway holding position after the original inscription panel showing 3850 m was replaced with one showing 2230 m

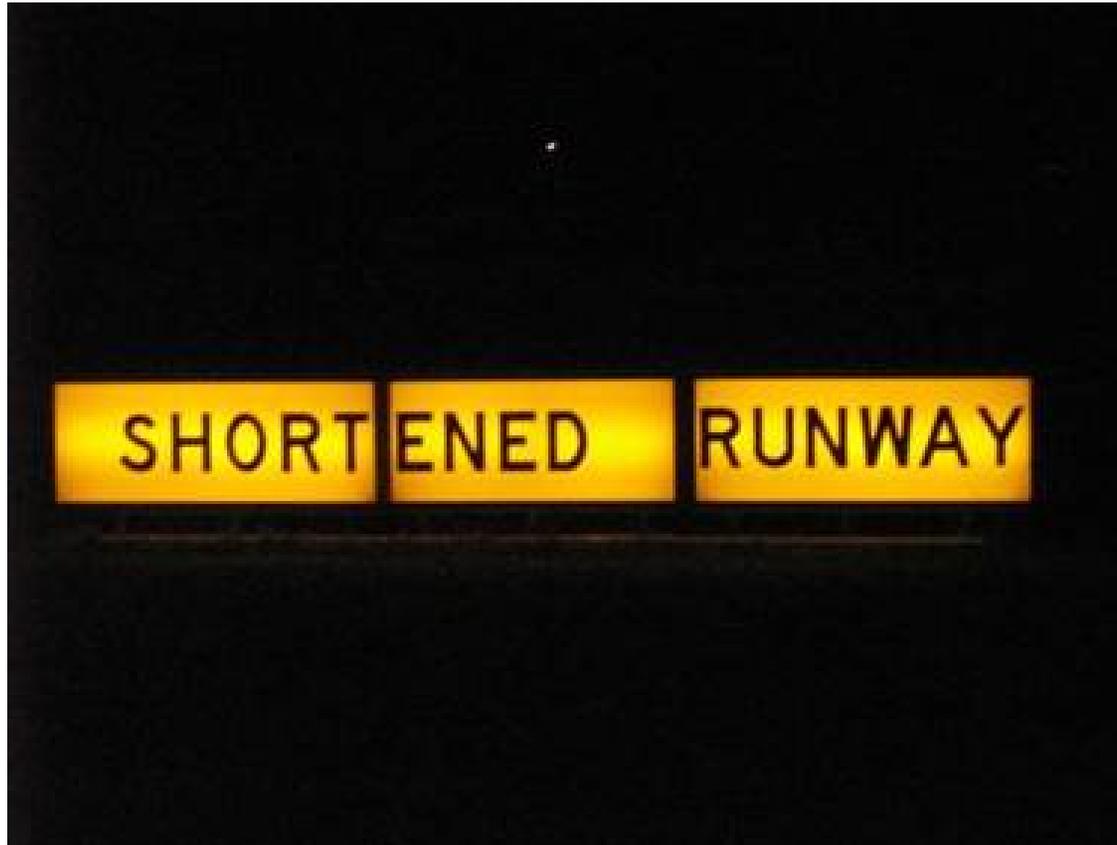
Figure 7. Guidance sign facing E1, on the left side of Runway 20C

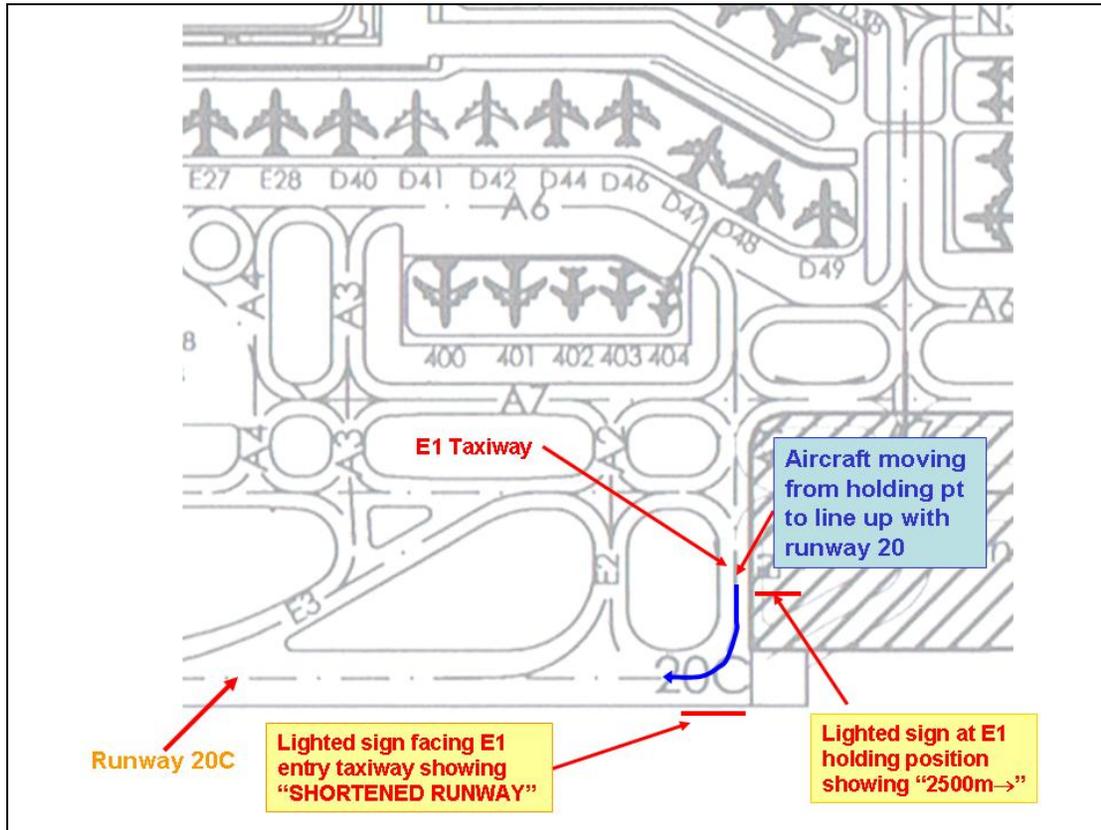
Figure 8. Positions of the guidance signs

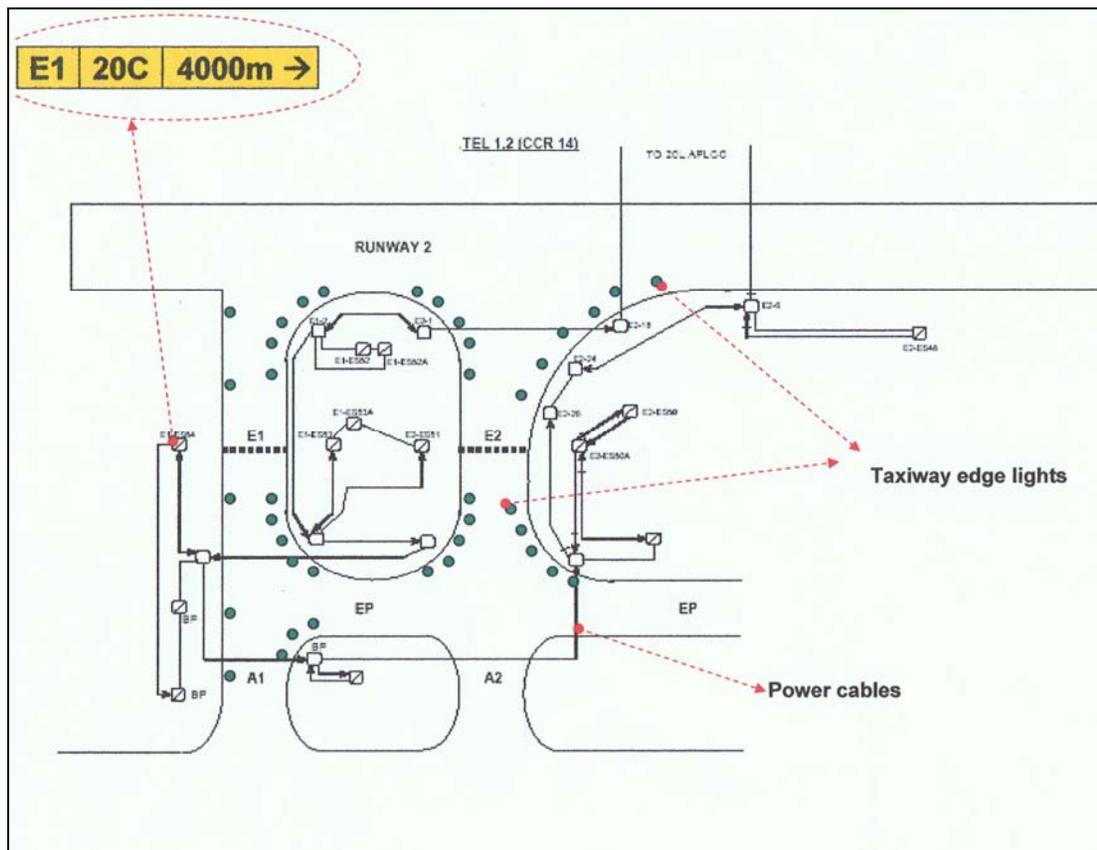
1.10.5 The guidance signs as indicated in **Figure 5** and **Figure 6** were controlled by a single switch in the control tower. This switch controlled also the taxiway edge lights in the vicinity of the guidance signs (see **Figure 9**). The 'Shortened Runway' sign as indicated in **Figure 7** was controlled by a single switch in the tower that controlled also a segment of runway edge lights adjacent to the 'Shortened Runway' sign. There were records indicating that the airfield contractor had checked the lights and

Figure 9. Guidance Signs Control Circuitry
