# **FINAL REPORT**

**WINGTIP COLLISION INCIDENT INVOLVING  
B777-200ER AIRCRAFT, REGISTRATION 9V-SVH AND 9V-SVO  
AT SINGAPORE CHANGI AIRPORT  
ON 4 AUGUST 2007**

**AIB/AAI/CAS.042**

**Air Accident Investigation Bureau of Singapore  
Ministry of Transport  
Singapore**

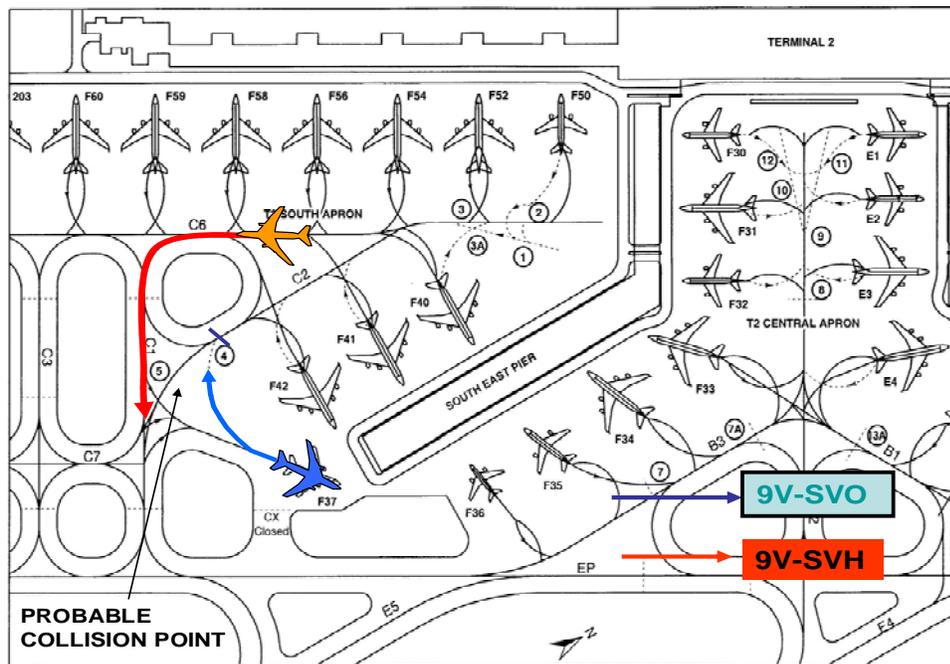
1.1.10 The tracks of 9V-SVH and 9V-SVO are as shown in **Figure 1**.

Figure1. Tracks of 9V-SVH and 9V-SVO, prior to collision.

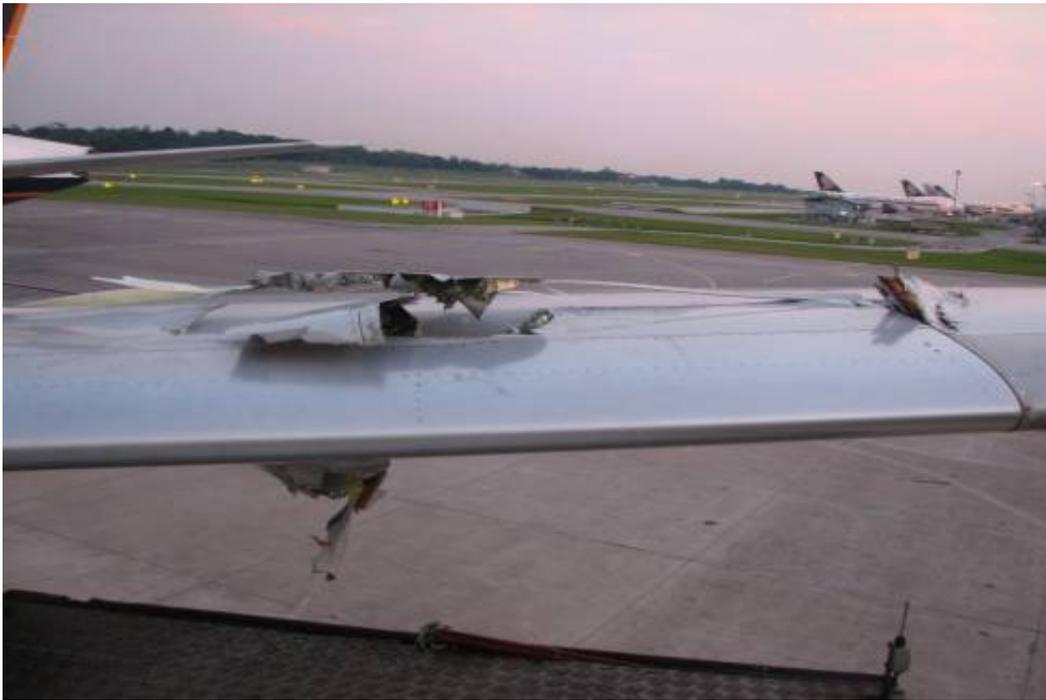
1.3.1 **9V-SVH** - The left hand wingtip was damaged. The surrounding fibreglass panels were broken and the No.1 leading edge slat was damaged. Wing fibreglass panels below the leading edge slat were also damaged. See **Figure 2**.

Figure 2. 9V-SVH damage at top of left wingtip area. View from front / above

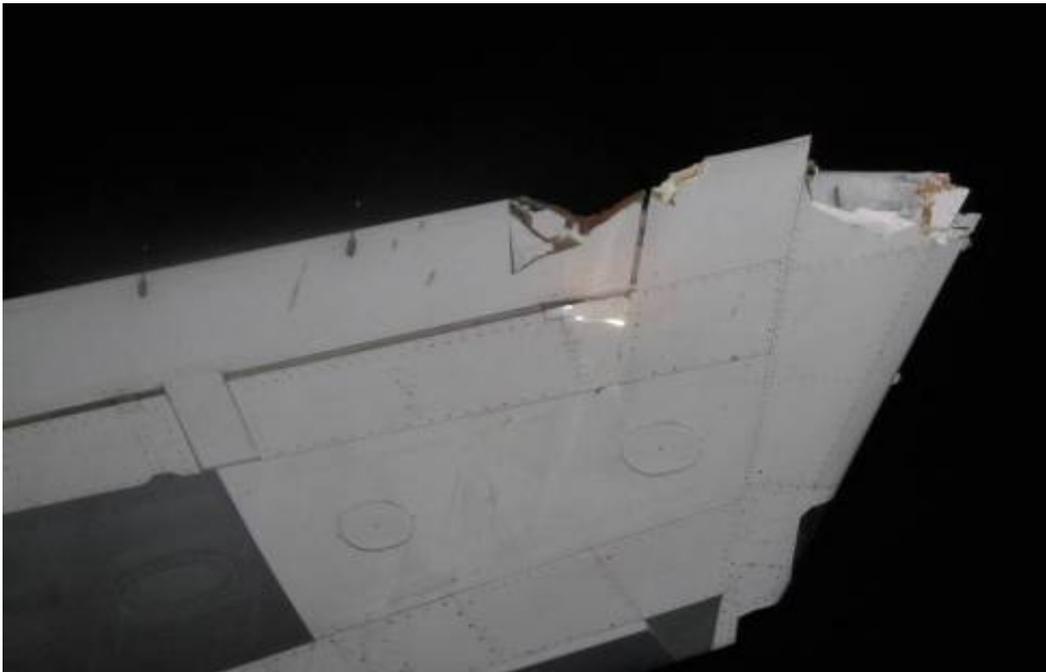
1.3.2 **9V-SVO** - The right hand wingtip leading edge was damaged. The trailing edge fibreglass honeycomb was broken, with about 100 sq cm of material missing. The right hand aileron was damaged at the outboard edge with about 130 sq cm missing. The honeycomb material on the lower surface was crushed. See **Figure 3**.

Figure 3. 9V-SVO damage at right wingtip and aileron. View from rear / below.

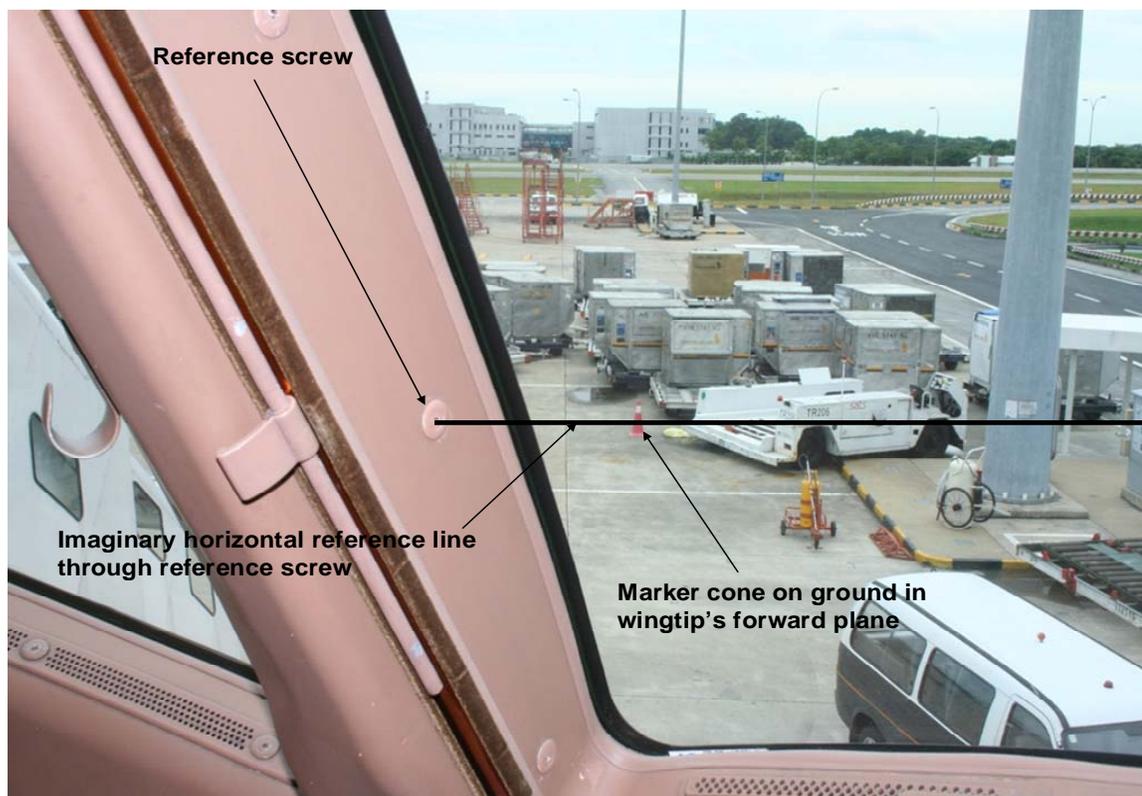
1.14.2.1 The PIC of 9V-SVH said during interview that he used a technique to judge wingtip clearance that had been taught to him by some instructors during his B777 aircraft training and that he had used the technique successfully several times before. This technique consisted of determining whether the wingtip of a B777 was clear of a nearby object by determining whether the object was seen to be above or below the level of the middle screw on the side window post on the same side of the aircraft as the pilot seat (see **Figure 4**). According to the PIC, if an object was sighted above this middle screw, it would be judged to be clear of the wingtip on that side. The pilot said that he looked at the right wingtip of 9V-SVO and saw that it was clearly above this reference screw. He decided therefore that there was sufficient clearance and proceeded to taxi forward slowly. However, the wingtips still ended up colliding with each other.

Figure 4 – Side view from pilot's (left) seat, using a screw located on a window frame as a reference to judge wingtip clearance.

1.14.2.2 The operator and the manufacturer of the aircraft had no documented process or method for judging B777 wingtip clearance from the cockpit. The operator's training videos did not provide any guidance for judging wingtip clearance and the operator said during this investigation that it did not endorse the technique of using the window frame screw for wingtip clearance reference.

- (a) The responsibility of crew to ensure aircraft separation at all times, and when in doubt, to stop.
- (b) Crews should not determine wingtip clearance using solely non-documented processes.

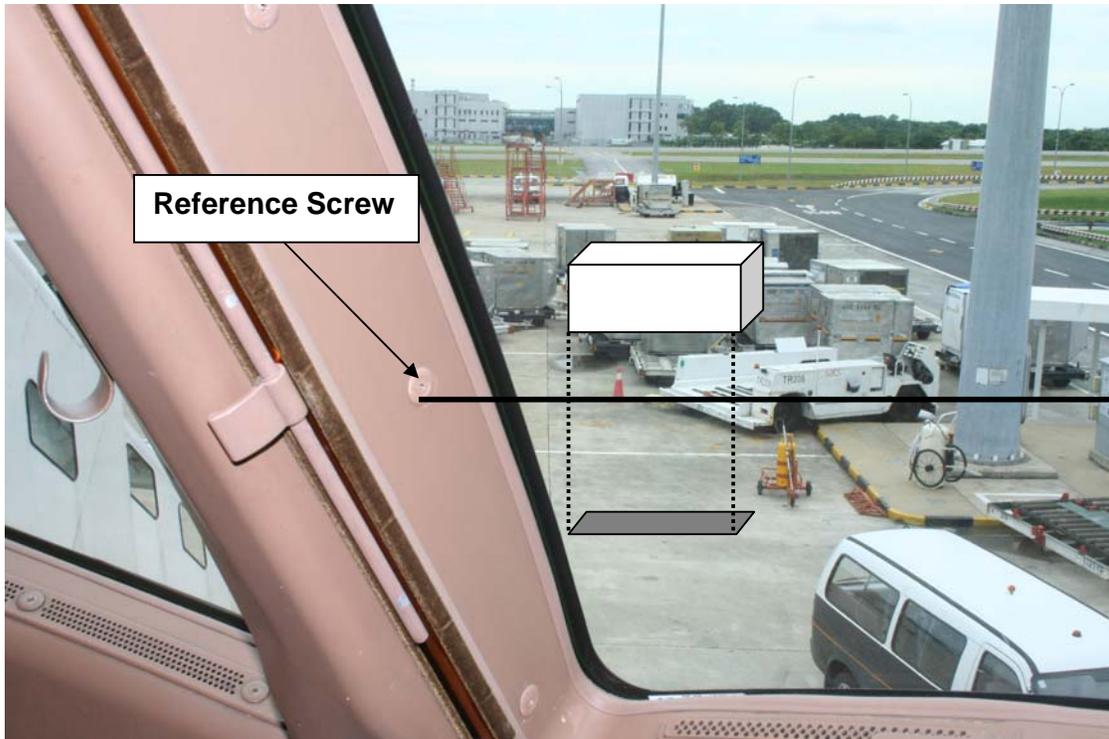
2.3.1 The technique used by the PIC of 9V-SVH to judge the wingtip clearance of his aircraft was flawed. The technique appears unsuitable for judging

clearance from objects not lying on the ground. If the object is in mid air, the technique would require the pilot to estimate the position of the object's ground shadow position in relation to the reference screw. For example, if the white box in **Figure 5** represents a mid-air object within the wingspan distance from the cockpit, it will be wrong to conclude that it is outside the span of the wing just because it appears above the reference screw. The decision by the PIC of 9V-SVH to proceed with the taxiing was based on his seeing that the wingtip of the 9V-SVO was clearly above the reference screw, but he did not assess the ground shadow position of the wingtip, relative to the reference screw.

Figure 5 Mid-air object represented by the white box appears to be above reference screw.
