# **FINAL REPORT**

**BREAKDOWN IN SEPARATION BETWEEN  
AIRBUS A319, REGISTRATION 9V-SBE AND  
BOEING B737, REGISTRATION PK-GGN  
WITHIN CHANGI CONTROL ZONE  
ON 6 DECEMBER 2007**

**AIB/AAI/CAS.045**

**Air Accident Investigation Bureau of Singapore  
Ministry of Transport  
Singapore**

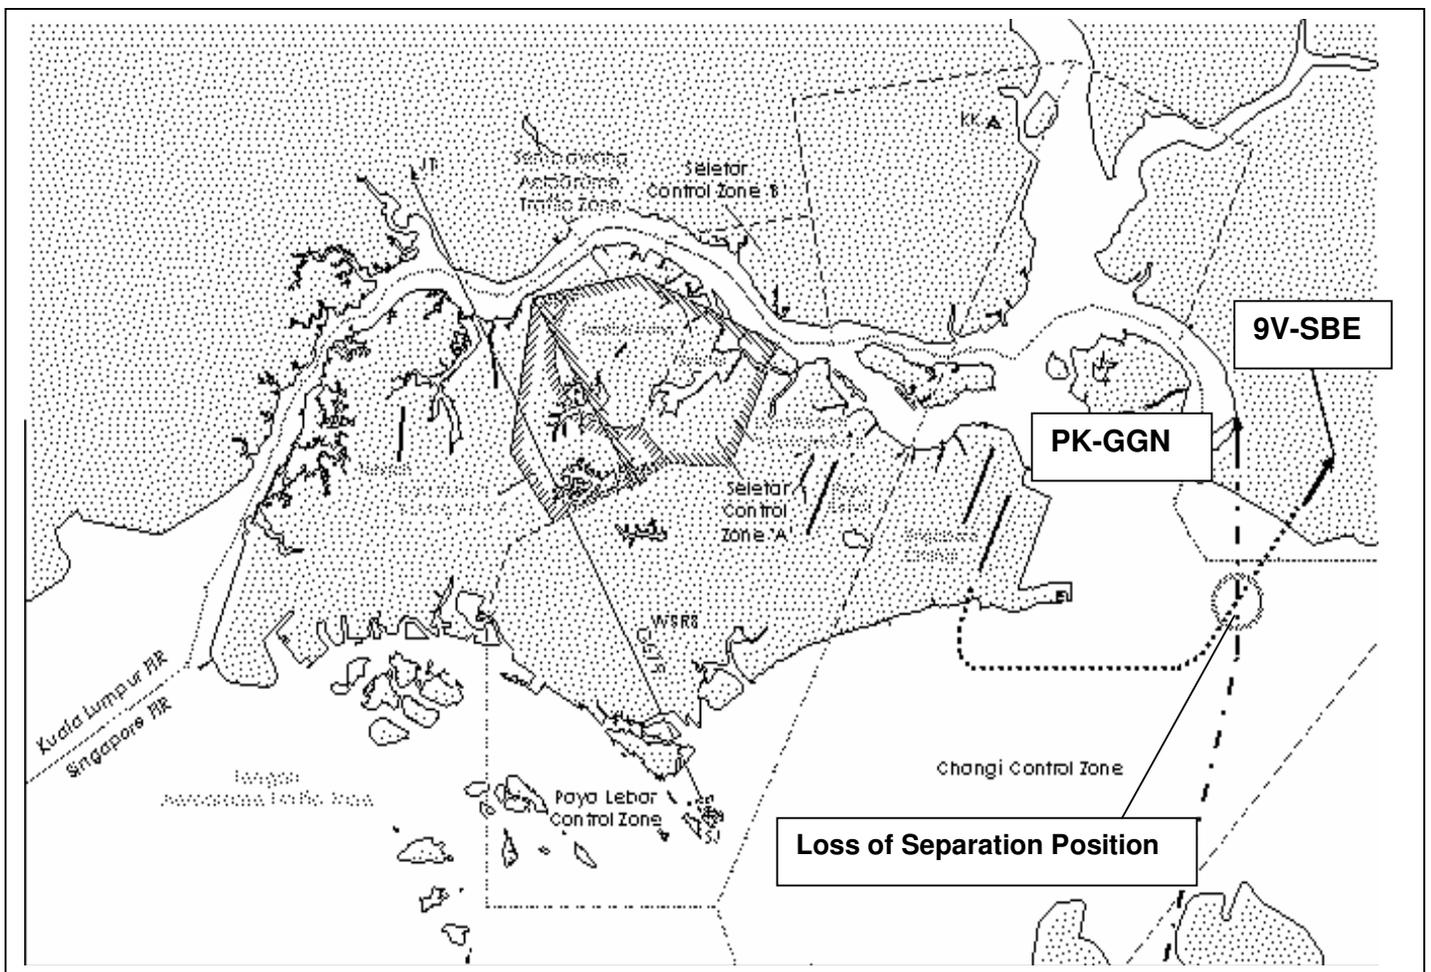
Figure 1 – Location of Loss of Separation Incident

- 1.1.1 The aircraft took off from Runway 20C of Singapore Changi Airport. Under the Singapore Air Traffic Control Centre's (SATCC) Approach Controller, the aircraft was initially cleared to climb to 6,000 ft and to turn left to 090 degrees. About two minutes later, the aircraft was directed to turn to 330 degrees but the crew requested a heading of 050 degrees to avoid weather. The Approach Controller did not approve this initially but about 30 seconds later, at 1515:13 hrs, she cleared the aircraft to turn onto the requested heading and to climb to 10,000 ft. At about 1515:50 hrs while the A319 was climbing through 8,500 ft on this new heading, it came within 0.67 NM of a Boeing B737 aircraft (PK-GGN) at 9,000 ft. See **Figure 1**.

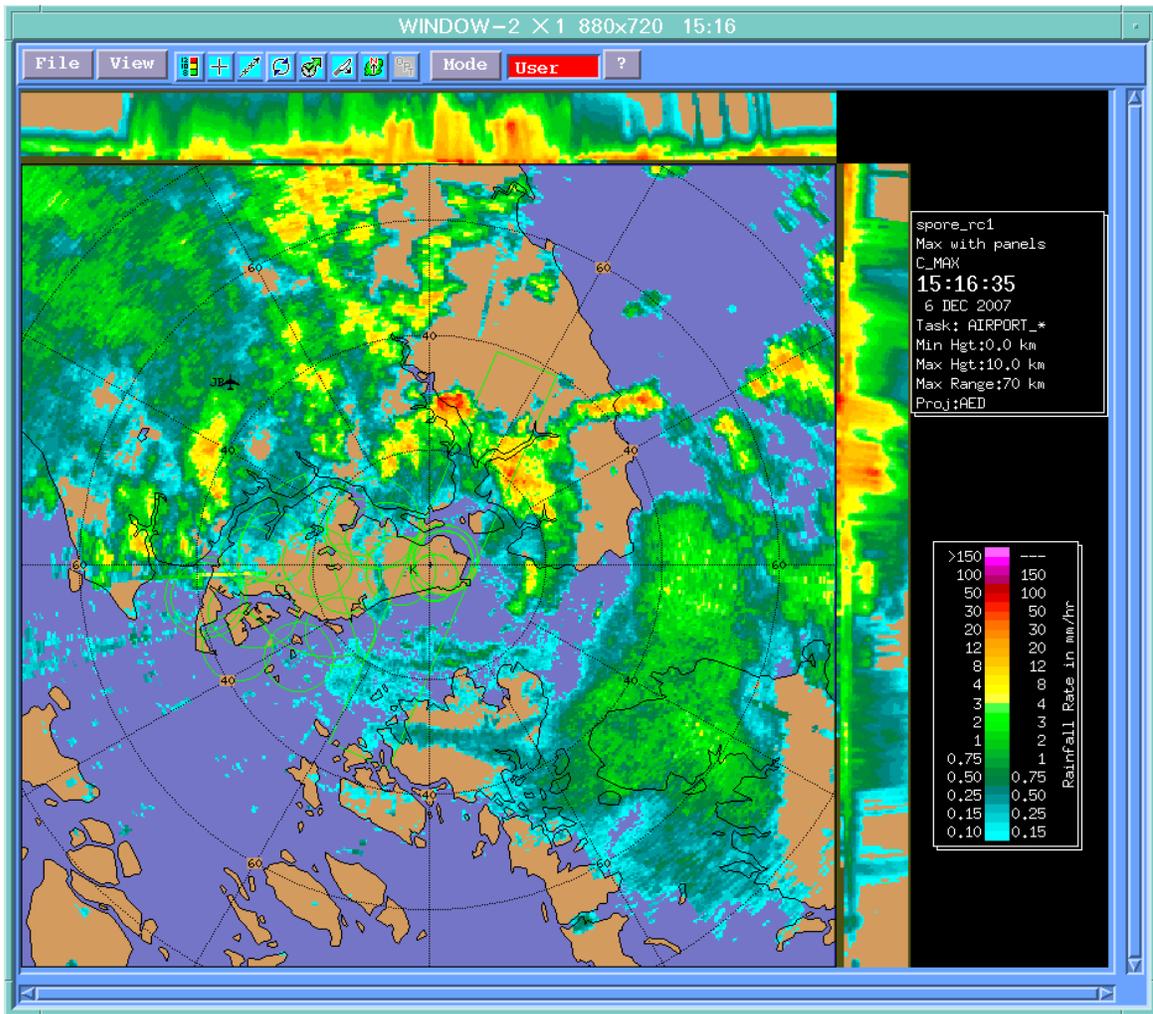
Figure 2 Weather Radar Display at 1516 hrs, 6 December 2007

1.4.2 The weather in the Changi Control Zone was poor during the time of the incident, with widespread cloud and rain. The radar display in **Figure 2** shows the spread of weather at Changi at the time of the incident.
