# **FINAL REPORT**

## **REPORT ON THE INCIDENT TO BOEING 737-400, 9M-MQK AT CHANGI AIRPORT, SINGAPORE ON 6 OCTOBER 2003**

AIB/AAI/CAS.015

26 April 2005

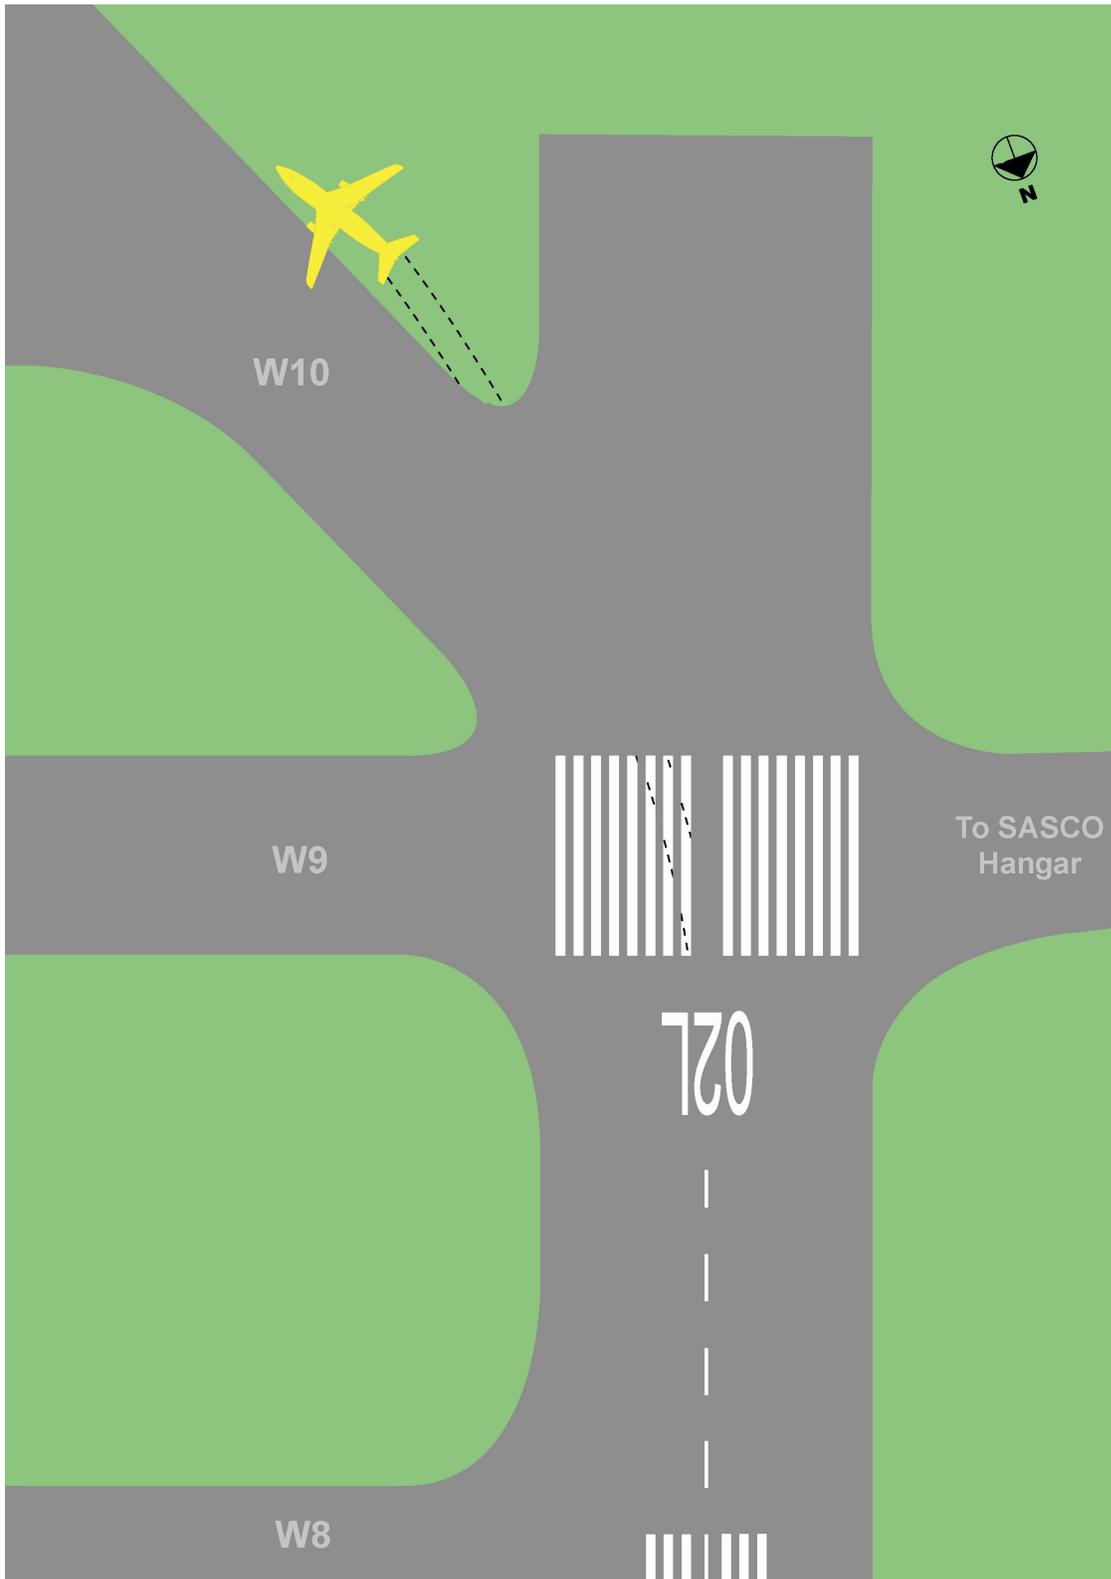
1 Chart showing the final position of aircraft

- 1.1.11 The PNF said that their speed was about 60 knots when the aircraft departed the paved surface at the intersection of Runway 20R and Taxiway W10 and came to a stop on the grass verge about 50 m from the runway and about 8 m from the edge of the closed Taxiway W10 (See Appendix 1). The nose gear became ensnared with airfield lighting cables that were temporarily laid on the grass verge.

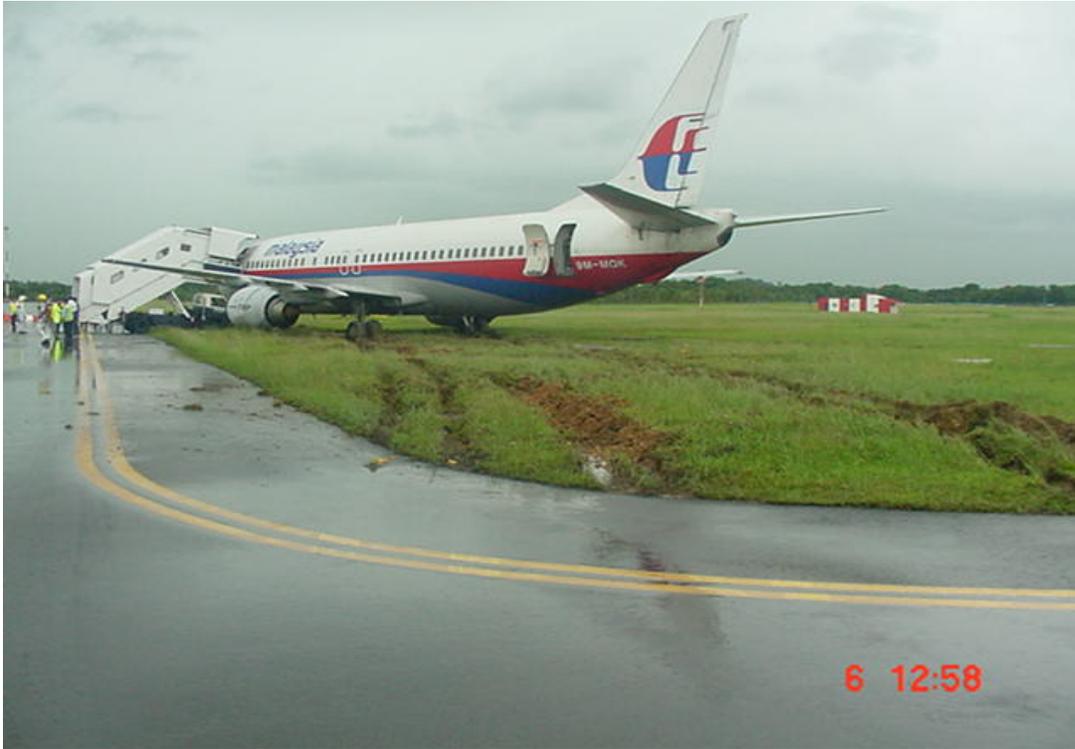
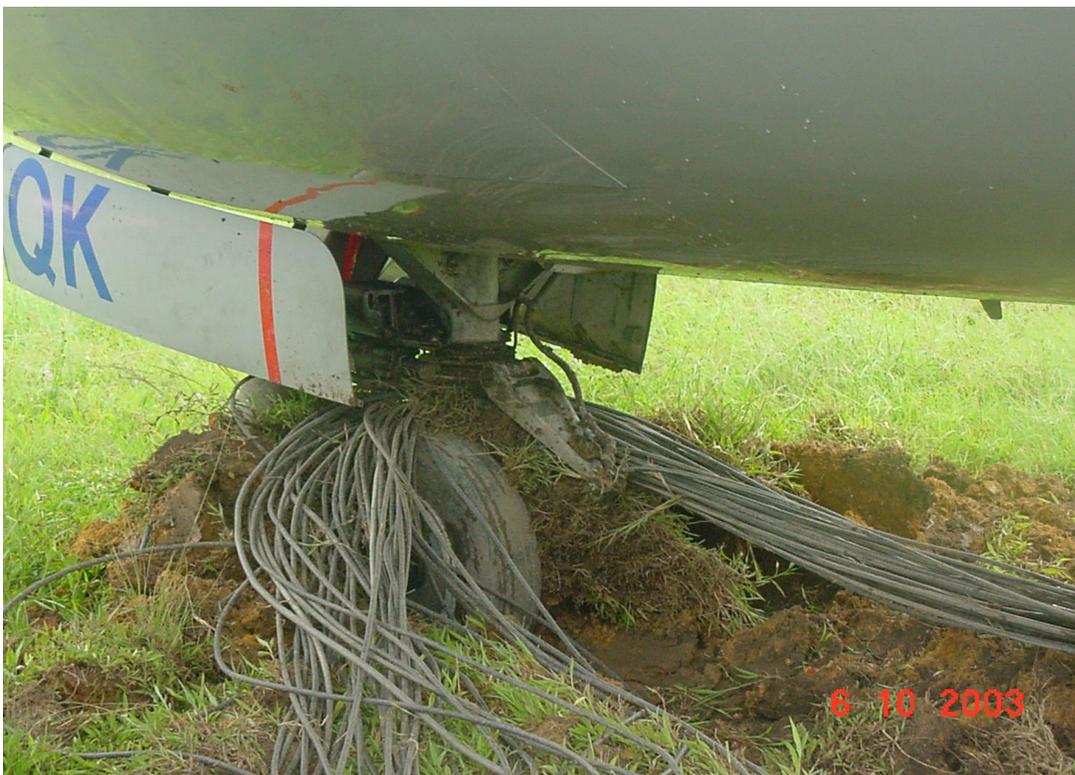
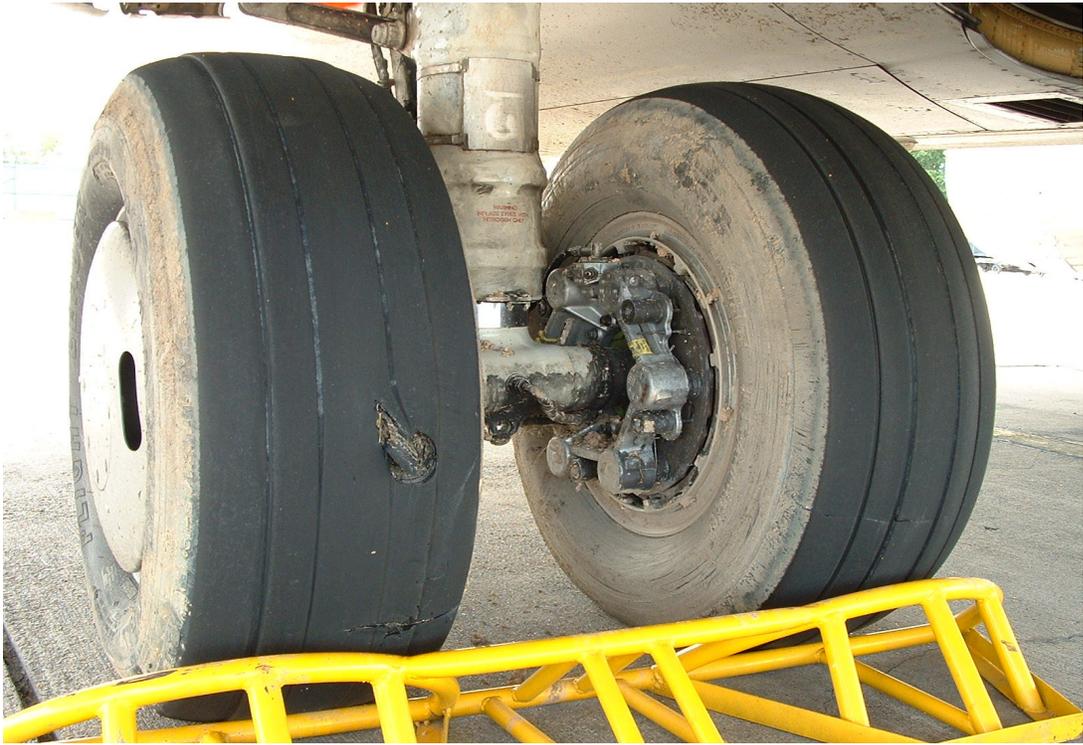
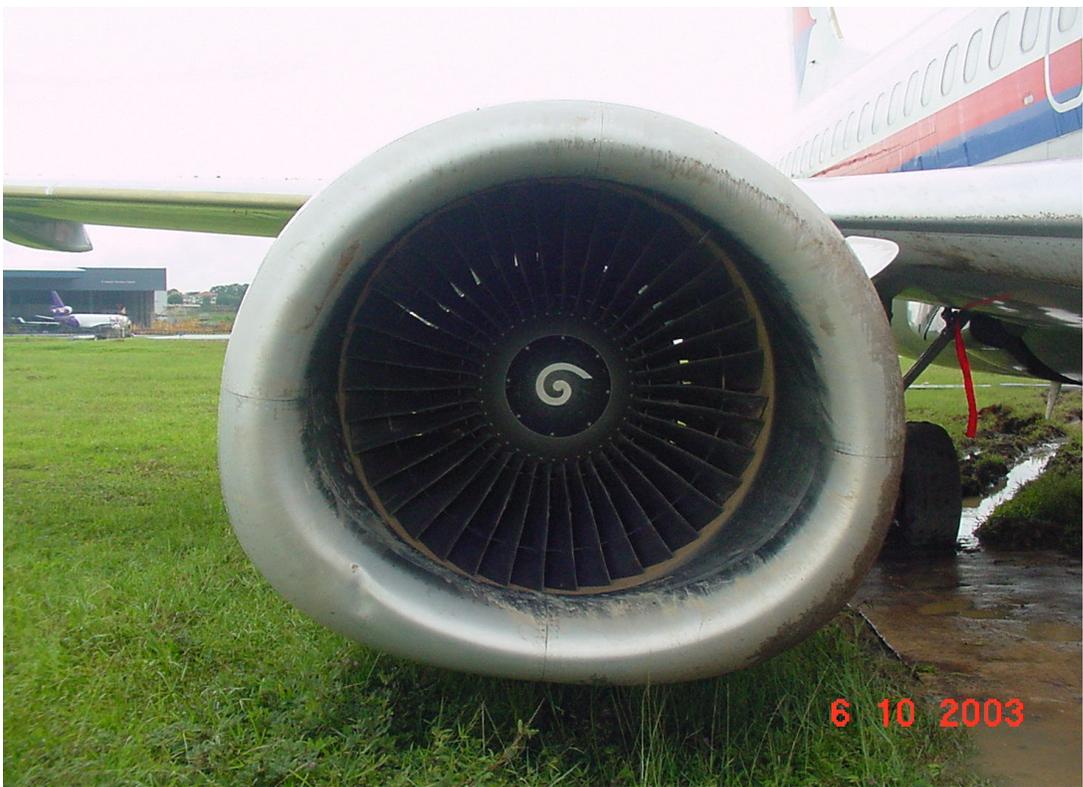
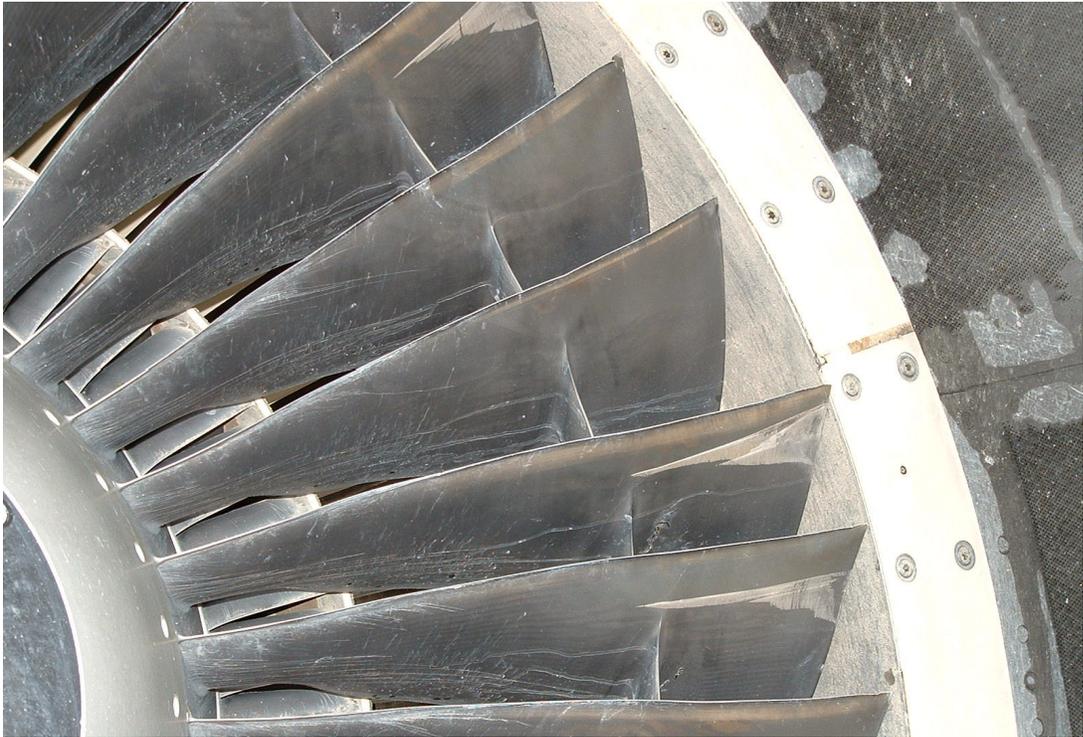
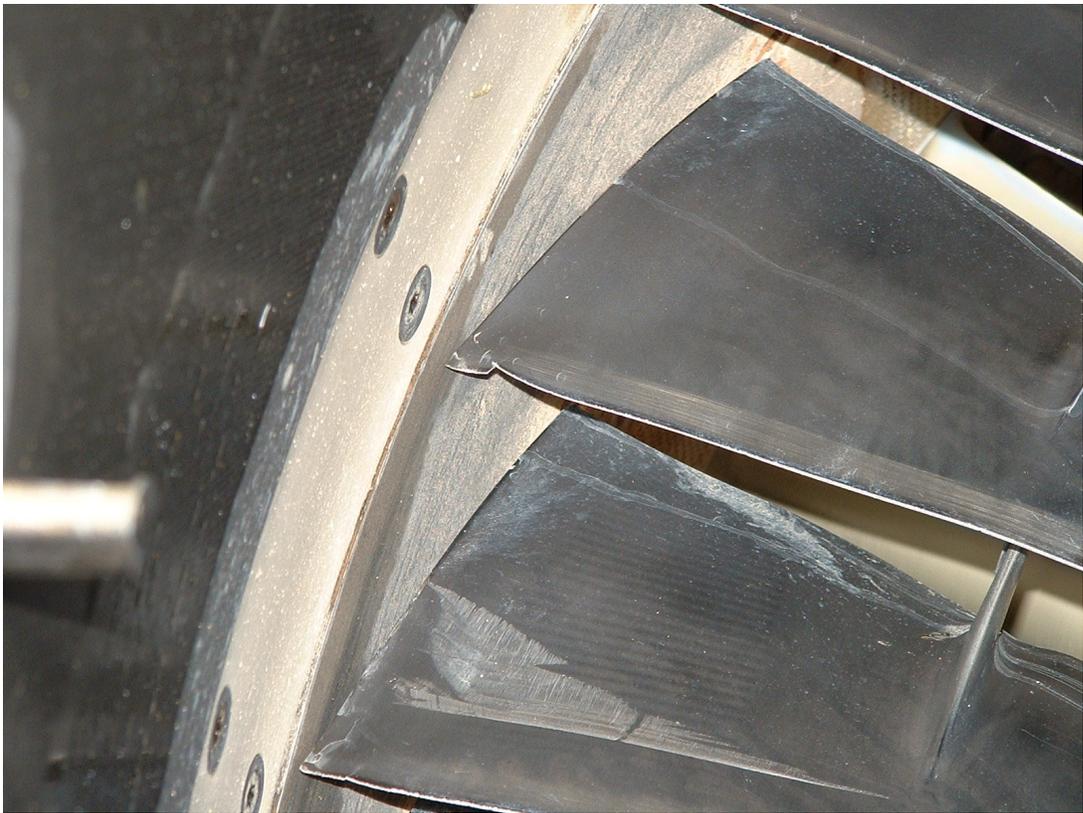
**APPENDIX 2**

The starboard engine of the aircraft ingested some mud and grass while the outboard tyre of the left hand main landing gear had a deep gouge. Some first stage rotor blades of the right hand engine suffered tears.

1.3.1 The outboard wheel on the left hand main landing gear suffered a gouge while the right hand engine suffered some first stage rotor blade tears due to ingestion of mud and grass. (See Appendix 2)

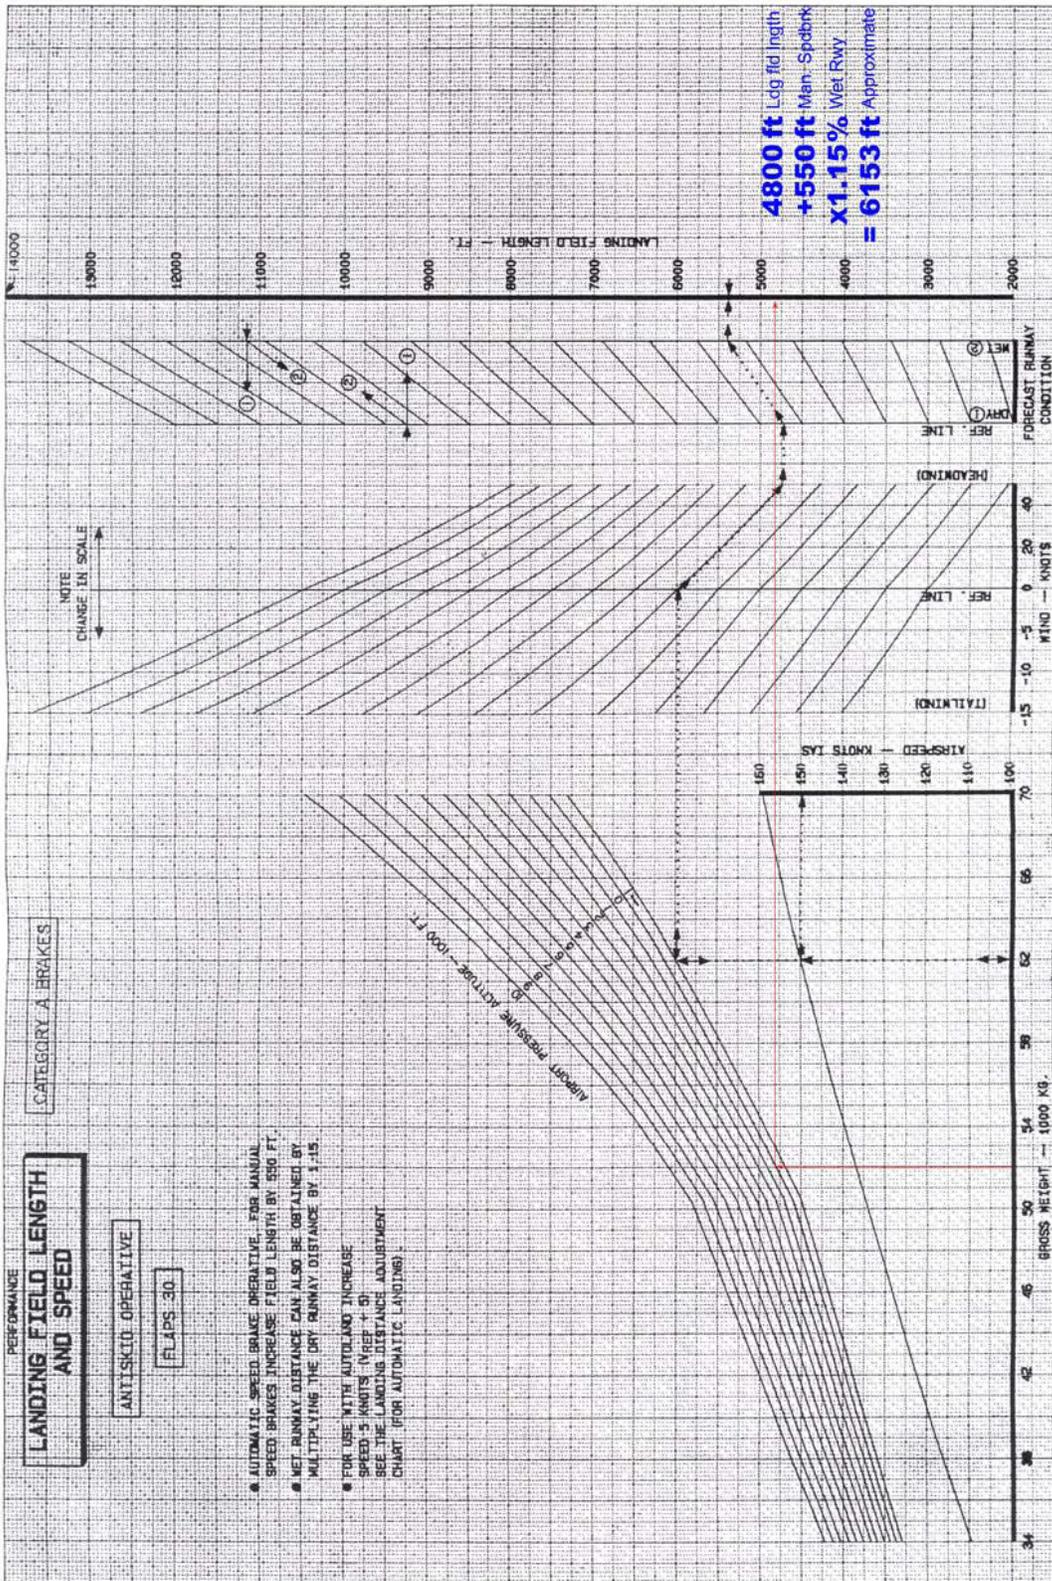
**LANDING FIELD LENGTH AND SPEED**

1.6.3.2 According to the Boeing "Landing Field Length Chart" (Appendix 3) the minimum landing distance required for the above landing weight was approximately 1,876 m (6,153 ft<sup>2</sup>) for a wet runway when using manual speedbrakes and Flaps 30°. The landing distance available was 3260 m (10,695 ft).

<sup>2</sup> 4800 ft is the Landing Field Length required for a dry runway. An additional 550 ft is needed for manual speedbrake deployment followed by a 15% increase in the distance for wet runway conditions.
