**MCDONNELL DOUGLAS MD-11 REGISTRATION N413LT
CENTRE LANDING GEAR DAMAGE DURING LANDING
SINGAPORE CHANGI AIRPORT
7 APRIL 2005**

AIB/AAI/CAS.023

**Air Accident Investigation Bureau of Singapore
Ministry of Transport
Singapore**

08 May 2009

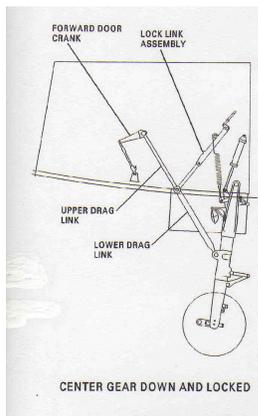
Normal CLG geometry

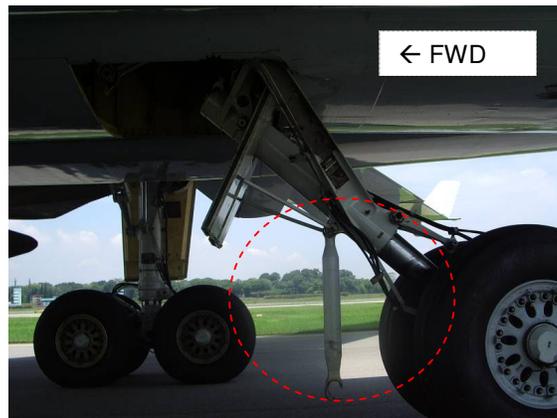
- 1.1.9 The inspection revealed that the CLG, which was normally at an angle of 15° forward of vertical, was angled at about 45° aft of vertical.

CLG angled at about 45° aft of vertical with the broken lower drag link dangling

The forward lugs of the lower drag brace link, which attached the link (CLG) to the aircraft structure, were broken.

2.1.1 Metallurgical examinations revealed that both the CLG lower drag brace link and retract actuator had fractured under overloading.

- 4.4 As the root cause of overloading of the CLG lower drag brace link is still unknown, the investigation team has suggested to the aircraft manufacturer that periodic inspections be devised to check the condition of the attachment lug of the CLG lower drag brace link. The aircraft manufacturer is of the view that the current inspection/overhaul interval of the subject line is sufficient and that as the failure was due to overload, a more frequent inspection of the link would not mitigate the overload problem.

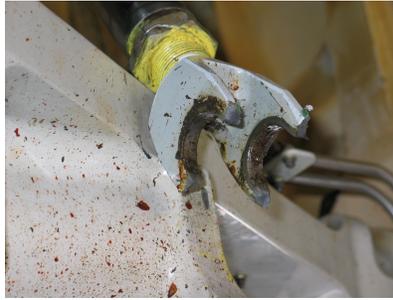
The lugs on the CLG gear retraction actuator were also broken.

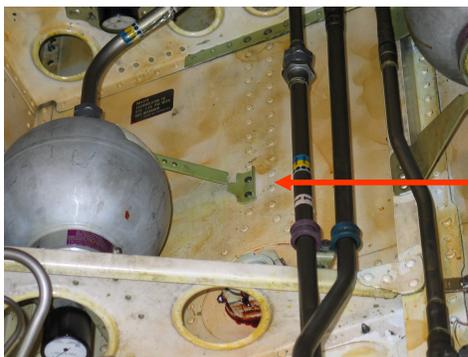
- In the left MLG wheel well, an accumulator bracket was broken.

Broken accumulator bracket

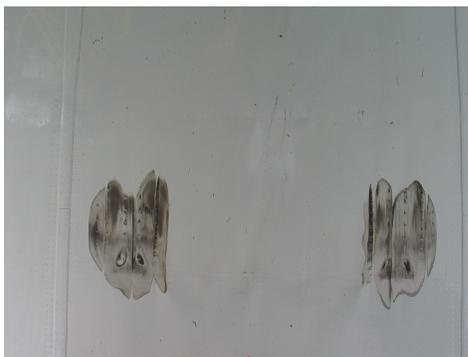
- Two dents with tyre marks were found on the aft fuselage above the CLG tyres. They were caused by the backswing of the CLG after the detachment of the lower drag brace link and retract actuator.

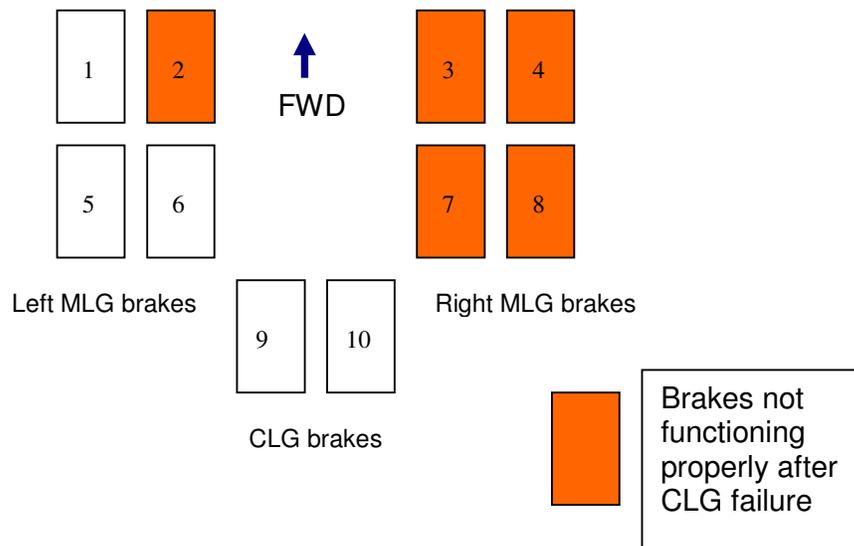
- 1.8.4.2 The operator performed a spin check of the antiskid system after the aircraft was towed back to the maintenance facility following the incident. It was noted that brake #2 (in left MLG), #3, #4, #7 and #8 (in right MLG) did not function properly. In each of these five brake units, the four pistons that were powered by brake system #2 did not operate, whereas the four pistons powered by brake system #1 operated normally. The two brake units in the CLG (#9 and #10) functioned properly. The aircraft manufacturer could not determine the cause of the malfunction. It commented that if the brakes #2, #3, #4, #7 and #8 did not function properly during the autobrake RTO tests on 7 April 2005, their energy absorption effectiveness could be reduced by about 40%.

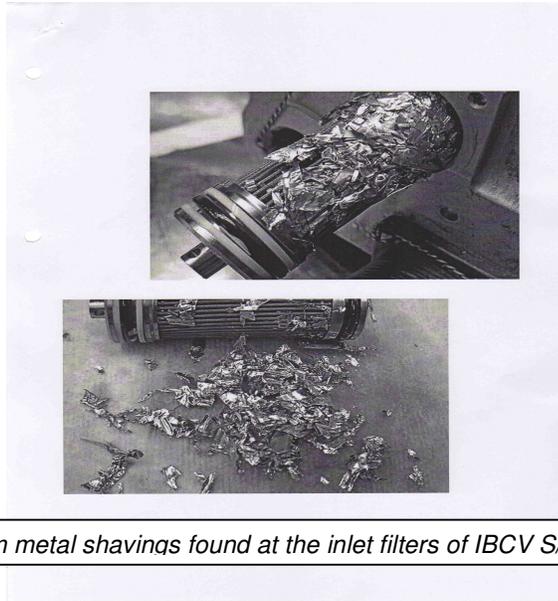
carried out on them. S/N 221 was found to have excessive aluminium shavings at the inlet filter. No shavings were found in S/N 363.

- 1.8.5.2 IBCV S/N 363 was installed in place of SN 219 before the incident. S/N 219 had been sent to the IBCV manufacturer before the incident and was found to have excessive aluminium shavings at the inlet filter.

- 4.1 The aircraft manufacturer informed all MD-11 operators on 15 June 2005 of the N413LT incident as well as the findings regarding the presence of aluminium shavings at the IBCV inlet filters. The aircraft manufacturer issued Service Bulletin MD11-32-073 dated 1 December 1997 and revised on 21 December 2005, which recommends inspection/replacement of the Brake Check Valve Manifold Assembly and IBCV inlet filters on all MD-11 aircraft. Accomplishment of the recommended modification/inspection will minimise the possibility of contamination induced brake system anomalies.
