FINAL REPORT

**AERO AT4, REGISTRATION 9M-EVA
VEERING OFF TAXIWAY**

AIB/AAI/CAS.116

**Transport Safety Investigation Bureau
Ministry of Transport
Singapore**

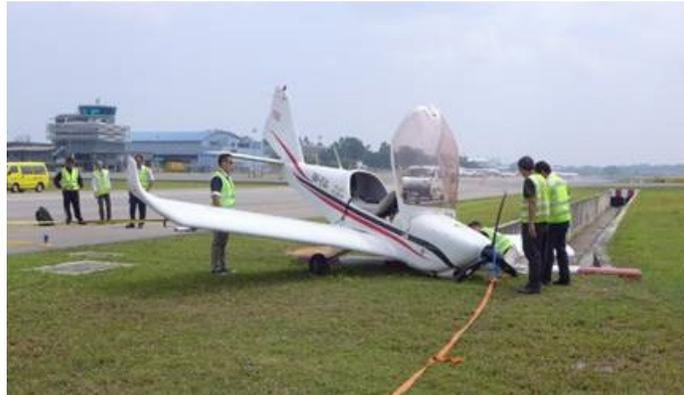
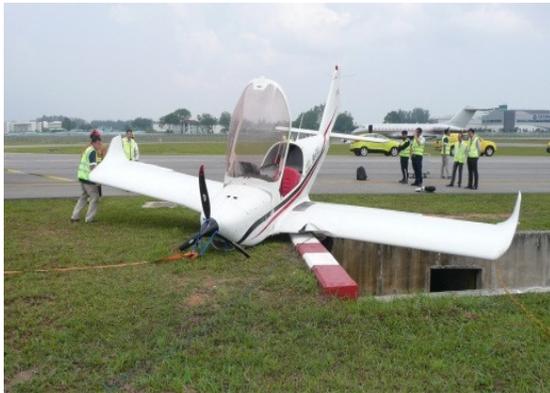
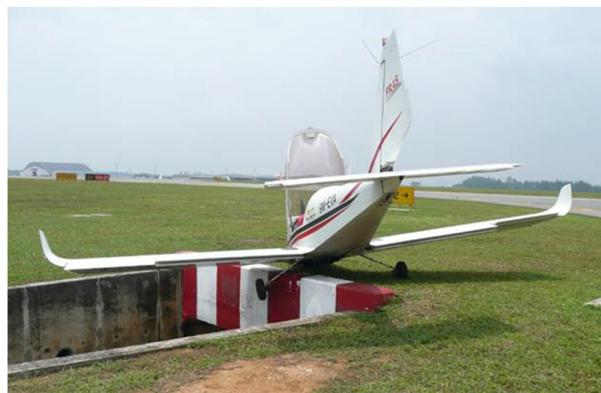
Figure 2: Aircraft final position

prevent the aircraft from continuing to veer to the left. The aircraft eventually came to rest on a grass patch next to a drain (see **Figure 2**).

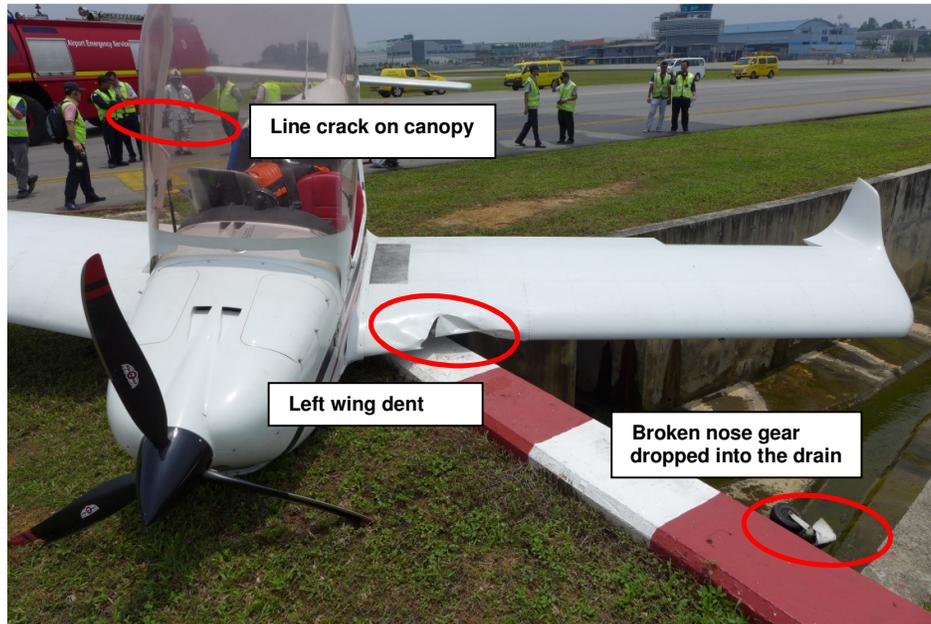
Figure 3: Damage to the aircraft

1.3.1 The damage to the aircraft included the following:

- Sheared off nose gear
- Impact damage on left landing gear (misalignment of wheel, misalignment of brake disc relative to the brake caliper resulting in rub marks on the internal interface of the left forward brake caliper)
- Dents on leading edge of left wing
- Scratch marks on left wing tip
- Crack across canopy

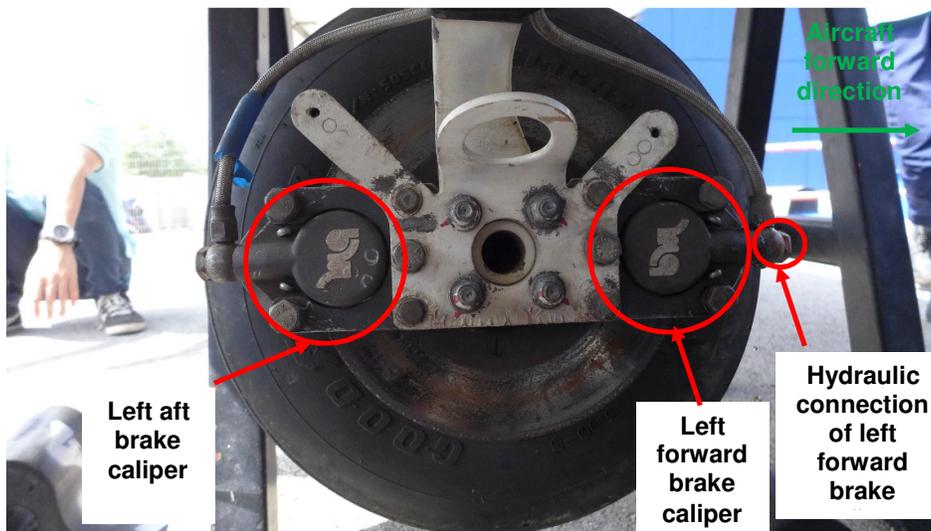
Figure 4: View looking inboard of left landing gear

2.2.3.2 The rub marks on both of the left brake calipers could have been a result of towing of the aircraft after the occurrence with a misaligned left brake disc.

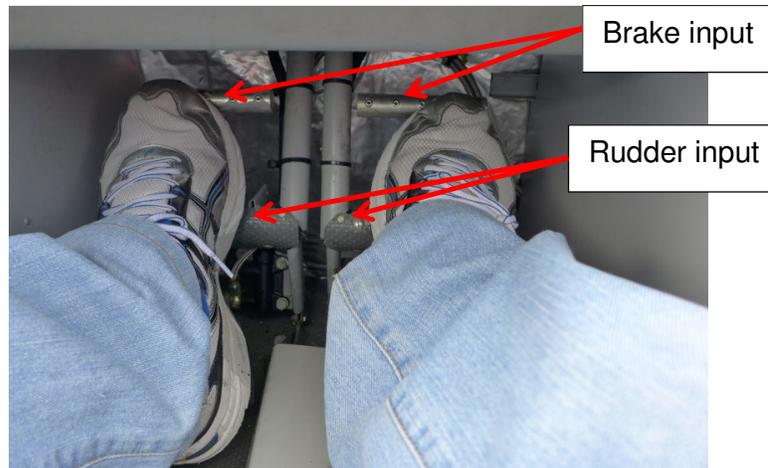
Figure 5: Position of rudder and toe brake pedals

1.5.3.1 The foot pedals in each pilot position² are used for moving rudder as well as for applying brakes. When the upper portion of a foot pedal is depressed (using toe force), the foot pedal functions as a brake pedal. When the lower portion of the pedal is depressed (using heel force), the foot pedal functions as a rudder pedal (**Figure 5**).

1.5.4.3 If a pilot applies his foot control inappropriately, he may end up applying rudder control when he actually wants to apply brakes, and vice versa.

2.3.2 One possibility is that the pilot might have inadvertently applied the right rudder input instead of depressing the right toe brake pedal. Under a low taxiing speed and a low wind speed condition, the deflection of the rudder would not have any effect on the direction of travel. If the pilot did apply inadvertently rudder pedal input instead of brake pedal input, it would be natural that there would be no braking action, as the pilot had perceived in this case. This may explain why the pilot felt that the right brake was not responsive. Without braking action on the right wheel but with braking action on the left wheel, the aircraft would veer to the left. The combination of left brake application and right rudder input would cause the aircraft to veer to the left.

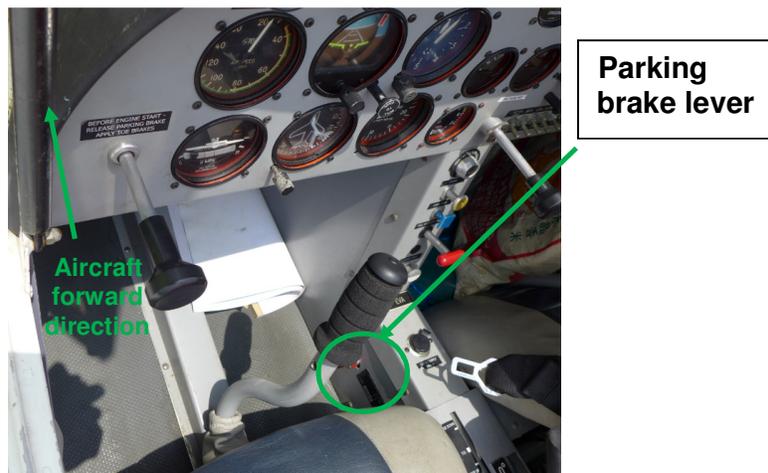
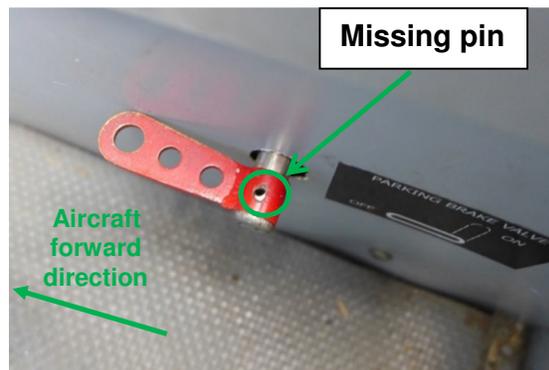
1.11.2 The parking brake lever of the aircraft was found to be rotating freely as a pin that holds the lever in place was missing (**Figures 6 and 7**). To set the parking brake, the pilot had been using an improvised method – by inserting a makeshift thin rod through the missing pin hole and then turning the lever.

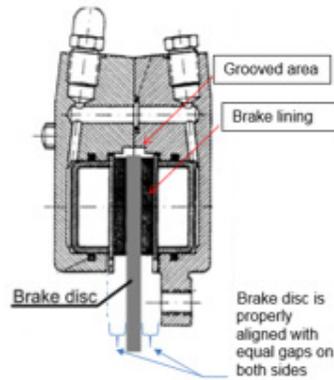
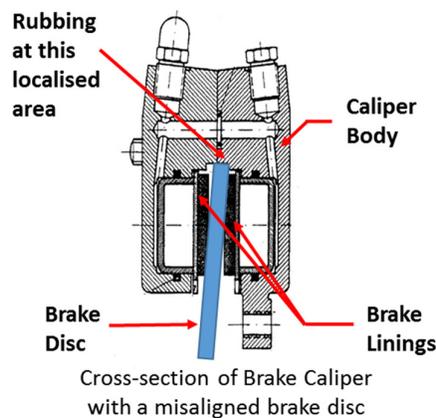
Figure 8: Cross section of a brake caliper

- Misalignment of the brake disc in the left wheel brake calipers from the impact damage, causing internal rubbing within the caliper (**Figure 8**)
- Fusion of the brake disc with the brake linings of the calipers in the left landing gear during emergency braking operation

2.2.3.1 A high pitch screeching noise would have been produced if the brake disc had been in contact with the calipers while taxiing. The pilot did not recall hearing any such noise while operating the aircraft on 4 and 7 October 2015.

2.2.3.3 A locked wheel situation resulting from a misalignment of brake disc is highly unlikely.
