# **FINAL REPORT**

## **AIRBUS A320, REGISTRATION 9V-TRH FAN COWL DAMAGE DURING TAKE-OFF**

**16 October 2015**

**AIB/AAI/CAS.117**

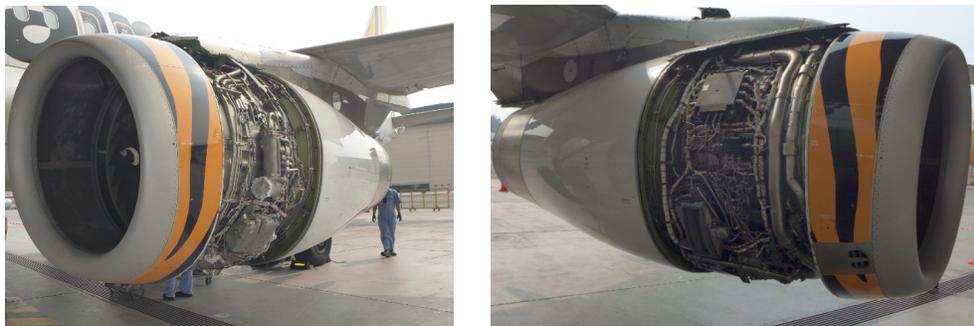
- 1.2.1 The left engine's inboard and outboard fan cowls were missing (see **Figure 1**).

Figure 1: Loss of inboard and outboard fan cowls

- 2.1.2 With fan cowl latches not fastened, the airflow generated during the aircraft's flight would tear off the fan cowls.
- 2.1.3 As mentioned in paragraph 1.1.2, the BLO LAE "checked that there were no gaps between the surfaces of the fan cowl and the engine nacelle which, from his experience, would indicate an unfastened fan cowl condition." And as mentioned in paragraph 1.1.6, "the FO also checked that the fan cowl surfaces were flush with that of the engine nacelle and that there was no gap." It is not known how such flushness assessment has become an acceptable way of ascertaining that the fan cowl latches are fastened, in lieu of bending down or crouching to bring eye level low enough to confirm latches are fastened. The simulation test (paragraph 1.6.3) showed that a fan cowl with unfastened latches could still appear flush with the engine nacelle. Such a flushness assessment is not a method recommended by the aircraft manufacturer.

- 3.1 The European Aviation Safety Agency (EASA) issued an Airworthiness Directive (AD 2016-0053) on 14 March 2016 to modify the fan cowls such that a special key had to be used to unlatch the fan cowls, the key cannot be removed unless the fan cowl front latch is safely closed.

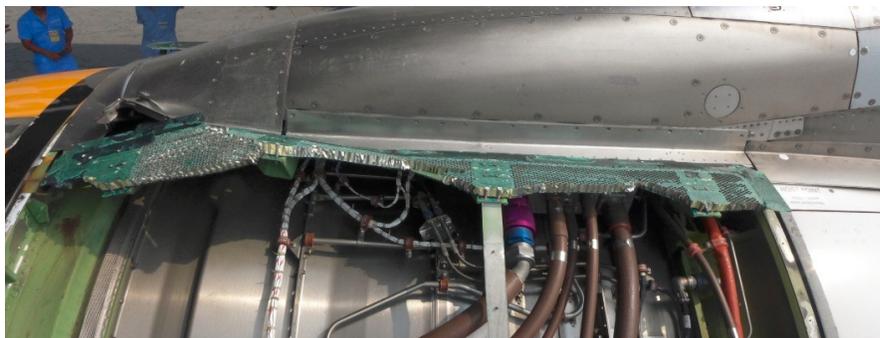
- 1.2.2 The left engine forward pylon was buckled (**Figure 2**).

Figure 2: Damage on the engine forward pylon

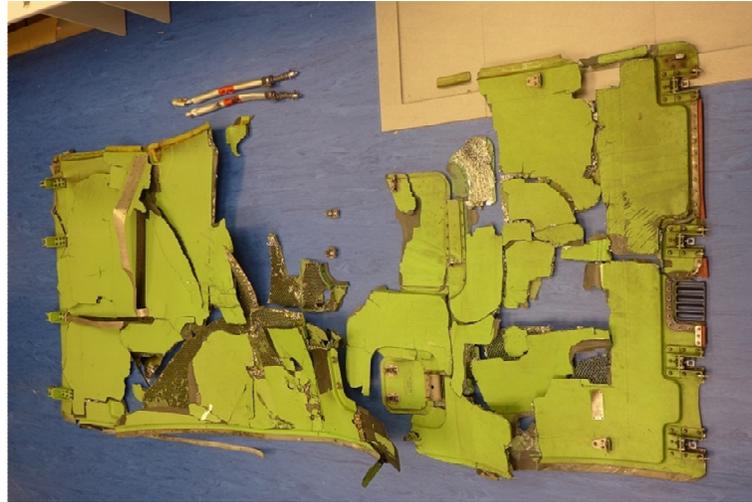
1.2.3 Debris of the outboard fan cowl was found on the runway. **Figure 3** shows a reconstruction of the debris.

Figure 3: Reconstructed outboard fan cowl

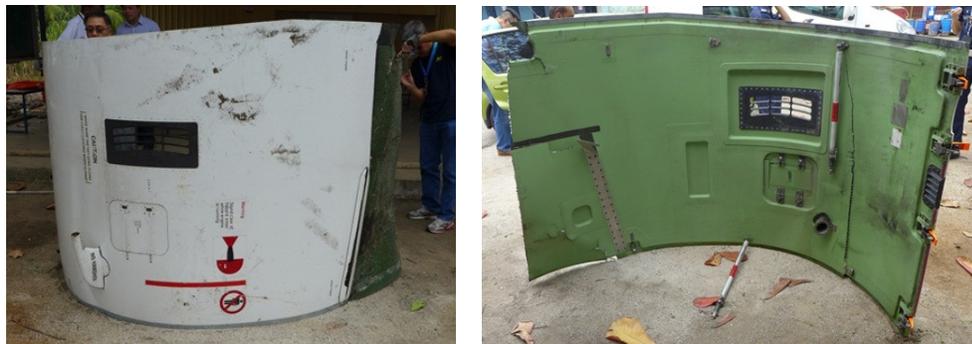
1.2.4 The inboard fan cowl was recovered from the sea by a passing ship. It was essentially in one piece (**Figure 4**). There was a tear across the top near where the fan cowl was attached to the engine forward pylon. The original state of the latches (e.g. fastened or unfastened) could not be ascertained as some degree of latch handling had occurred before the investigation team received the fan cowl.

Figure 4: Inboard fan cowl

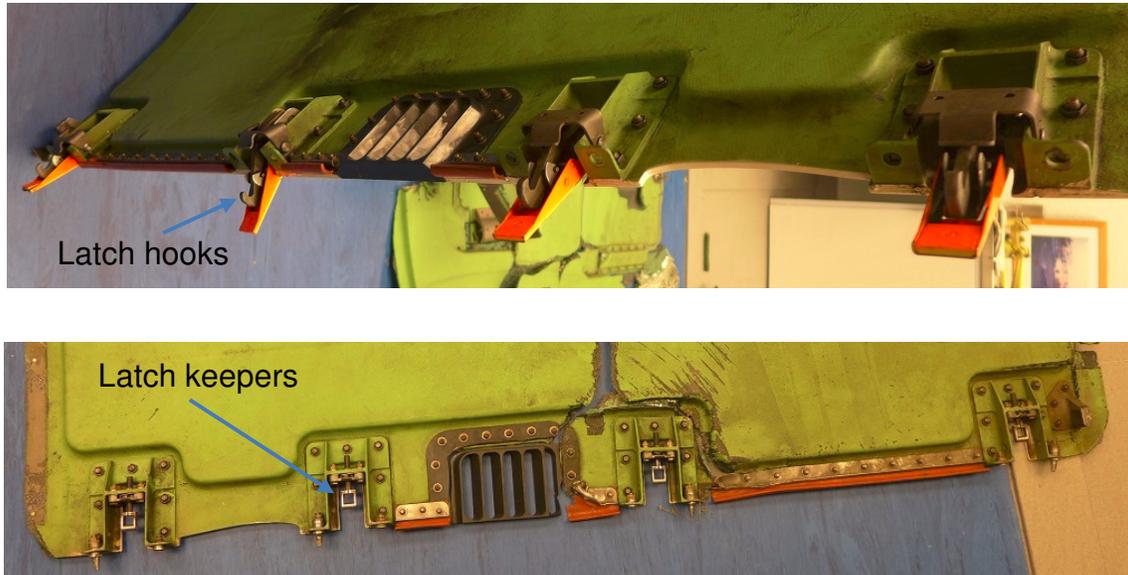
- 1.2.5 All the four latches (comprising four hooks at the bottom edge of the inboard fan cowl and four corresponding keepers at the bottom edge of the outboard fan cowl) were recovered. Apart from operational wear, no damages were observed on the four latches (**Figure 5**).

Figure 5: No damage to the hooks and keepers of the latches

- 2.1.1 Evidence shows that at least three of the four latches of the fan cowl of the left engine were not fastened four hours before the incident aircraft took off. Detailed inspection on the recovered latches (inboard fan cowl hooks and outboard fan cowl keepers) showed no damage on the connecting surfaces, and the damage was solely on the fan cowl structure. This would indicate that there was no mechanical failure or structural damage on the latch hooks and keepers, and would suggest that all latches were likely to be unfastened at the time of take-off.

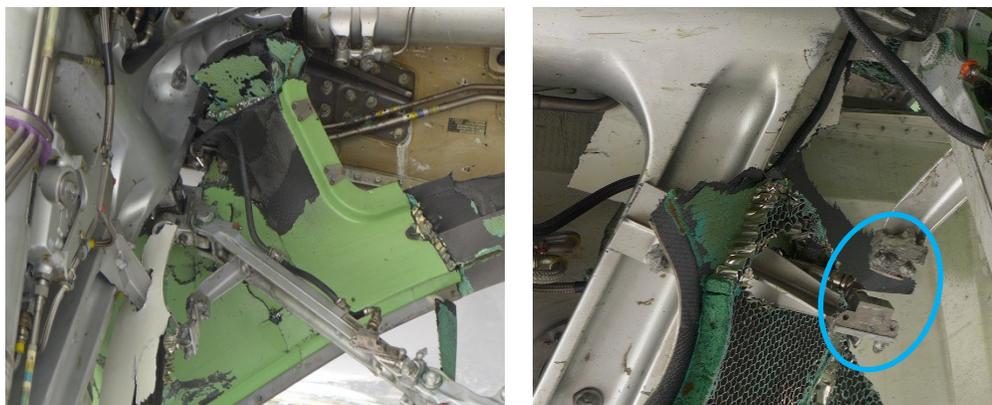
- 1.2.6 Some fan cowl debris had lodged into the left main landing gear door, and damaged the proximity sensor on the left main landing gear (**Figure 6**).

Figure 6: (Left) Fan cowl debris wedged into left main landing gear door  
(Right) Proximity sensor (blue circle) impacted by fan cowl debris

2.2.1 Fragment from the outboard fan cowl impacted the left main landing gear proximity sensor. The damage to the proximity sensor resulted in the erroneous Master Warning indicating that landing gear was not downlocked.

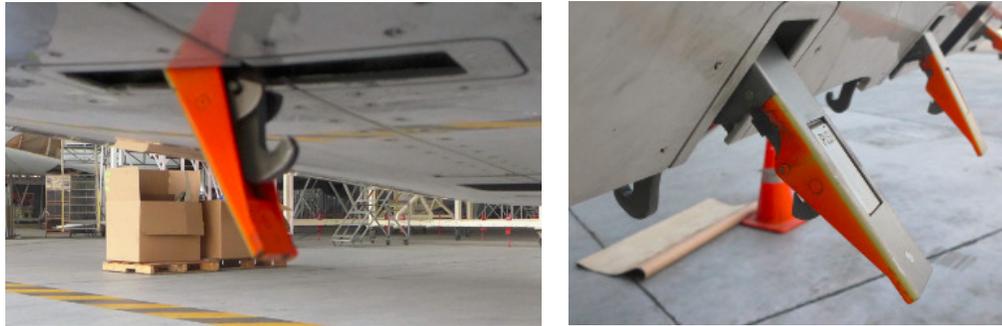
1.4.3 If the latch is not fastened, the latch handle will protrude from the surface (**Figure 8**).

Figure 8: Protrusions due to unfastened latches

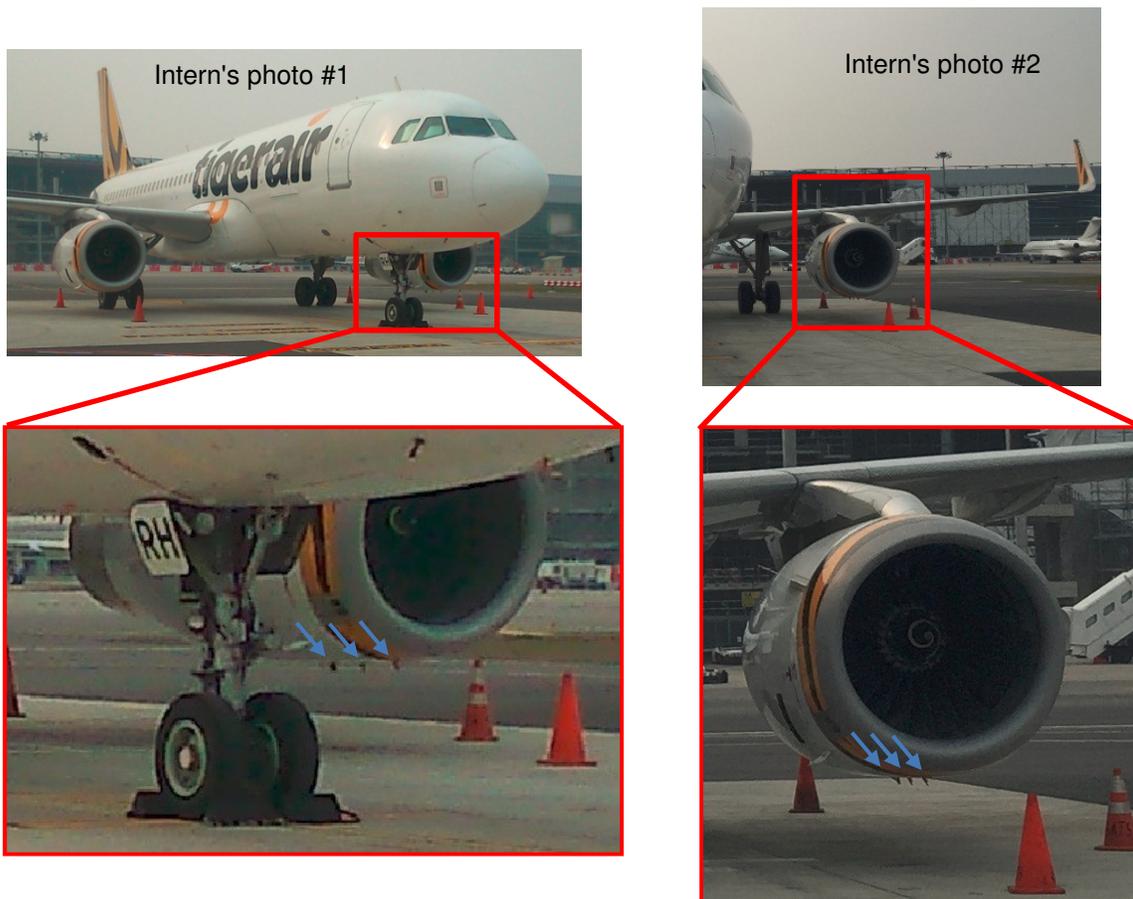
1.4.4 In the afternoon of 16 October 2015, the aircraft operator was conducting an orientation tour for a group of interns. The interns visited the incident aircraft at Bay 702 at 1650hrs. Photographs taken by one of the interns showed that at least three of the four fan cowl latches of the left engine were unfastened (**Figure 9**).

Figure 9: Photographs showing unfastened latches on 16 October 2016

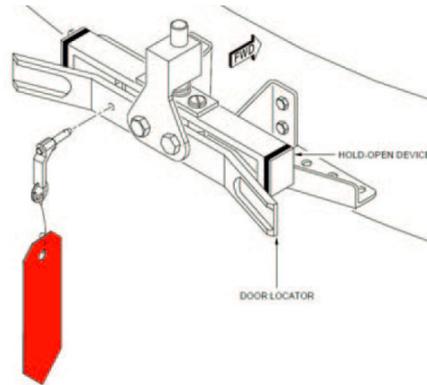
- 1.4.5 Damage to fan cowls in flight when the fan cowl latches were not fastened had happened before. The aircraft manufacturer has introduced a modification for making a hole in the hold-open device (HOD) of the fan cowls which can receive a dedicated red warning flag tool to make an unfastened condition of fan cowls more noticeable (**Figure 10**). This modification was incorporated on the incident aircraft.

Figure 10: Red warning flag tool in the HOD indicating an unfastened fan cowl

- 1.5.3 The BLO technician was not aware that the red warning flag tool had to be used when the fan cowls were opened. He was not aware of the key actions for opening and closing fan cowls as described in paragraph 1.5.1 (a)-(c) and he did not refer to the AMM for the fan cowl opening/closing procedure during the BLO prior to the incident flight.

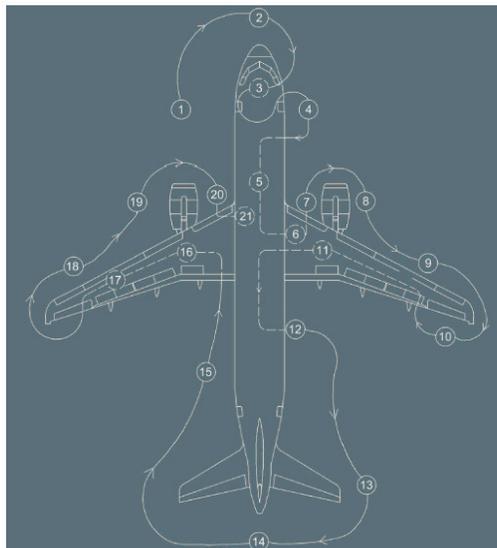
- 1.5.5 The aircraft manufacturer had provided guidance in its Flight Crew Operations Manual (FCOM) for exterior walkaround check (**Figure 11**) to be performed by flight crew or maintenance personnel. The check was to, among others, ensure that fan cowls are closed and latched before flight. Each engine must be checked from both the inboard and outboard side of the nacelle. The guidance did not mention that one should crouch to check the latches.

Figure 11: Aircraft manufacturer's instructions on the exterior walkaround check

2.1.8 It is noted that, although the aircraft manufacturer has emphasised the need to bend down or crouch to check that latches are fastened in its Safety First Magazine, this requirement is not mentioned in the aircraft manufacturer's FCOM for exterior walkaround check.

- 4.2 The aircraft maintenance service provider remind its maintenance personnel that fan cowl flushness with nacelle is not a reliable method for checking that fan cowl latches are fastened. [TSIB Recommendation RA-2017-029]
- 4.3 The aircraft manufacturer emphasise, in its maintenance documentation on exterior walkaround check, the need for inspection personnel to bend down or crouch to bring eye level low enough to confirm latches are fastened. [TSIB Recommendation RA-2017-030]

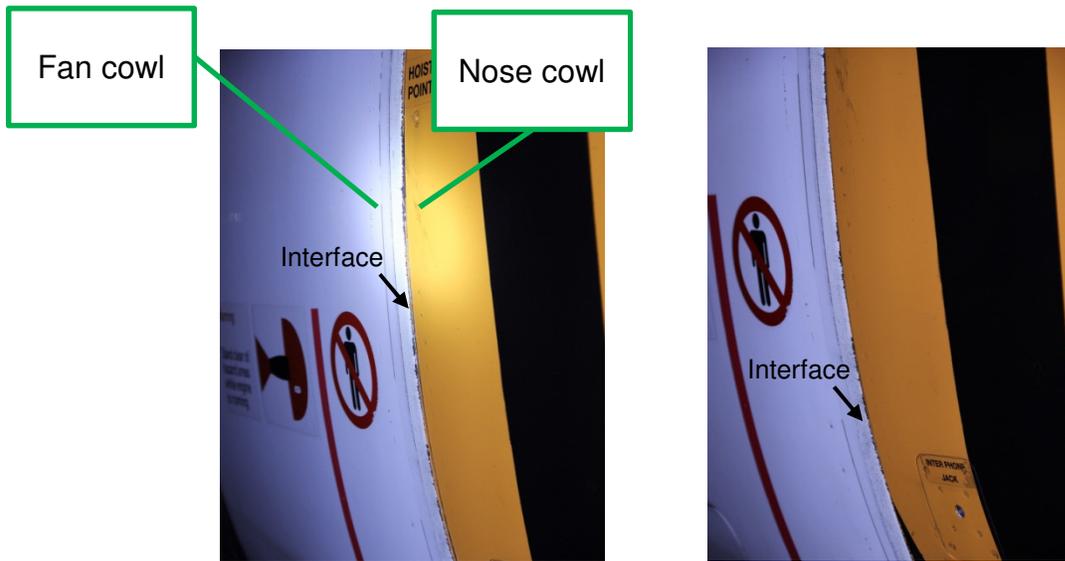
- 1.6.2 It was observed that, even in night conditions, the airport lighting was sufficient to illuminate the aircraft and its surrounding.
- 1.6.3 The aircraft manufacturer's fan cowl closing procedure required the removal of the red warning flag tool, the depressing of the HOD to allow the fan cowls to close fully and finally the fastening of the four latches from rear to front. It was observed that after depressing the HOD to allow the fan cowls to fully close and prior to fastening the latches, the fan cowl was relatively flushed at the interface with the nose cowl. The existing design of the HOD still could allow the fan cowl to be closed flush at the interface, there was minimal difference in flushness whether latches were unfastened or fastened (see **Figure 12**).

Figure 12: (Left) Flushness at interface when all latches are not fastened  
 (Right) Flushness at interface with all latches fastened

- 4.1 The aircraft operator remind its flight crew personnel that fan cowl flushness with nacelle is not a reliable method for checking that fan cowl latches are fastened. [TSIB Recommendation RA-2017-028]

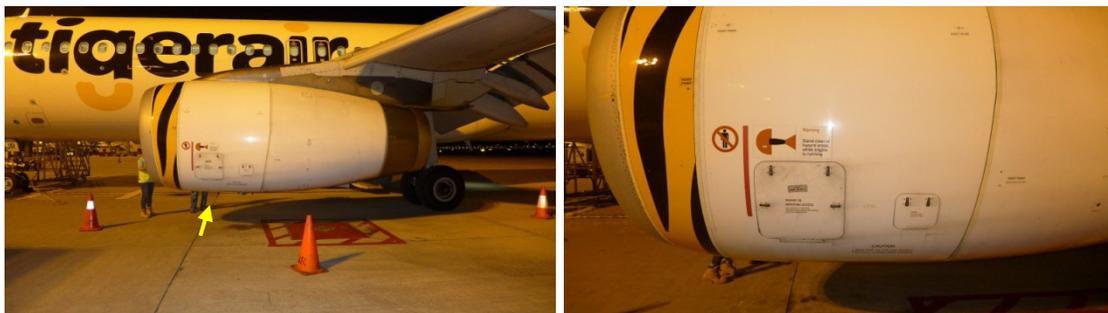
1.6.4 With the fan cowls were closed, latches that were unfastened and protruding could not be seen at certain locations from the engine (particularly when viewed from a standing position). The curvature of the engine nacelle obscures the latches even when they are unfastened, making it difficult to sight the protruding latch handles<sup>6</sup>.

Figure 13: (Left) Unfastened latches can barely be seen from a distance (side of engine)  
 (Right) Unfastened latches cannot be seen when standing next to engine

- 2.1.5 It is also found from the simulation test that, at a distance away from the engine, the unfastened latches could be difficult to detect as the curvature of the engine nacelle could obscure the view of the latches.

- 2.1.7 In short, a better way to ascertain whether the fan cowl latches are fastened is to squat down low enough to sight the latches.

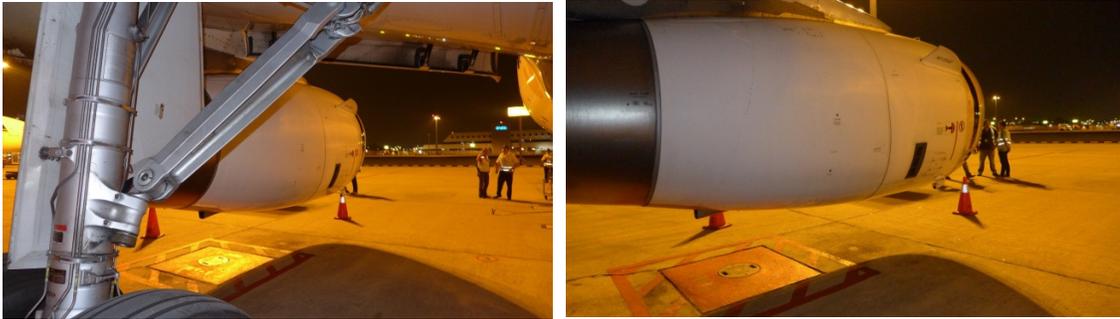
Figure 14: Unfastened latches cannot be seen at any point from the main landing gears to the engine

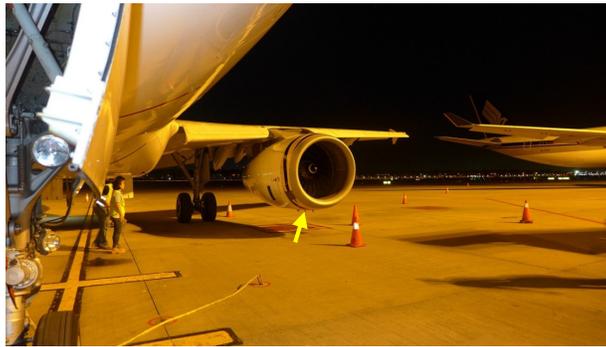
- 1.6.5 While it might be possible to notice latches that were unfastened from the front of the aircraft at positions around the nose landing gear (i.e. some distance away from the engine) (see **Figure 15**), the silhouette of the engine drain mast might obscure the protruding latches.

Figure 15: Unfastened latches can barely be seen from the nose landing gear location

- 2.1.6 It is not a reliable method to determine if the fan cowl's latches had been fastened properly by trying to judge from a distance whether there are protrusions of the latches. The lighting condition and the angle of view may make the judging difficult. The silhouette of the engine drain mast may also obscure the outline of protruding latches.
