FINAL REPORT

A330 RUNWAY EXCURSION AT YANGON AIRPORT, MYANMAR 21 MAY 2014

AIB/AAI/CAS.105

**Transport Safety Investigation Bureau of Singapore
Ministry of Transport
Singapore**

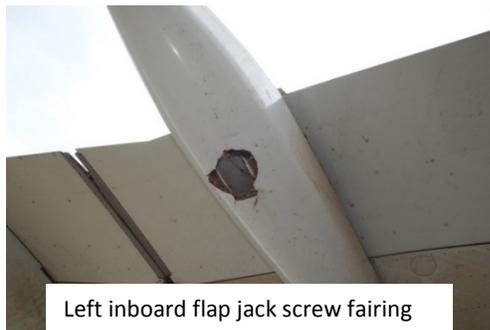
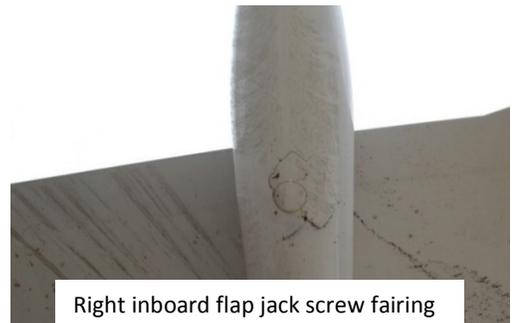
- Damage to its innermost flap fairing canoes on the left and right sides

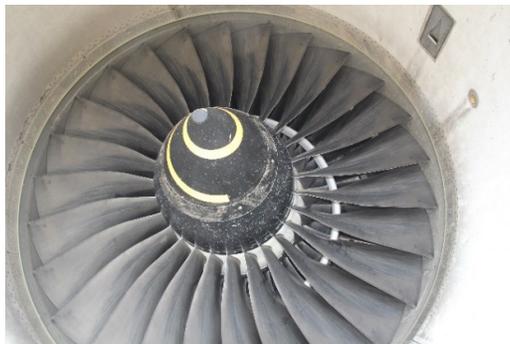
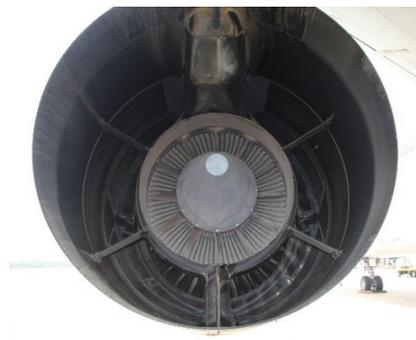
Left Hand Engine

- The left engine’s ingestion of mud and debris

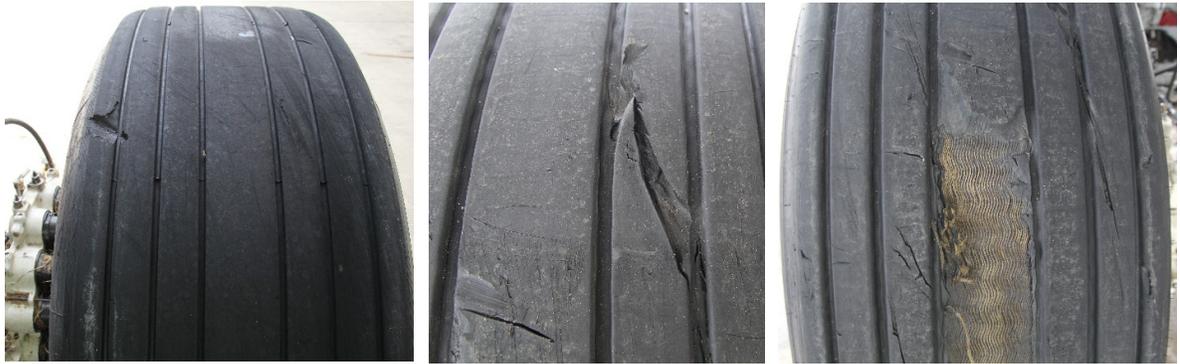
- Gouging and cuts on several tyres

Examples of gouged and cut tyres

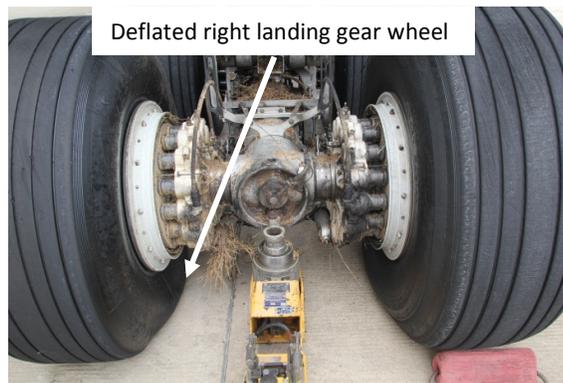
- Deflation of Tyre No. 7

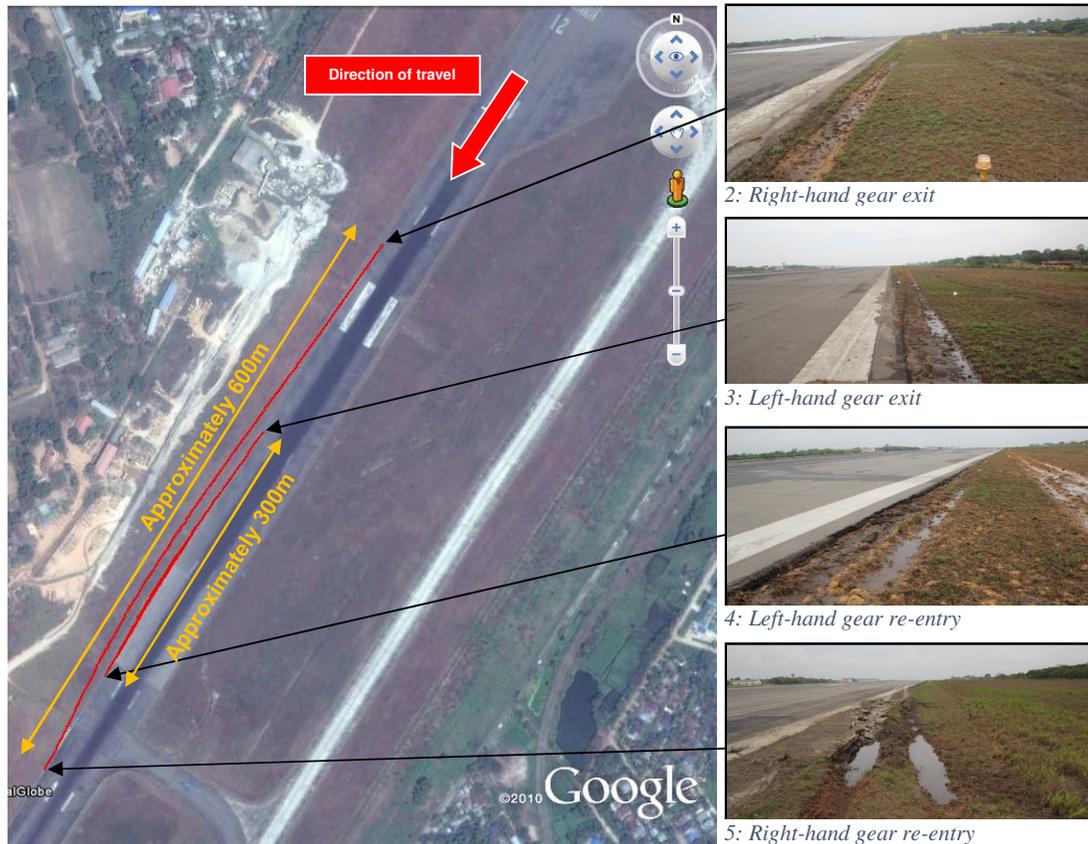
Figure 1. Runway excursion ground scars

- 1.5.1 After the touchdown the aircraft exited the paved runway surface on the right side of the runway edge. As shown in **Figure 1**, the aircraft's right main landing gear was off the runway for a distance of about 600 metres and the left main landing gear was off the runway for a distance of about 300 metres.

1.5.2 Between the points where the aircraft exited and re-entered the paved runway surface, the surface of the shoulder that abutted the runway pavement was not flush with the surface of the runway and was also uneven⁸.

2.4.1 Between the points where the aircraft exited and re-entered the paved runway surface, the surface of the shoulder that abutted the runway was not flush with the surface of the runway and was also uneven. This condition of the shoulder did not seem to meet the recommended practice spelt out in paragraph 3.2.4 of Annex 14 Volume 1.

- 4.1 The aerodrome operator consider improving the conditions of the shoulder of Runway 03/21 to meet the ICAO requirement in Recommendation 3.2.4 of Annex 14 Volume 1.
[TSIB Recommendation RA-2017-036]
