FINAL REPORT

B737-800, REGISTRATION 9V-MGM PUSHBACK INCIDENT

6 December 2015

AIB/AAI/CAS.118

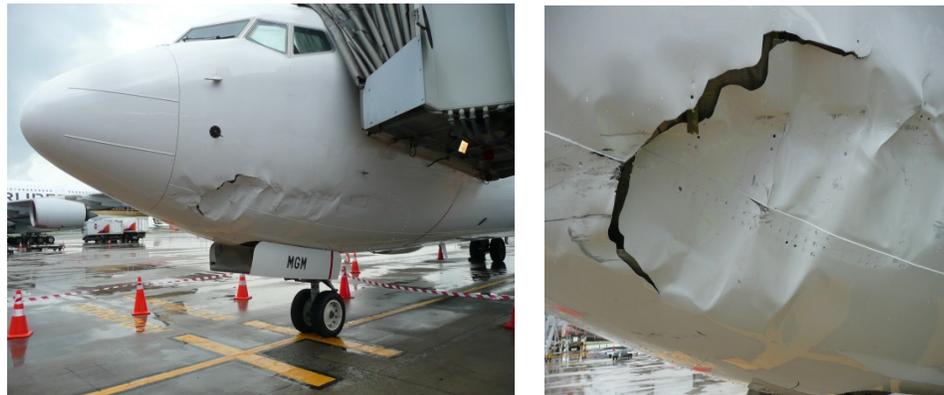
Figure 4: Damage to the lower left front fuselage

- 1.2.1 The aircraft sustained structural damage to an area of about 280cm by 60cm on the lower left front fuselage just behind the radome (see **Figure 4**).

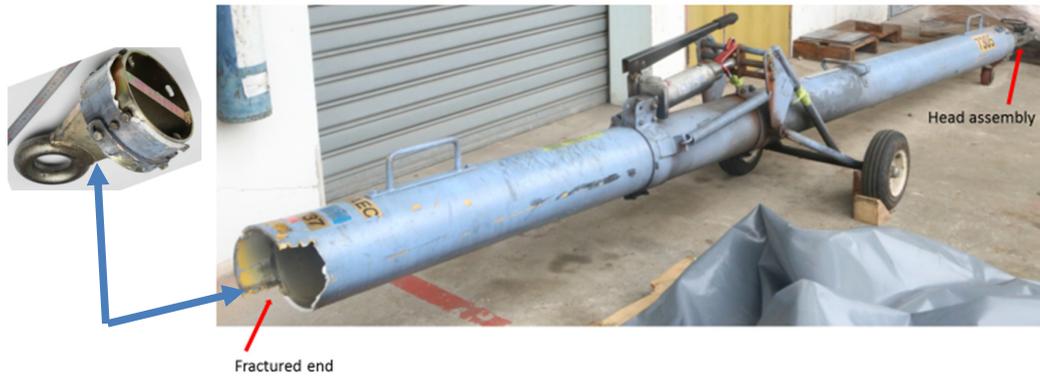
Figure 5: Damage to towbar

- 1.3 Damage to towbar and airtug
 - 1.3.1 The towbar broke near the end that was connected to the airtug's tow hitch

1.6.3.1 The towbar broke near the end that was connected to the airtug's tow hitch. The broken towbar (including the lunette ring end that had broken off) and the airtug's tow hitch were sent to an outhouse laboratory for examination. The examination showed the following:

- (a) The material of the towbar tube conformed to specifications.
- (b) The towbar tube had no material defects, corrosion or fatigue.
- (c) The towbar tube had turned about 96° with respect to the centerline of the airtug and cause the lunette mount flat to make contact with and dent the stop plate in the airtug's tow hitch.
- (d) The failure of the towbar was due to overloading and the tube material fractured in a ductile⁵ manner.

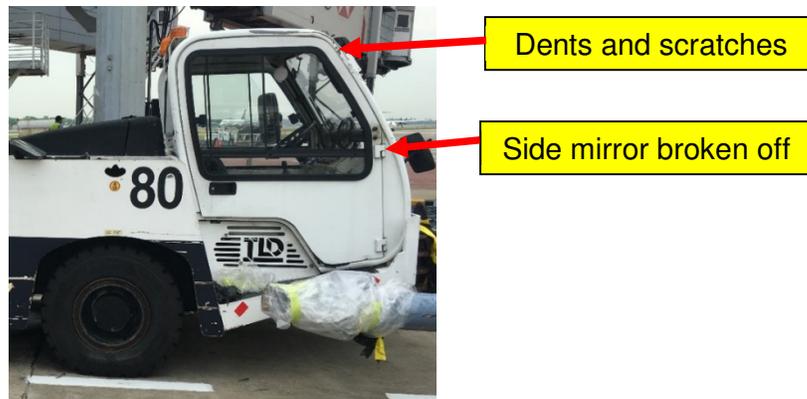
Figure 6: Damage to airtug

1.3.2 The airtug sustained damage to its right door (dents and scratches) and its right hand side mirror (broken off) (see **Figure 6**). The stop plate³ in the airtug's tow hitch sustained an indentation (see **Figure 7**).

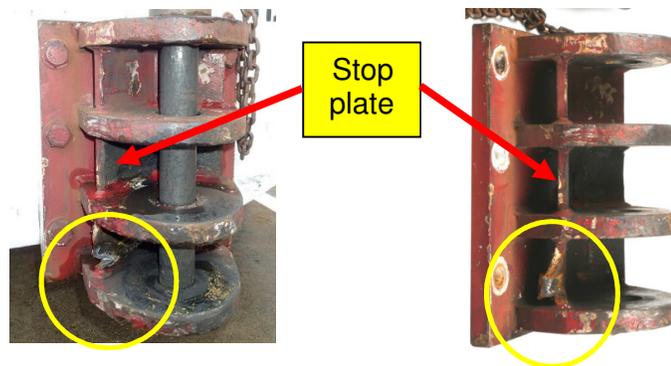
Figure 7: Indentation on tow hitch

- 1.3.3 The indentation was a result of pressing by the lunette mount flat (see **Figure 8**) when the latter had turned and reached the stop plate.

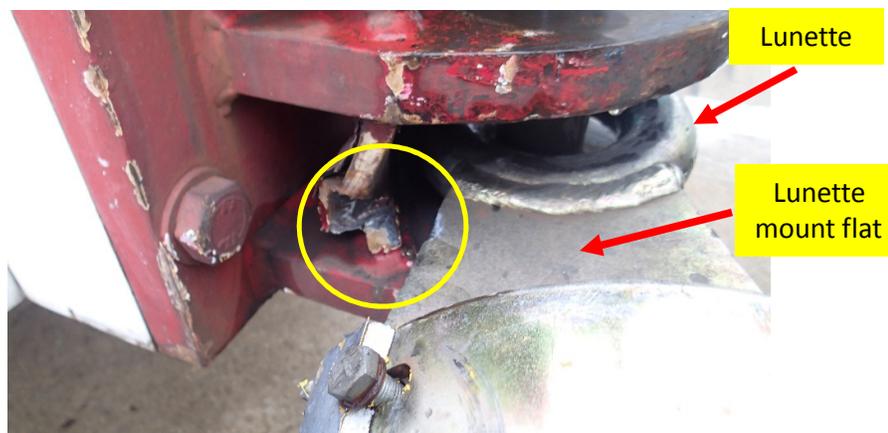
Figure 8: Cause of the indentation

- The angle between the centerline of the airtug and the centerline of the towbar increased. When the angle reached 60°, the lunette mount flat came into contact with the stop plate in the tow hitch. Further turning, however, caused the lunette mount flat to press on the stop plate and dent it. By the time the lunette mount flat became stuck in the tow hitch, the angle had reached about 96° (see paragraph 1.3.3 and Figure 8).
