# **FINAL REPORT**

## **B777-300ER, REGISTRATION 9V-SWB ENGINE FIRE**

**27 JUNE 2016**

**AIB/AAI/CAS.122**

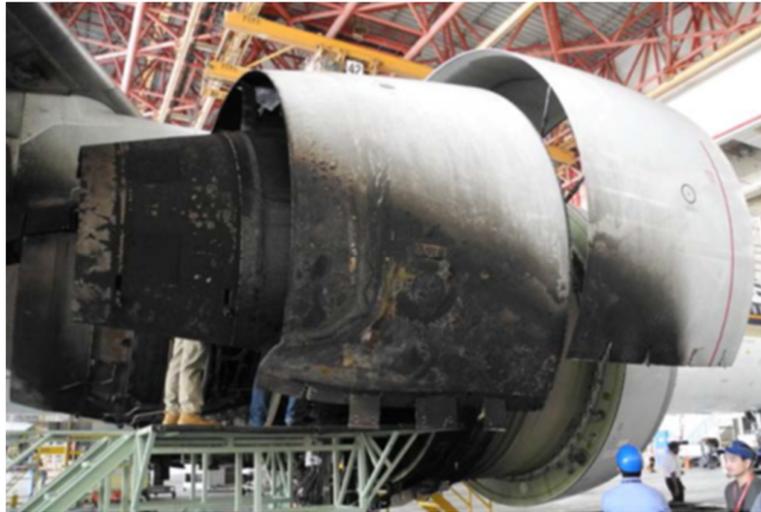
- Heat damage and delamination of the outboard thrust reverser (TR) cowl external surfaces from 4 to 6 o'clock position (**Figure 1**)

Figure 1: Right engine outboard fan cowl and TR forward cowling

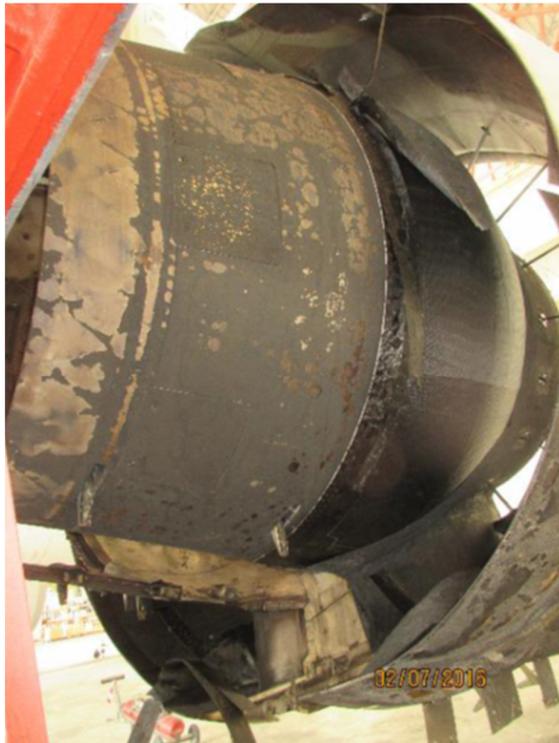
- Heat damage to the outboard TR aft cowl (**Figure 2**)

Figure 2: Outboard TR aft cowl

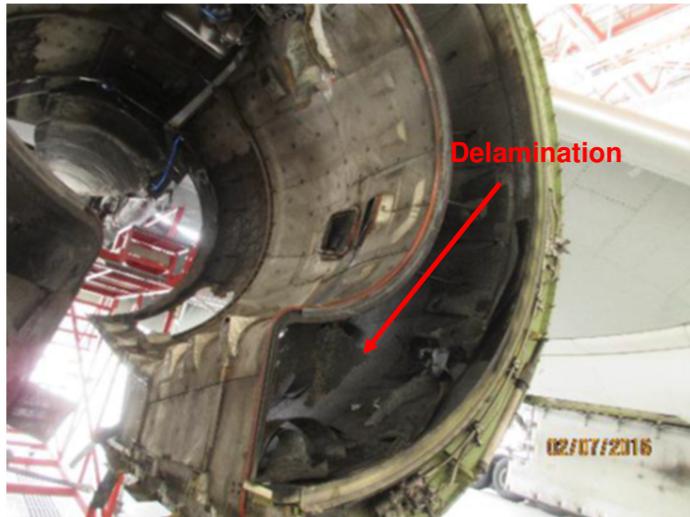
- Heat damage to the TR fan duct inner and outer walls and significant delamination to the outer wall trailing edge surfaces (**Figure 3**)

Figure 3: Delamination of the inboard TR fan duct walls

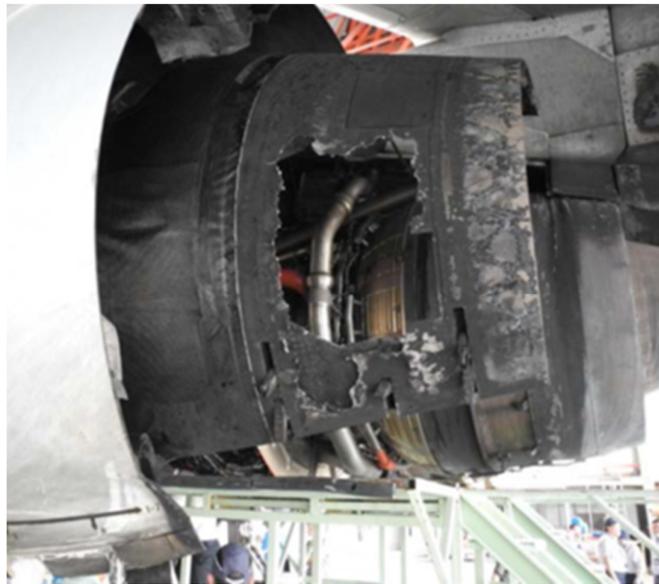
- Heat damage observed on all eight inboard TR blocker doors
- Heat damage to the four upper inboard TR blocker door links
- Four lower inboard TR blocker door links sustained heat damage and were severed 3-4 inches above the blocker doors
- Heat damage to the inboard TR aft cowl, with a section of material missing (measuring 21 inches vertically by 32 inches horizontally, including a 13 inches by 13.5 inches pressure relief door) (**Figure 4**)

Figure 4: Inboard TR aft cowl with missing material

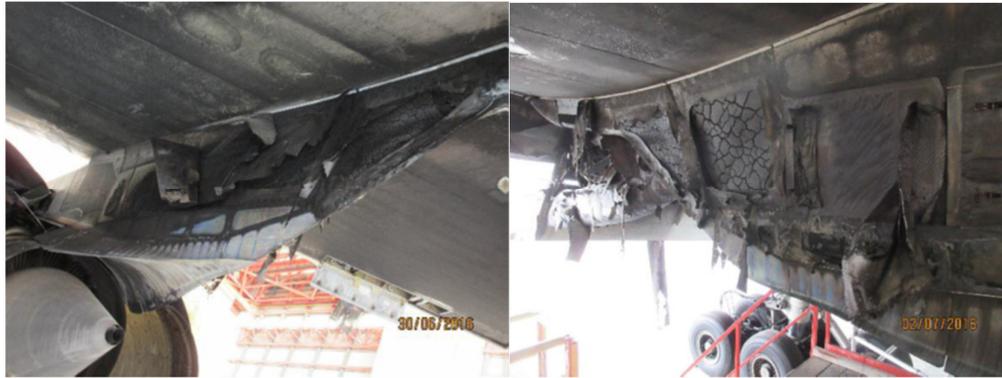
- Heat damage and delamination at the outboard and inboard engine strut (also commonly known as pylon) panels where some material was consumed by the fire in the areas of delamination, exposing the core honeycomb structure (**Figure 5**)

Figure 5: Inboard and outboard view of engine strut area

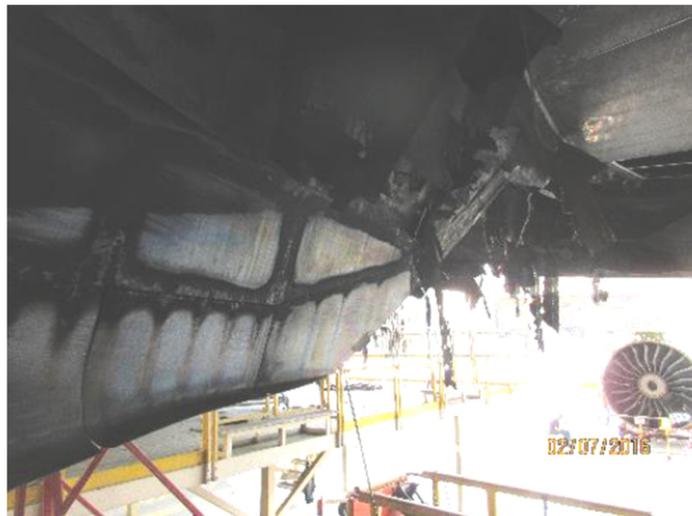
- Multiple colouration due to effects of heat exposure to the two aft heat shield panels (**Figure 6**)

Figure 6: Multiple colouration of heat shield panel

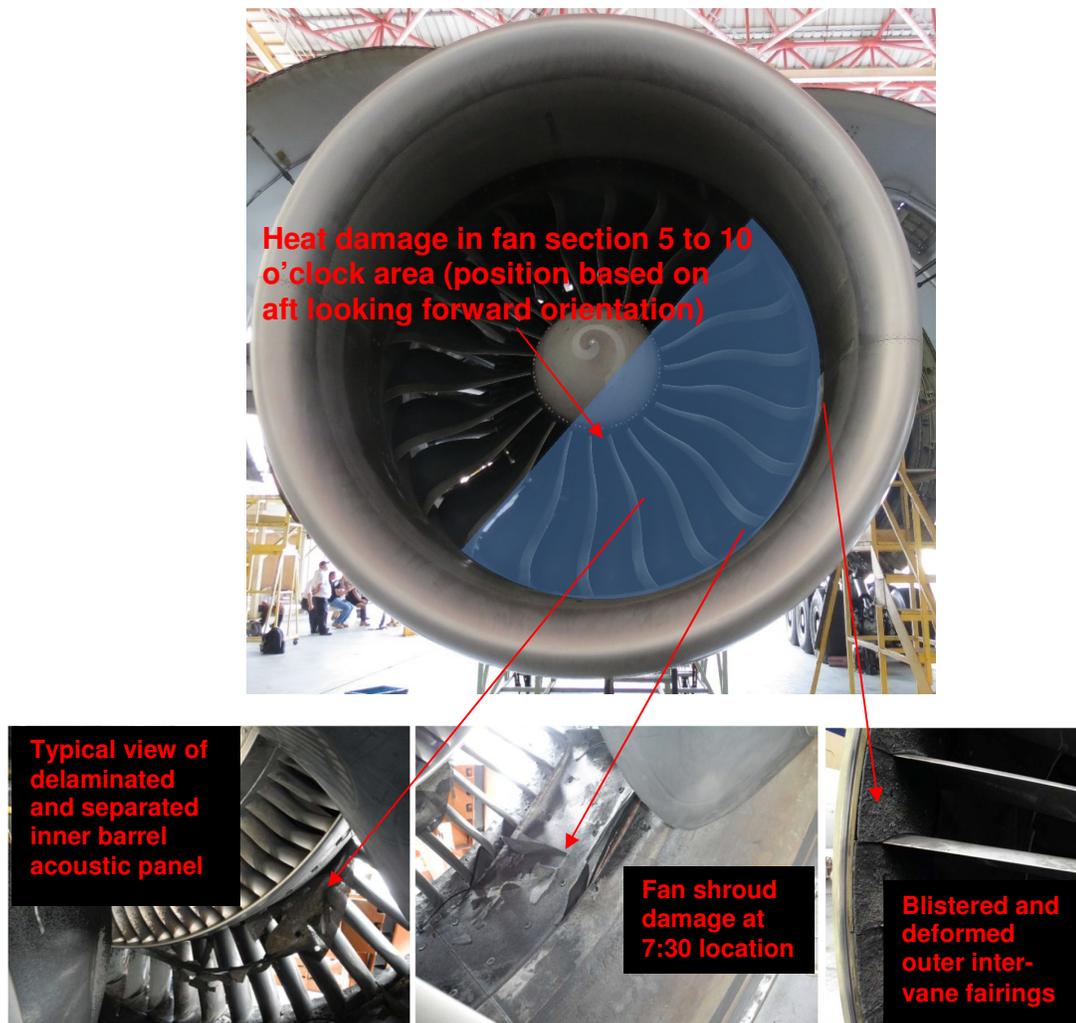
1.2.4.4 In the fan section area, heat damage was observed in the 5 to 10 o'clock area of the following areas (**Figure 7**):

- Fan shroud area with the most significant damage in the 7 to 9 o'clock area
- Outer aft acoustic panels, made of composite material, where the resin material was burnt, leaving the fabric delaminated and loose
- Inner barrel acoustic panels, made of composite material, with the most severe damage in the 6 to 8 o'clock area where the resin material was burnt, leaving the fabric delaminated and loose
- Blistering and fractures on the outlet guide vanes (OGVs)
- Outer inter-vane fairings displayed blistering and distortion, with the most affected region in the 6:30 to 8 o'clock area

Figure 7: Occurrence engine forward looking aft view

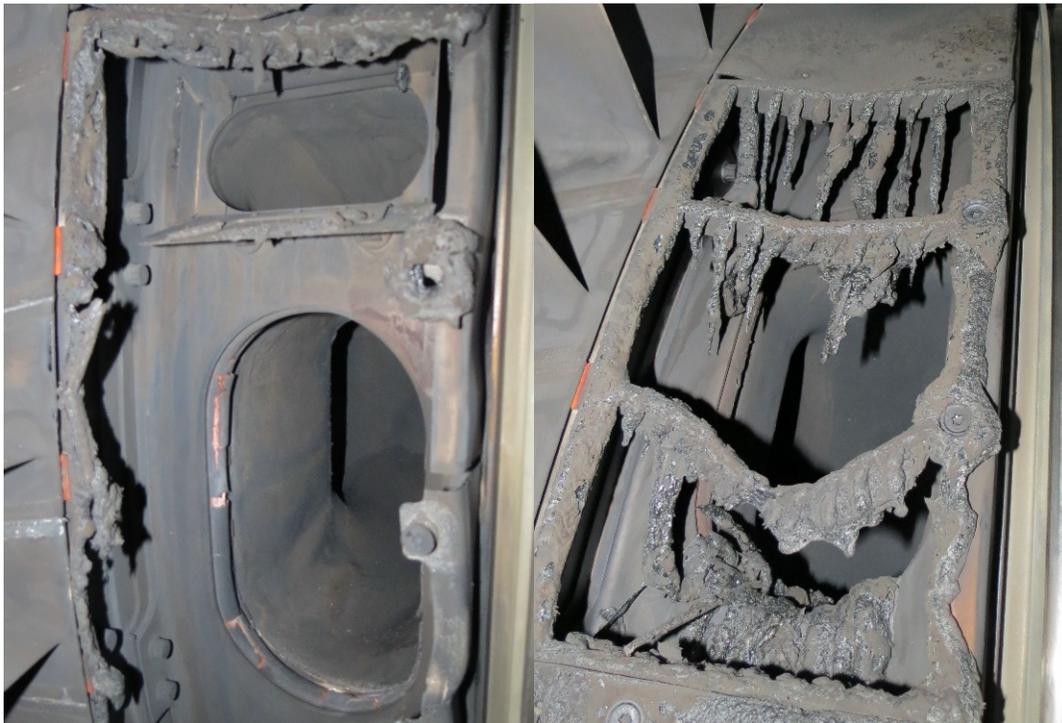
- 1.2.4.5 Heavy soot collection was observed in the VBV exhaust area and VBV ducts. Most of the VBV exhaust grills were melted away (**Figure 8**), with the exception of those in the 9 to 12 o'clock area which were still present but heavily deformed by heat. The VBV duct, made of composite material, cracked under application of moderate finger pressure which is consistent with loss of resin material.

Figure 8: (Left) Typical VBV exhaust grill that was melted away  
(Right) Heavily deformed VBV exhaust grill

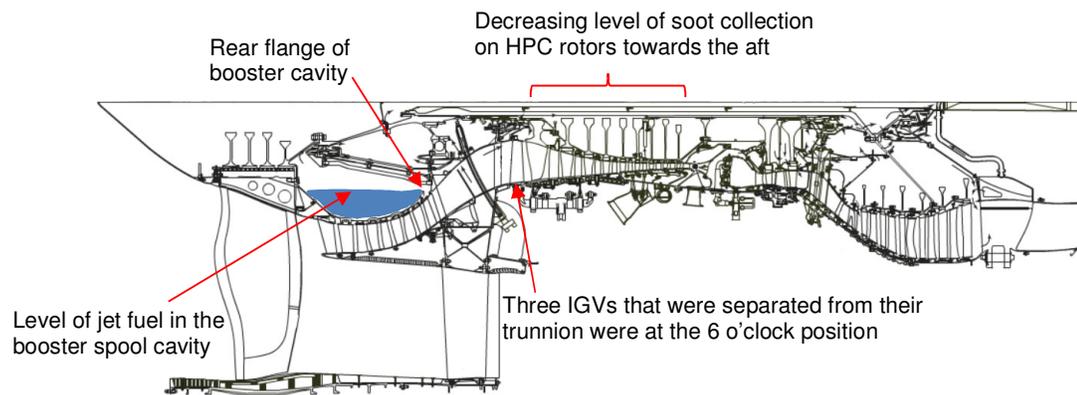
1.2.5.6 Jet fuel was also found in the booster spool cavity<sup>9</sup>. During the initial examination of the engine, the level of the jet fuel collected was up to the rear flange of the booster spool (**Figure 9**).

Figure 9: Observations with reference to the cross section view of the engine

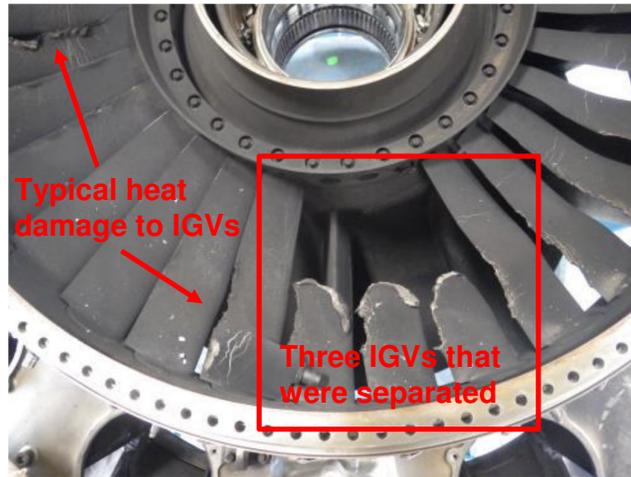
1.2.5.7 Heat damage was observed at the inlet guide vanes (IGV) of the high pressure compressor (HPC). Three IGVs which were installed at the 6 o'clock position were found separated due to melting near the inner trunnion which holds these IGVs in position (**Figure 10**). Several IGVs also exhibited signs of heat damage.

Figure 10: Damage to IGVs

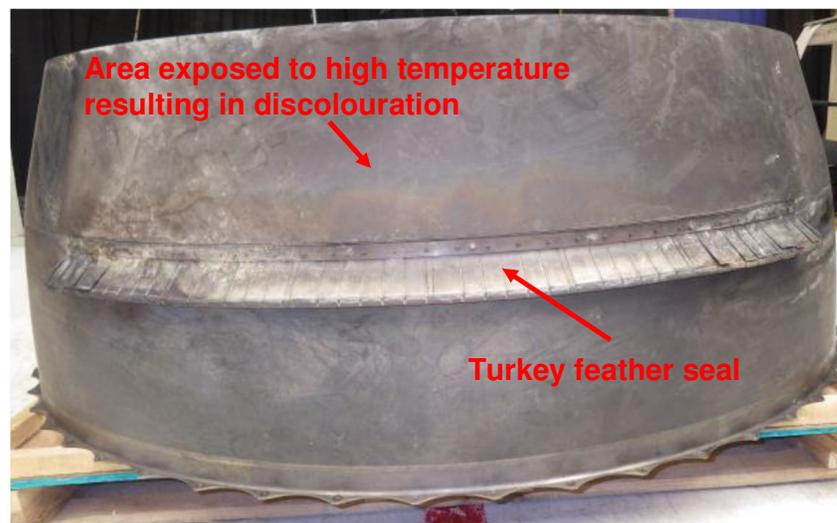
- 1.2.5.8 In the high pressure compressor (HPC), the heaviest evidence of soot collection was observed at the stage 1 rotor with decreasing level of soot collection towards the aft of the HPC (refer to **Figure 9**).
- 1.2.5.9 Localised discolouration due to high temperature exposure was observed at a section of the core exhaust nozzle, behind the feature known as the turkey feather seal<sup>10</sup> (**Figure 11**).

Figure 11: Core exhaust nozzle

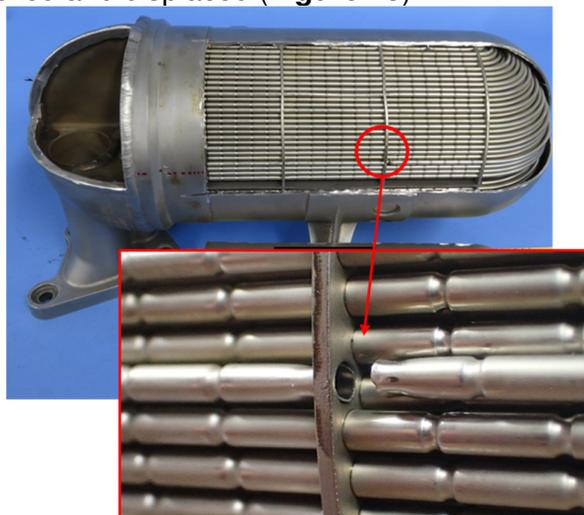
- 1.6.1.2 The MFOHE was removed from the engine and preliminary pressure tests performed on it confirmed an internal leak between the oil and fuel flow paths.
- 1.6.1.3 The MFOHE was sent to the engine manufacturer's facility where a computer tomography scan was performed on the MFOHE. The scan results showed that there was a cracked fuel tube which was displaced.
- 1.6.1.4 The MFOHE was then sent to the MFOHE manufacturer's facility for further examination. In a test performed to simulate the operation of the MFOHE at idle engine power setting, the leak rate from the displaced cracked tube was found to be about 31 pounds per minute.
- 1.6.1.5 A portion of the MFOHE casing was removed. One of the fuel flow tubes was found cracked and displaced (**Figure 13**).

Figure 13: View of cracked tube in MFOHE

- 1.7.2.6 The cause of the crack in the August 2014 event, was determined by the engine and MFOHE manufacturers to be the variation in the crimp on the tube that resulted in contact between the support plate and crimped tube. The contact resulted in stress concentration that could have led to crack initiation.

- 1.7.2.8 In a failure analysis test conducted by the engine manufacturer in September 2016, it was further discovered that unintended diffusion bonding<sup>16</sup> occurred during the manufacturing process of the MFOHE when elevated heat was applied. It was identified that the diffusion bonding occurred at the areas where there was close contact between the tubes and the support plates.

- 1.7.2.9 During normal operation of the MFOHE, stress was introduced at the fused area which ultimately led to the tube cracking. It was also determined that crimping increased the likelihood and severity of diffusion bonding to occur.

- 1.7.3.4 The small candle wicking fire occurrence in August 2014 was categorised as a CAAM Level 2 event by the engine manufacturer<sup>17</sup>.
- 1.7.3.5 Following its investigation into the August 2014 event, the engine manufacturer issued Service bulletin (SB) 79-0034 in December 2014 to address the issue of fuel leakage into the oil system. The SB requires the MFOHE to be removed from the engine no later than the next occasion when the engine is in an engine shop for engine shop maintenance<sup>18</sup>. This deadline for compliance with the SB was set in accordance with the CAAM consistent with a Level 2 criticality.

- 1.7.3.7 As required by SBs 79-0034 and 79-0058, the MFOHEs are to be sent back to the MFOHE manufacturer for checks to ensure that there are no leakages. Should a leakage be detected, the openings at the entrance and exit of the leaking tube will be welded close to prevent fuel from flowing into it. Crimped tubes that have a history of cracking will also be welded close, regardless of whether the MFOHE is found leaking.

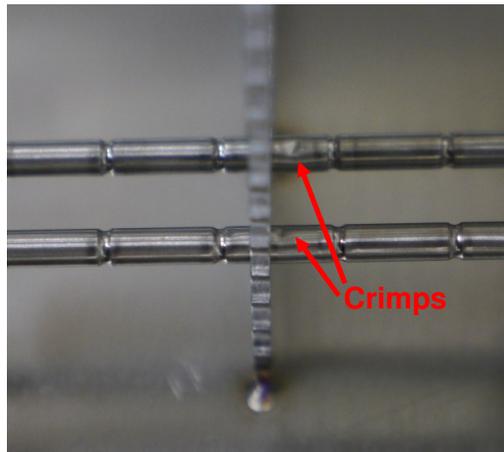
- 1.7.1.4 The manufacturing process involves crimping. Crimping is the application of a force to deform the tube slightly. The purpose of the crimping is to deform the cross-sectional shape of the tubes so that the tubes cannot slide freely through the round holes of the support plates. This prevents the support plates from moving during assembly (**Figure 14**).

Figure 14: Crimps on tubes

- 1.7.2.3 In April 2014, the engine and MFOHE manufacturers conducted a review of the manufacturing operations. Improvements to the manufacturing process were made in May 2014. The improvements included using a standardised crimping tool to eliminate the variation in the crimps due to the use of hand tools. In addition, the crimped fuel tubes that have a history of cracking will be welded close at assembly.

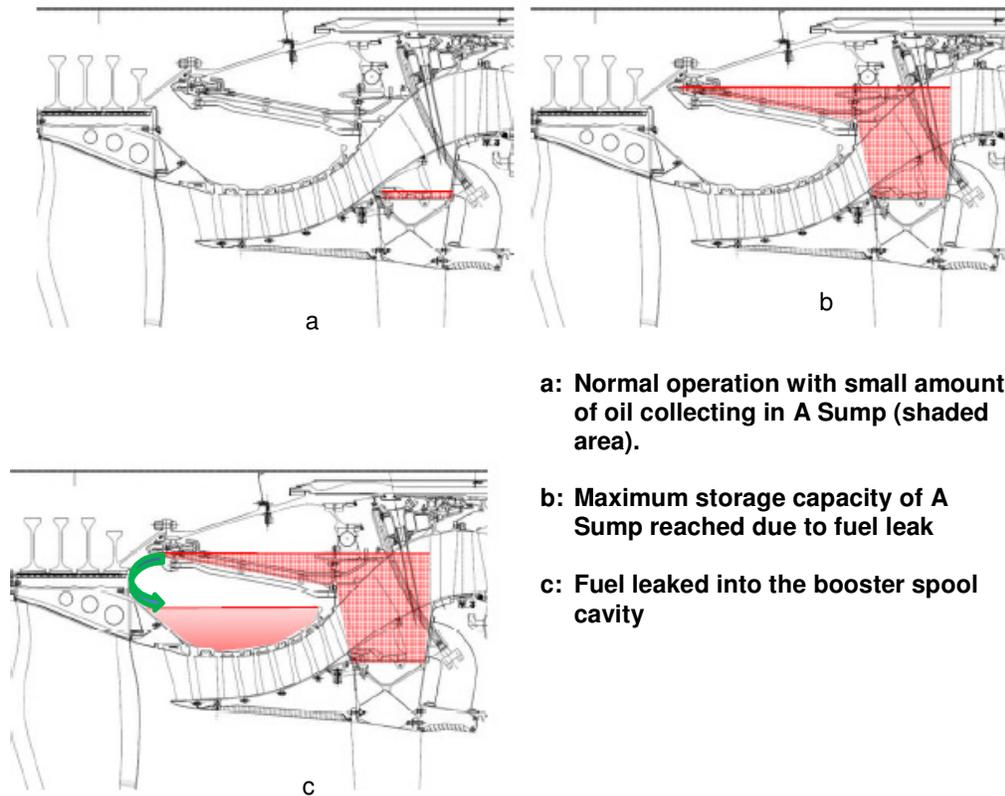
- 2.1.1 The cracking of a tube in the MFOHE allowed fuel in the fuel flow path of the MFOHE to flow into the oil flow path in the MFOHE. The investigation has not revealed other sources of fuel leak.
- 2.1.2 During all phases of the engine fuel pump operation, fuel is delivered at pressures between 400 and 1600 psi. In comparison, the pressure within the engine oil system is about 100 psi. As such, when the fuel carrying tube in the MFOHE cracked, the higher pressure fuel entered the engine oil distribution system.
- 2.1.3 During the normal operation of the engine oil system, a small amount of oil will collect in the A Sump<sup>19</sup>. However, when fuel leaked into the oil system, it filled the A Sump until its maximum storage capability. The additional quantity of leaked fuel overflowed into the booster spool cavity and started to collect there (**Figure 15**).

Figure 15: Process of fuel filling the A Sump and booster spool cavity

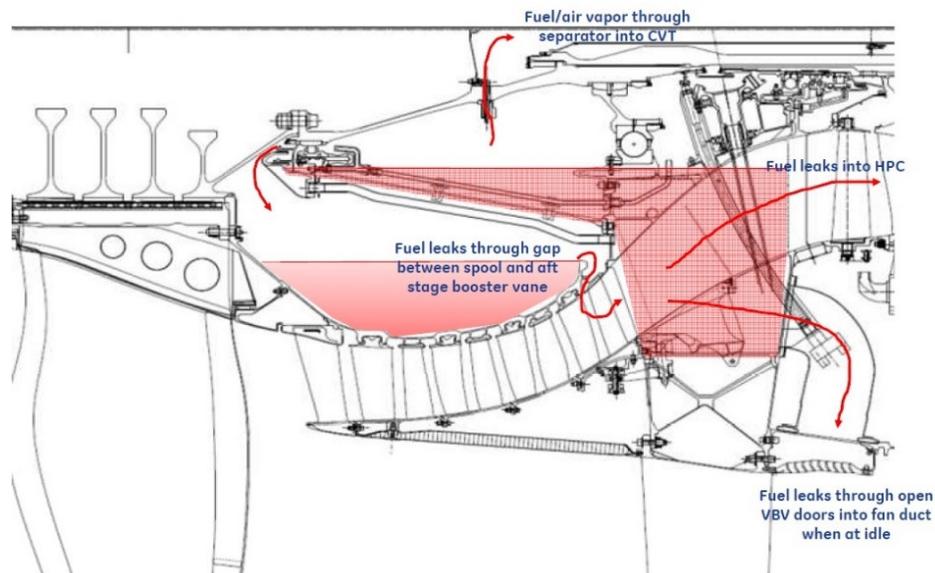
2.1.4 Once the booster spool cavity was filled up to the aft lip, the excess fuel leaked through a gap between the spool and aft stage booster vane into these areas (**Figure 16**):

- HPC through the core airflow
- Fan duct when the VBV doors are open at engine idle power

Figure 16: Leak path for fuel

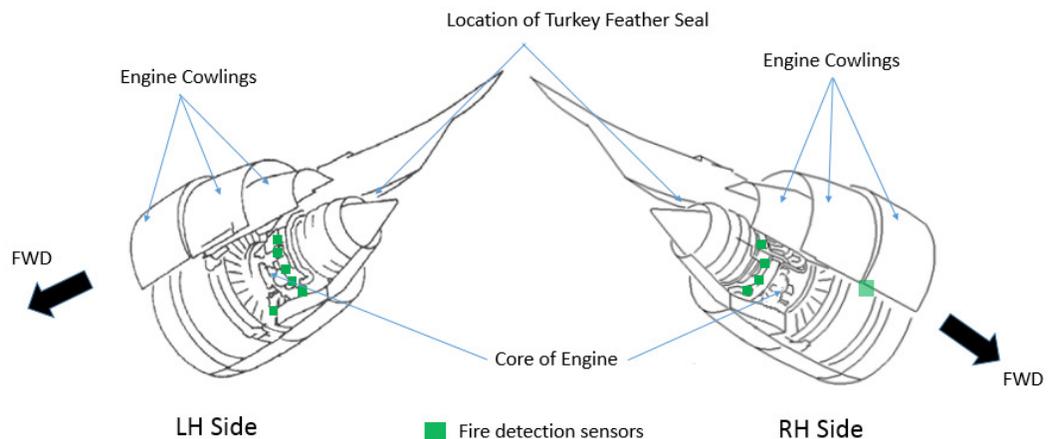
2.3.2 The schematic diagram in **Figure 17** shows the location of the engine fire detection elements.

2.3.3 These elements are located between the engine cowling and the core of the engine<sup>21</sup>. As these elements were shielded from the fire by the engine cowlings, there was no EICAS fire indication in the cockpit.

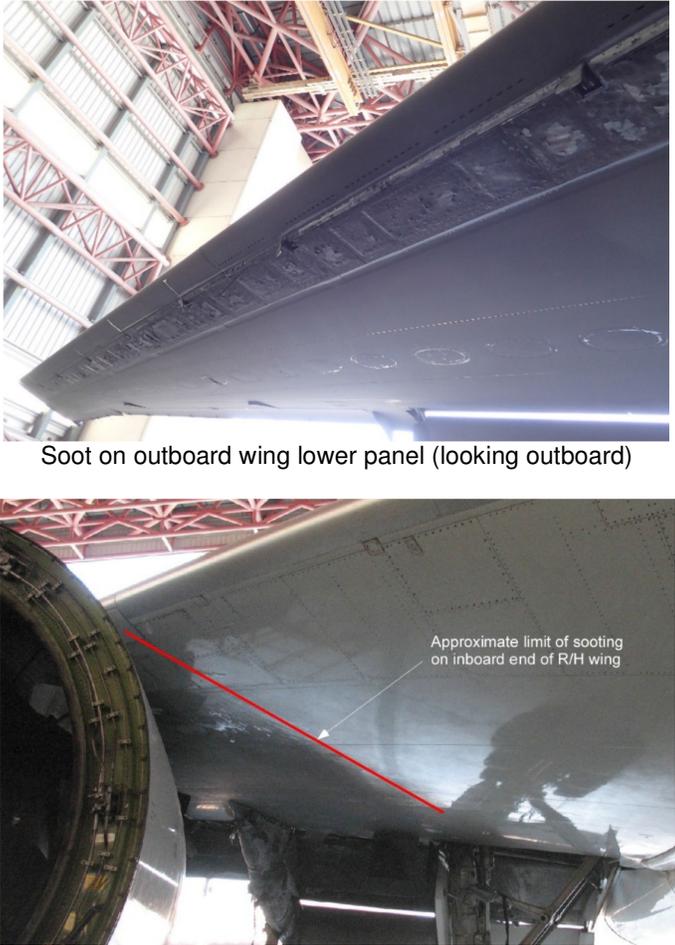
S/No	Description	Damage
1	Wing lower surface from the outboard of the engine strut towards the wing tip covered in heavy soot

<p>Soot on outboard wing lower panel (looking outboard)</p> <p>Approximate limit of sooting on inboard end of R/H wing</p> <p>Inboard limits of soot (looking aft)</p>
2	Upper wing skin areas at the wing leading edge covered in light soot

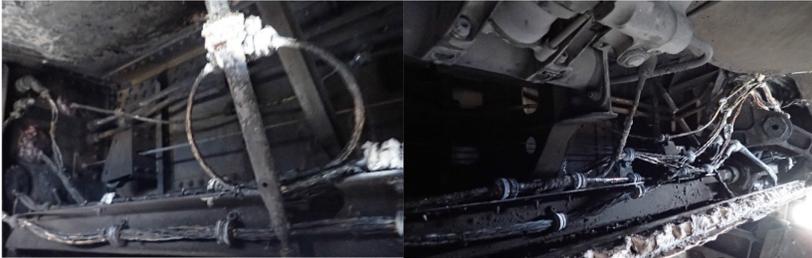
S/No	Description	Damage
3	Wing rear spar area and system components installed immediately behind and outboard of the right hand engine sustained fire damage

<p data-bbox="850 525 1192 558">Typical rear spar damage</p>
4	Lower fixed leading edge panels towards outboard of wing found with thermal damage on the exterior surface but the inboard surface was not damaged

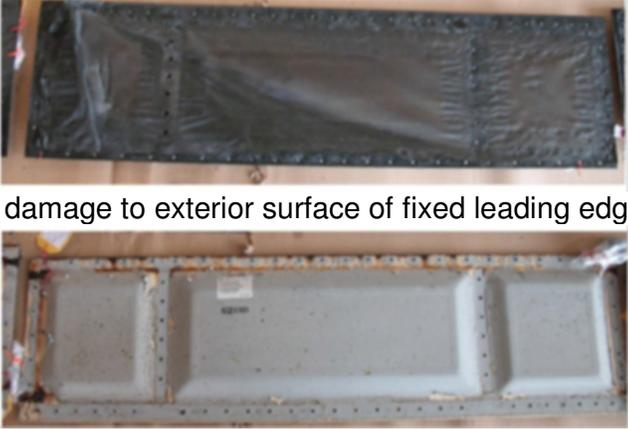
<p data-bbox="607 821 1435 854">Typical damage to exterior surface of fixed leading edge panel</p> <p data-bbox="607 1056 1435 1089">Typical condition of interior surface of fixed leading edge panel</p>
5	Upper fixed leading edge panels behind the slats exhibited discolouration due to heat exposure. The discolouration was more pronounced towards the outboard of the engine with the maximum discolouration occurring about mid-way between the engine and wing tip.

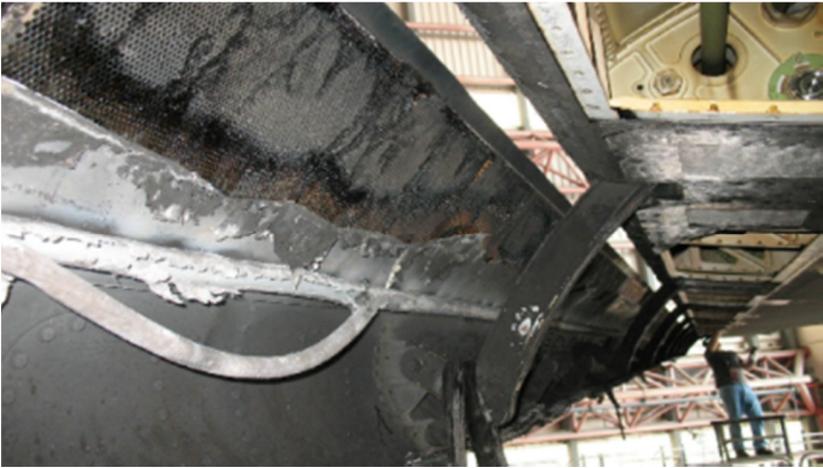
S/No	Description	Damage
6	Leading edge slats outboard of the engine found with varying degrees of heat damage

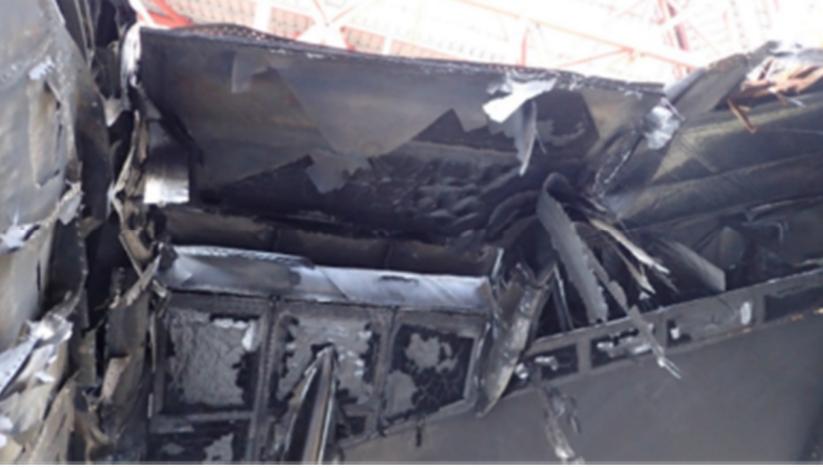
7	Heat damage to inboard and outboard trailing edge flap assemblies, flap track fairings, flaperon and spoiler panels in the vicinity of the right engine

<p data-bbox="764 1268 1279 1297">Flaperon and panels aft of right engine</p>

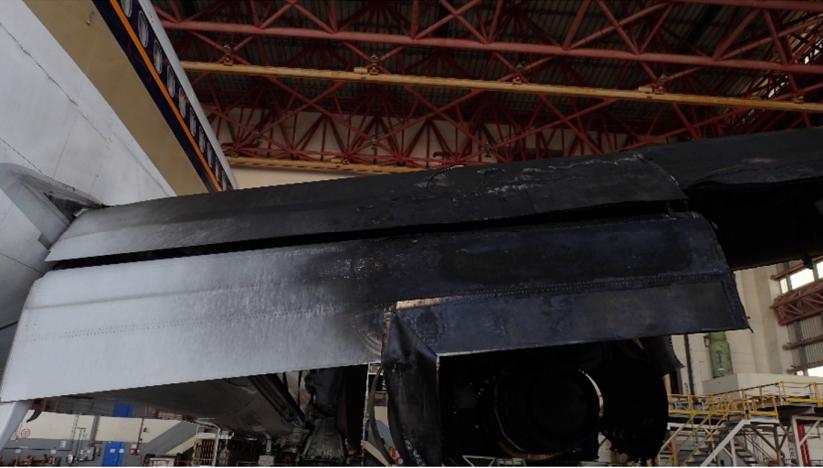
<p data-bbox="786 1803 1258 1833">Inboard main flap aft of right engine</p>

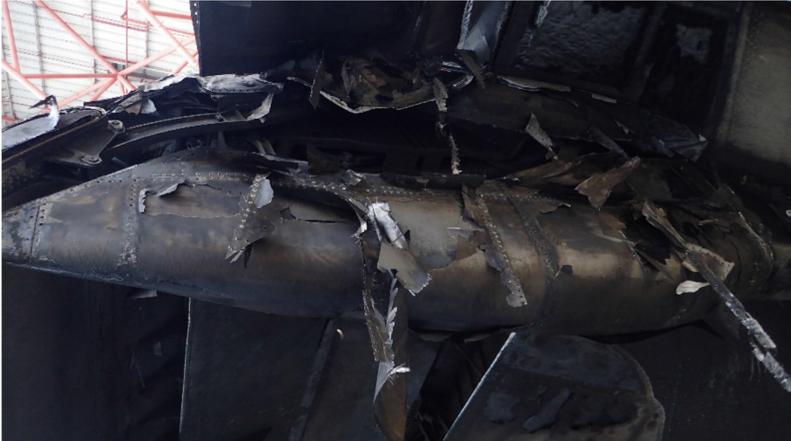
<p data-bbox="841 709 1203 741">Inner most flap track fairing</p>

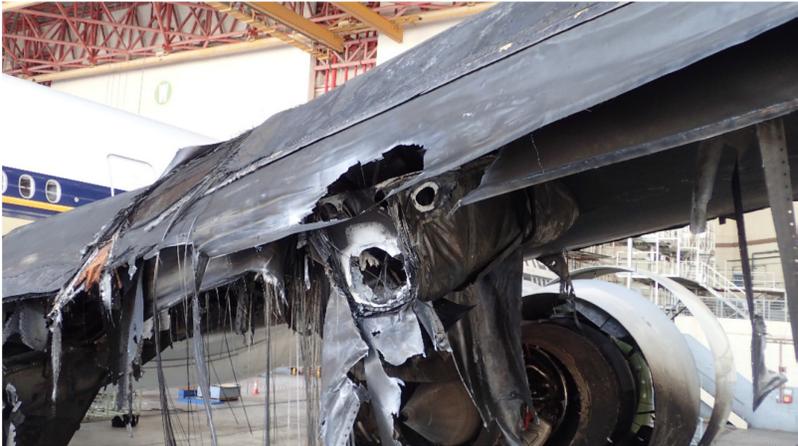
<p data-bbox="760 1224 1279 1255">Inner portion of right hand outboard flap</p>
8	Outboard facing side of right main landing gear shock strut door sustained heat damage
