# **Final Report**

## **B787-9, REGISTRATION 9V-OJD TURBULENCE EVENT**

**6 SEPTEMBER 2024**

TIB/AAI/CAS.239

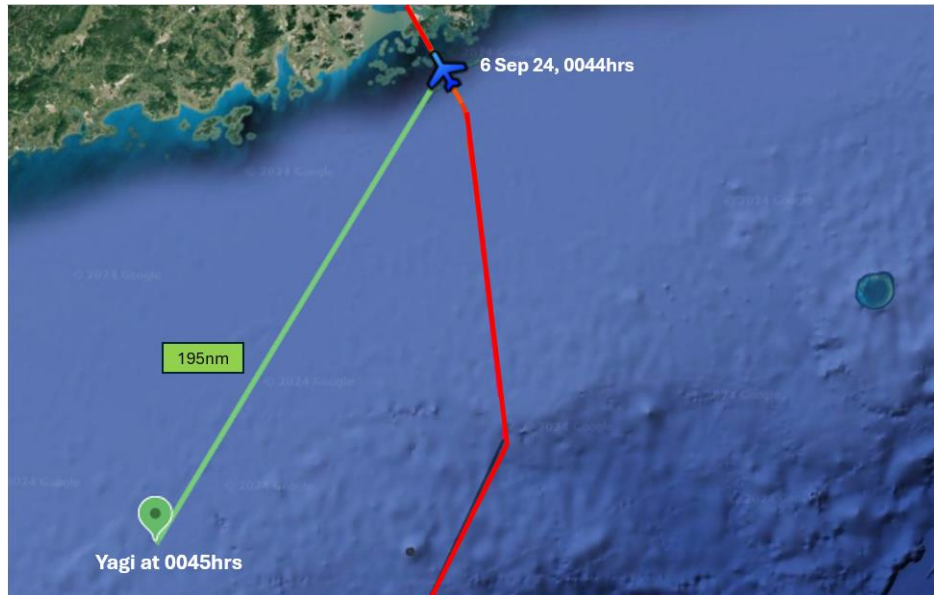
Figure 2: Distance between the aircraft and Yagi around the time of occurrence

1.6.2.1 The investigation team noted that the location of Yagi<sup>9</sup> as indicated in the Tropical Cyclone Warning Bulletin issued by the Hong Kong Observatory (HKO) at 0045hrs on 6 September 2024 (one minute after the incident aircraft’s turbulence encounter) was about 195nm southwest of the aircraft (see **Figure 2**).

- 2.2 The aircraft encountered turbulence when it was descending through 18,700 feet. Given that, at the time of the turbulence event, Yagi was some 195nm from the incident aircraft (as known from HKO's Tropical Cyclone Warning Bulletin), the investigation team does not believe that Yagi was a factor in the turbulence encounter. The investigation team opines that the turbulence encounter was more likely associated with the convective cell that had emerged by 0042hrs about 6.6nm to the south of the aircraft, as shown in the series of ground weather radar images (see **Figure 4** in paragraph 1.6.4.1). However, it must be noted that, the flight crew did not have the benefit of these ground weather radar images. As mentioned in paragraph 2.1 above, the flight crew observed no significant weather on their flight path.

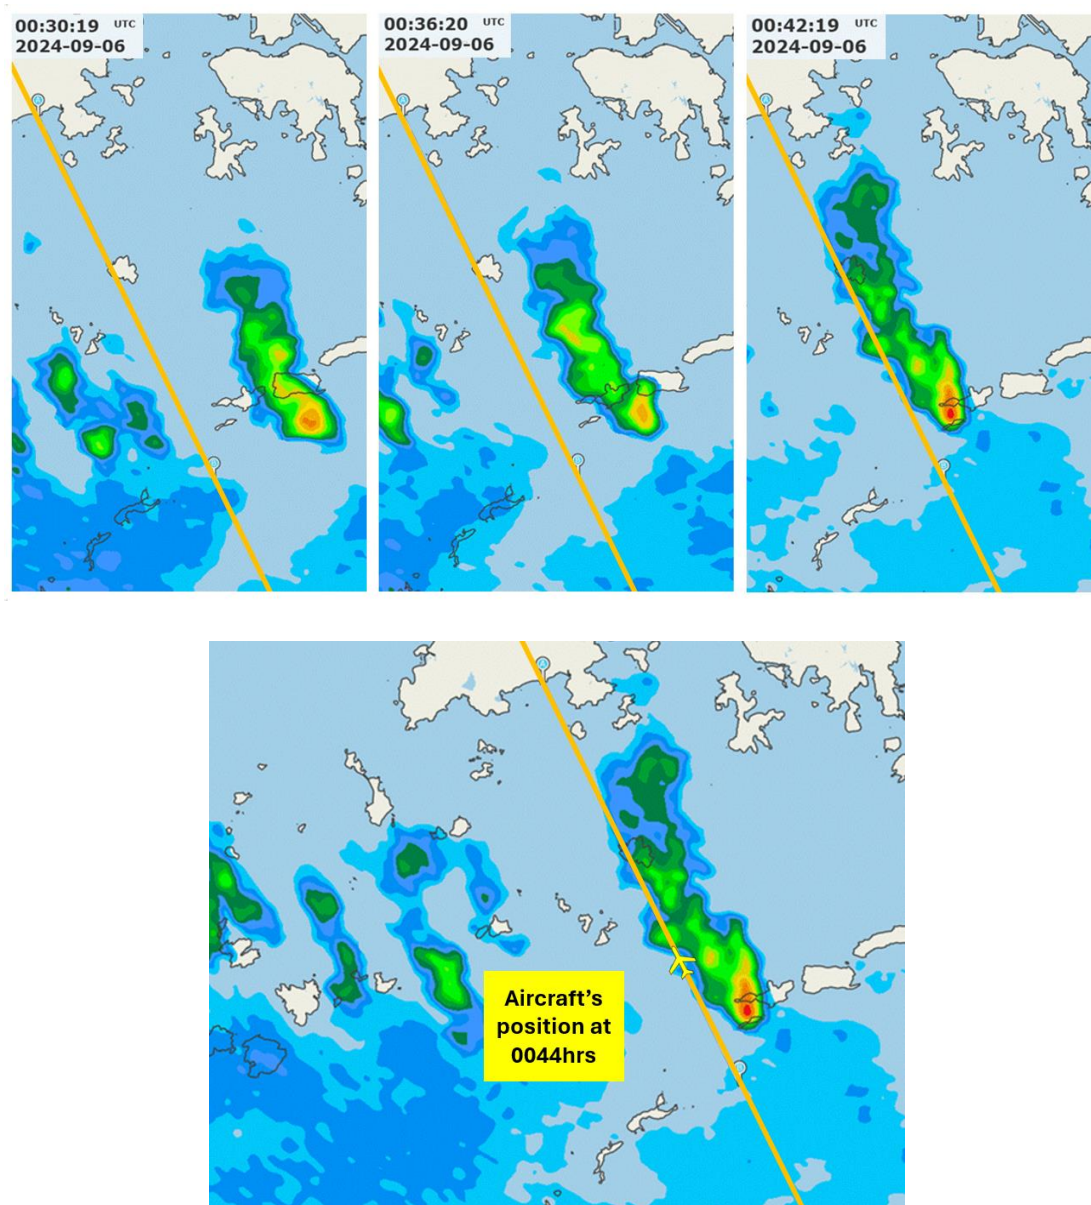
Figure 4: Series of ground weather radar images captured at 6-minute interval, illustrating the intensification of some areas within the weather cell (from yellow to red)

1.6.4.1 **Figure 4** is a series of ground weather radar images<sup>12</sup>, shared by HKO and taken at 0030hrs, 0036hrs and 0042hrs<sup>13</sup>. The images show a weather cell at an altitude of about 10,000 feet and located to the right of the aircraft's flight path and that:

- (a) The cell consisted predominantly of low intensity radar returns (represented in green<sup>14</sup>), with some isolated areas of higher intensity returns (represented in yellow and red).
- (b) This cell was moving towards the aircraft's flight path.
- (c) A more intense convective cell (represented in red) had emerged by 0042hrs (i.e. two minutes prior to the turbulence occurrence) about 6.6nm to the south of the aircraft.

- 3.2 The aircraft encountered turbulence when it was descending through 18,700 feet. The investigation team opines that the turbulence encounter was more likely associated with the convective cell that had emerged by 0042hrs about 6.6nm to the south of the aircraft. However, this patch of convective activity was to the rear of the aircraft and was not displayed on the aircraft's WXR, and the pilot could not see the weather behind the aircraft.
