FINAL REPORT

RUNWAY INCURSION BY MAINTENANCE VEHICLE 3 OCTOBER 2013

AIB/AAI/CAS.097

**Air Accident Investigation Bureau of Singapore
Ministry of Transport
Singapore**

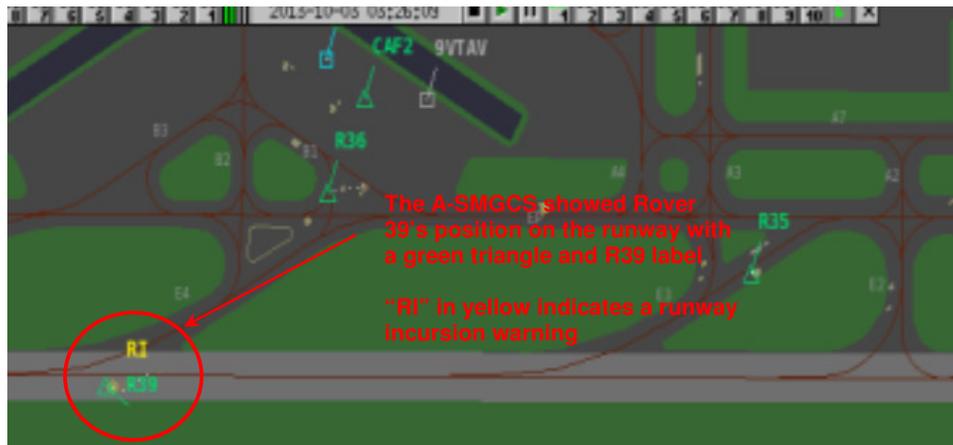
Figure 1: The A-SMGCS display at 1126:09 hours

- Recordings of the A-SMGCS visual display show that there was a runway incursion warning triggered by Rover 39 (see **Figure 1**).
- Control cabin ambient recordings did not register any corresponding aural warning.

2.4.2 Controller 2 did not use the A-SMGCS to double-check for the presence or absence of traffic on the runway. Had he referred to the A-SMGCS, there was a chance that he would see the runway incursion visual warning.

- 4.6 The air navigation service provider arranged for the volume of all the A-SMGCS speakers to be pre-set and for the volume control knobs of the speakers to be removed. At the start of each shift, controllers are required to test the functioning of the aural warning and to ensure that the aural warning is audible.

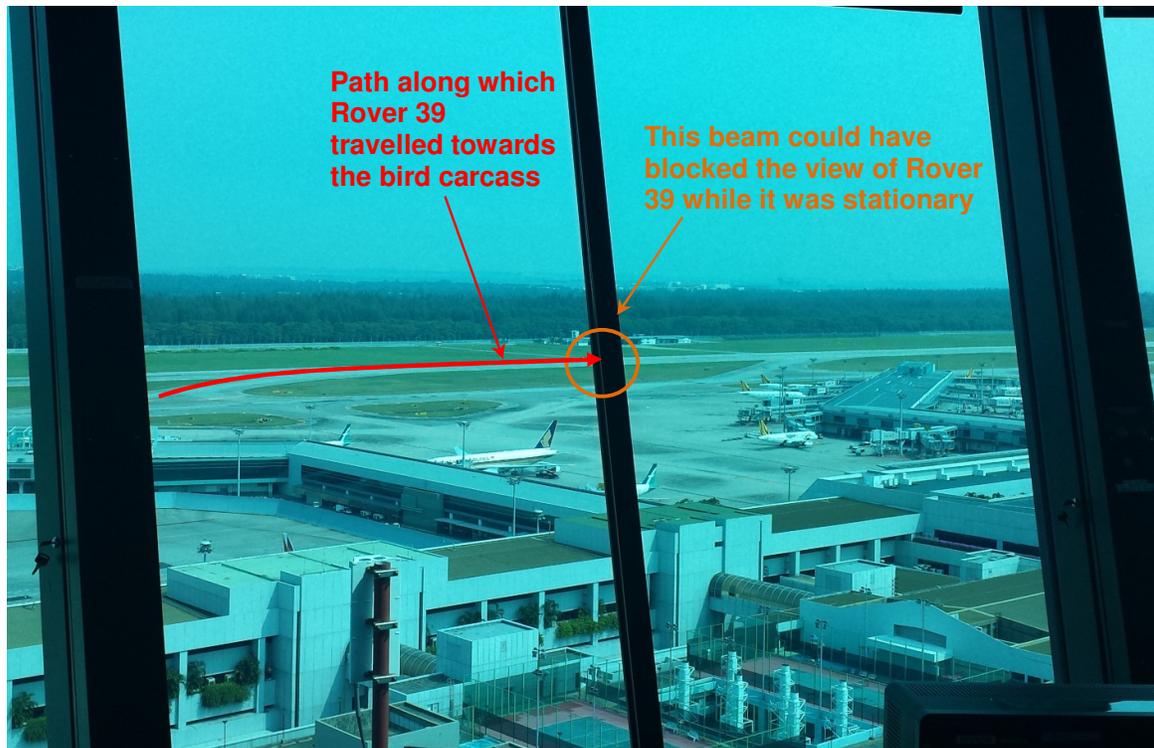
Figure 2: View from Controller 2's working position

2.4.1 Before Controller 2 issued the landing clearance for the approaching aircraft, he had visually scanned the runway but he did not notice Rover 39 which at that time was travelling towards the location of the bird carcass. He might have missed Rover 39 as the vehicle was small¹¹. His view might also have been blocked by a beam in the frame that held up the glass panels of the control cabin (see **Figure 2**). Controller 2 indicated that he did not shift his body to see what was behind the beam. It is possible that Rover 39 would be spotted had he done so.

¹¹ The investigation team observed that the Tower was about 800 m from where Rover 39 could have stopped on Runway 2, and that it would take some effort to spot visually a vehicle of Rover 39's size at that distance.
