FINAL REPORT

AIRBUS A380, REGISTRATION 9V-SKB INFLIGHT ENTERTAINMENT SMOKE INCIDENT

AIB/AAI/CAS.099

Transport Safety Investigation Bureau
Ministry of Transport
Singapore

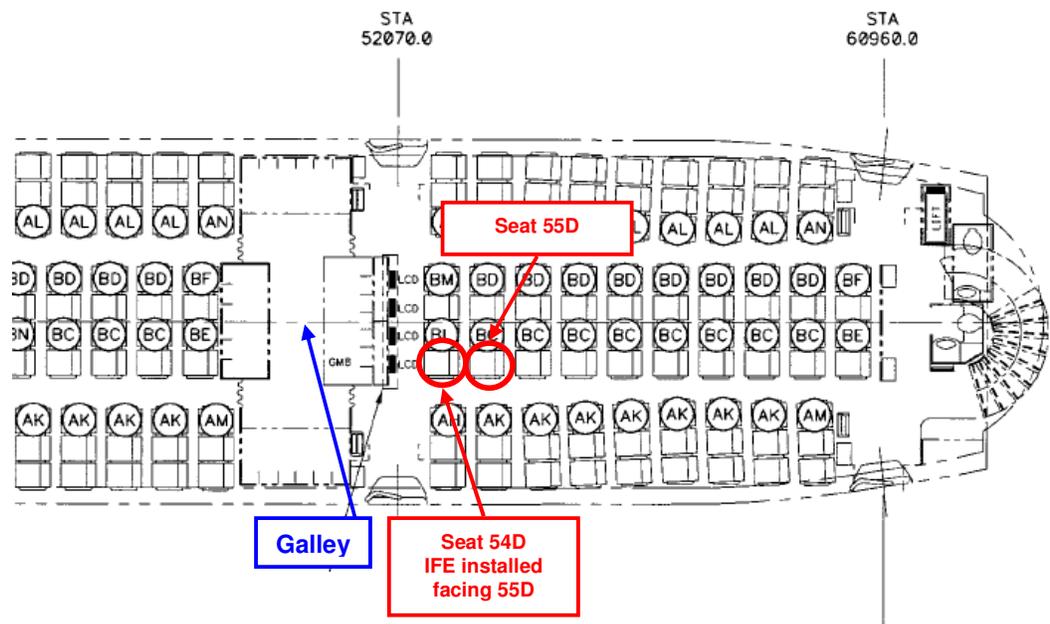
Figure 1: Seat location

1.1.2 While the aircraft was climbing through FL 130 to its cruising altitude, a Leading Stewardess (LSS) who was around the galley in front of seat row 54 noticed a wisp of smoke from the area around seat 55D. She went over to the seat to investigate.

1.1.3 When she reached seat 55D, she saw that the passenger at the seat was not looking at the In-Flight Entertainment (IFE) screen (which was installed on the rear face of the seat in front, i.e. seat 54D) but was doing something else and did not appear to notice anything amiss. She also saw sparks coming from behind the IFE screen and a puff of thicker smoke coming from the screen.

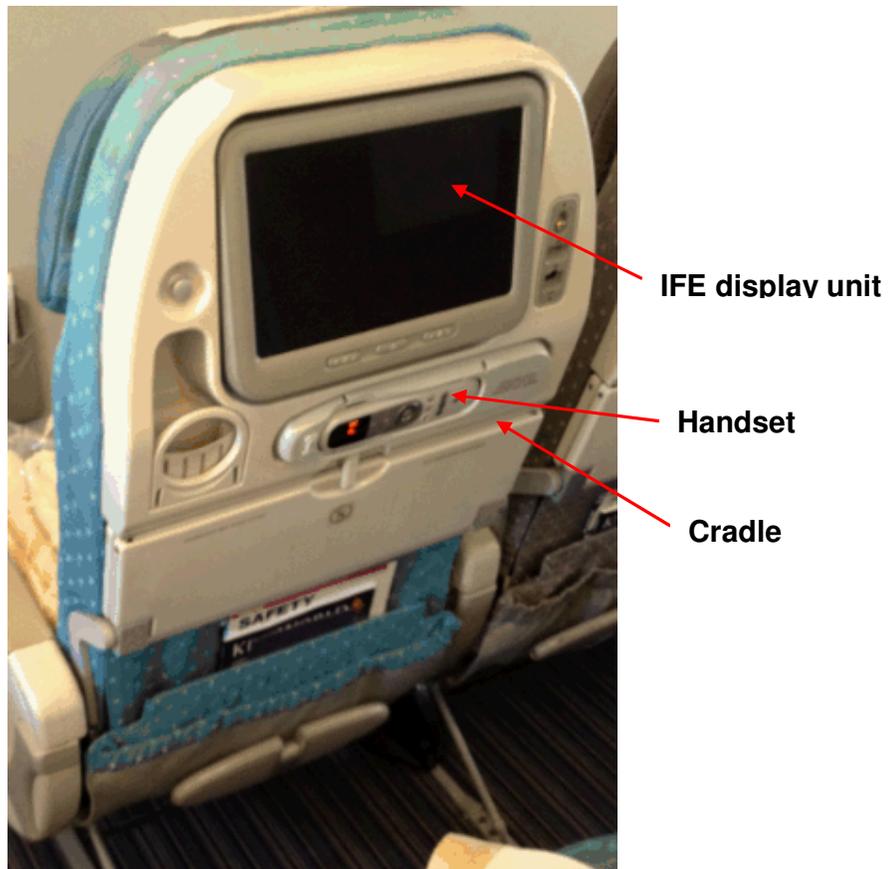
Figure 2: IFE components at each passenger seat

1.2.1 The IFE components for each passenger seat comprise the following (see **Figure 2**):

- IFE display unit (including a screen)
- Handset (for programme selection, etc.)
- Cradle (for housing the handset)
