**CONTACT BETWEEN AIRBUS A320
AND AEROBRIDGE**

5 OCTOBER 2012

AIB/AAI/CAS.087

**Air Accident Investigation Bureau of Singapore
Ministry of Transport
Singapore**

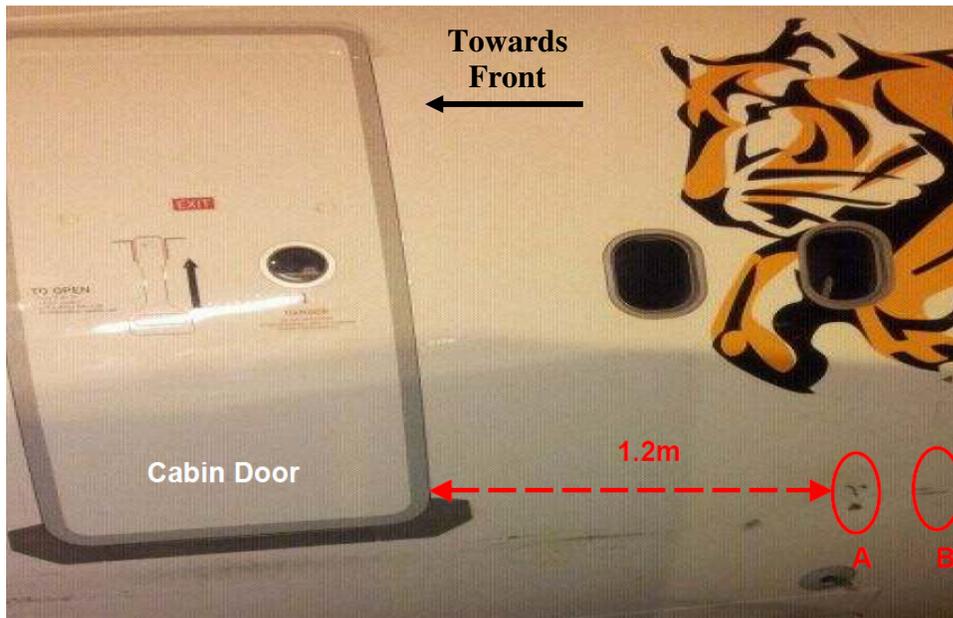
- 1.3.1 The scratch marks and skin puncture were located at about 1.2 m aft of the front cabin door, in line with the bottom level of the door opening (see the areas marked as A and B in **Figure 1**).

Figure 1: Location of damage on aircraft fuselage

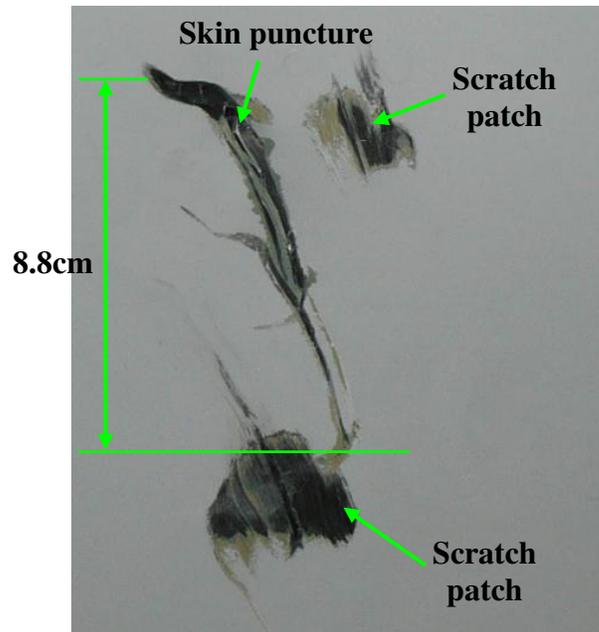
1.3.2 The damage at the area marked A in Figure 2 consists of an 8.8 cm long gouge mark (including the skin puncture) and two scratch patches (see **Figure 2**).

Figure 2: Close-up of damage area A

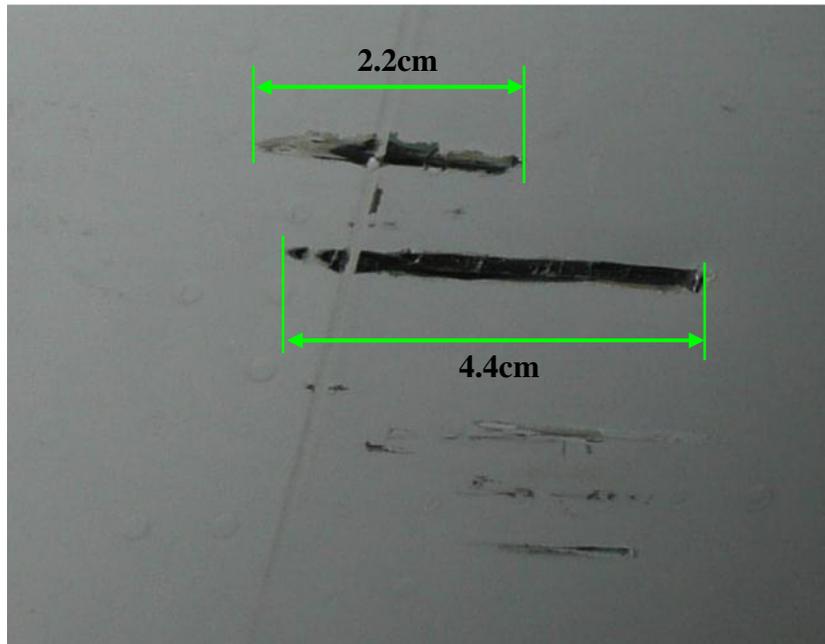
- 1.3.3 The damage at the area marked B in Figure 2 consists of two long gouge marks, one measuring 2.2 cm and the other 4.4 cm (see **Figure 3**).

Figure 3: Close-up of damage area B

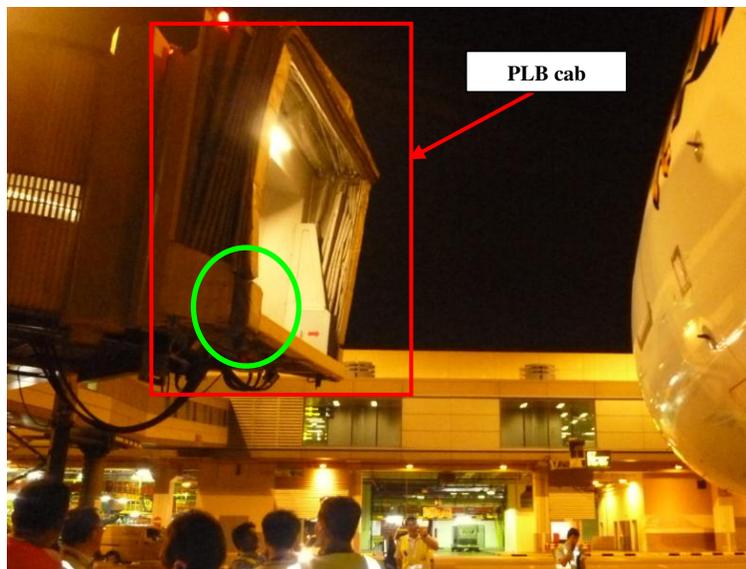
- 1.4.1 The right side metal plate and padding of the PLB operator cabin (PLB cab) were damaged (see **Figures 4, 5 and 6**).

Figure 4: Damage area (green circle) on PLB cab

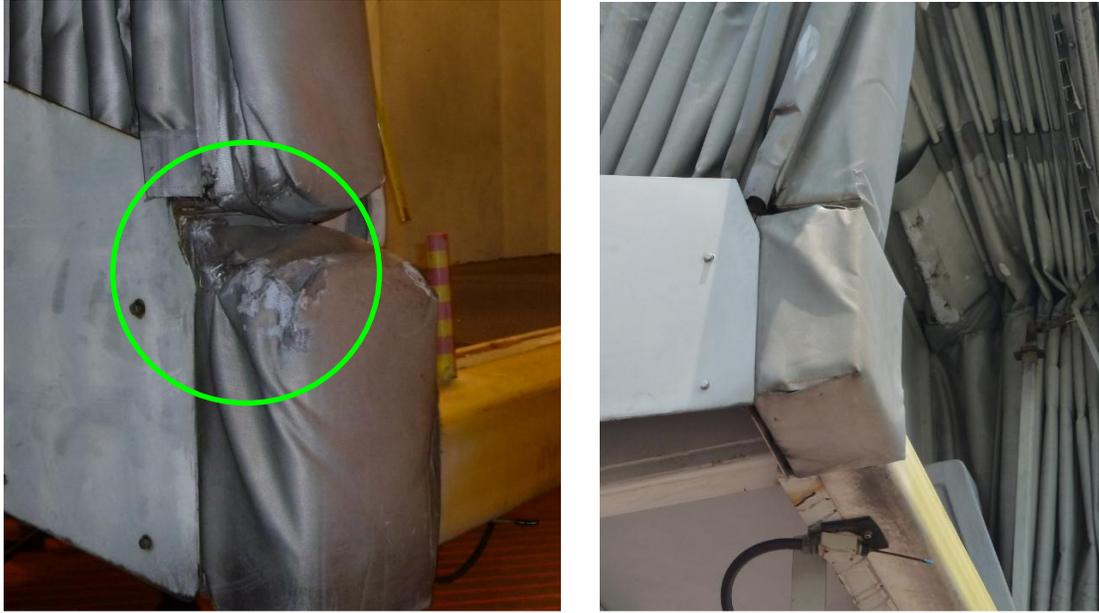
Figure 5: (Left) Damaged padding on incident PLB
(Right) Undamaged padding on normal PLB

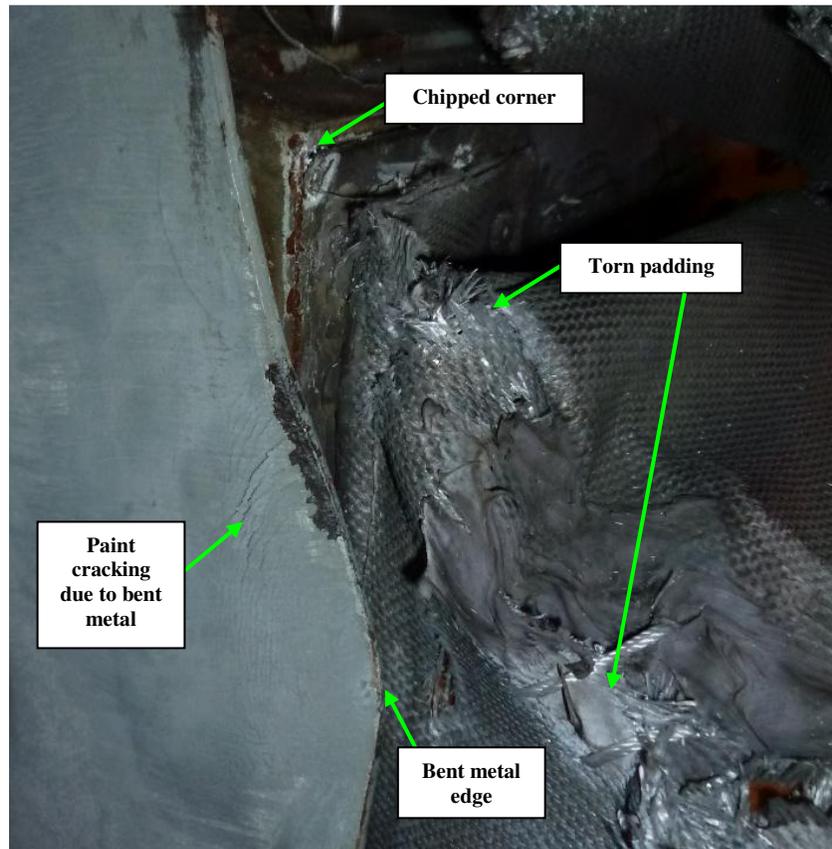
Figure 6: Details of the damaged padding of PLB

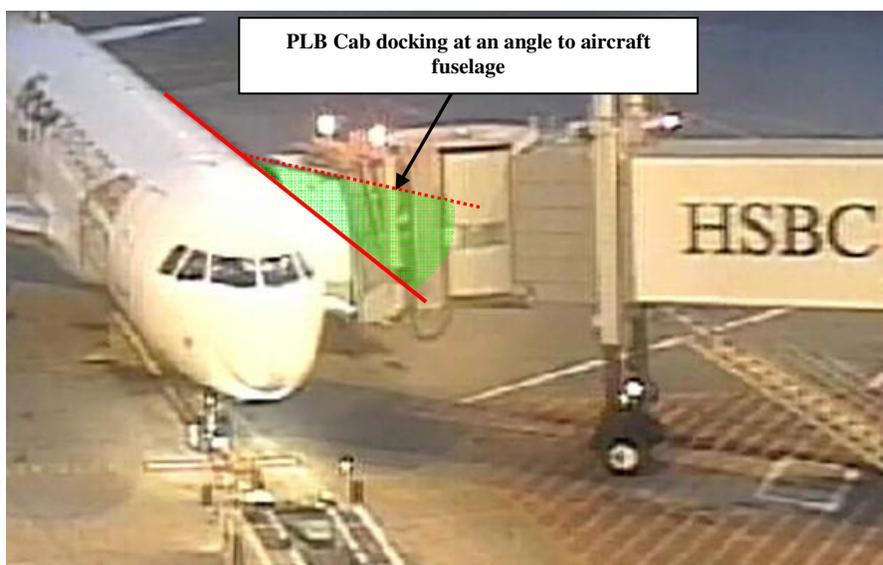
1.7.2 It is observed that, when the PLB cab was being re-docked, the PLB cab was tilting left and making an angle with the aircraft fuselage (see **Figure 7**).

Figure 7: Docking position of PLB at the time of the occurrence

- 3.1 Evidence shows that the PLB cab had contacted the fuselage during the re-docking. The PLB cab was not parallel to the fuselage. It was tilting towards the left at an angle when it approached the aircraft, resulting in the lower corner of the right edge of the PLB cab coming into contact with the fuselage.
- 3.2 In the non-parallel docking position, the safety-interlocking sensors under the PLB cab did not prevent the PLB cab from contacting the fuselage.

- 4.1 Following the incident, the airport ground handling provider has taken the following safety actions:
- Amending the PLB training manual to include a warning to PLB operators that highlights the importance of ensuring that the PLB cab is parallel to the aircraft fuselage, particularly when making adjustments when the bridge is 1.5 m and 0.5 m away from the aircraft. The amendment includes also a warning that non-parallel docking can cause damage to the aircraft fuselage.

- Emphasising to PLB operators that the PLB cab has to be parallel to the aircraft fuselage to ensure that the safety-interlocking sensors is effective in detecting potential contact with the aircraft.

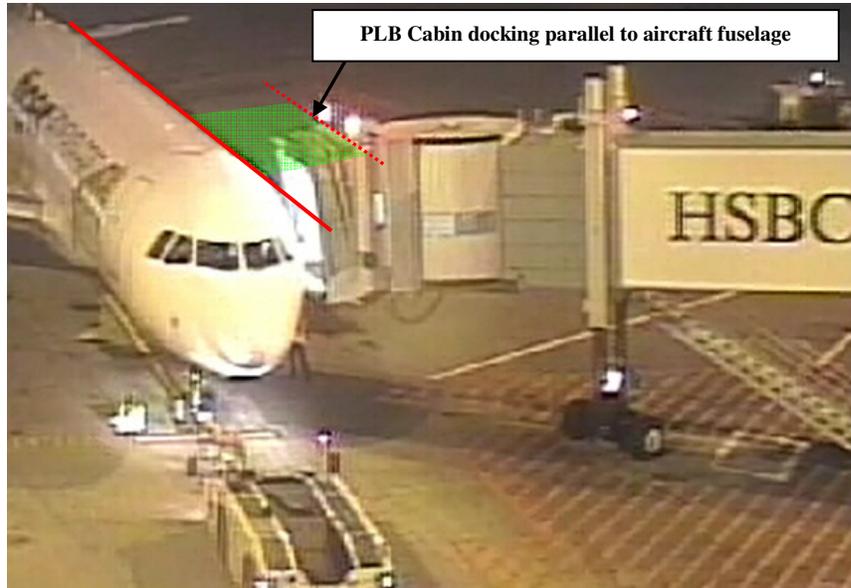
- 1.7.3 After the occurrence, another PLB operator re-docked the PLB to facilitate the disembarkation of passengers. At this instant, it was observed that the PLB cab was almost parallel to the aircraft fuselage prior to opening of the front cabin door (see **Figure 8**).

Figure 8: Docking position of PLB after occurrence (performed by another operator)

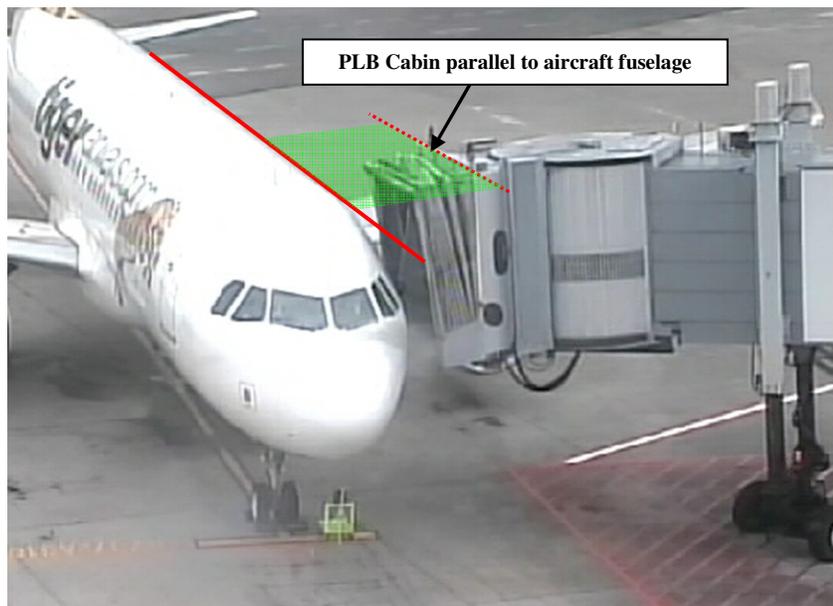
- 1.7.4 It was also observed that, during the first receipt of the aircraft at 1722 hours, the docking position of the PLB cab was almost parallel to the aircraft fuselage prior to opening of the front cabin door (see **Figure 9**).

Figure 9: Docking position of PLB on first receipt of aircraft at Bay E7

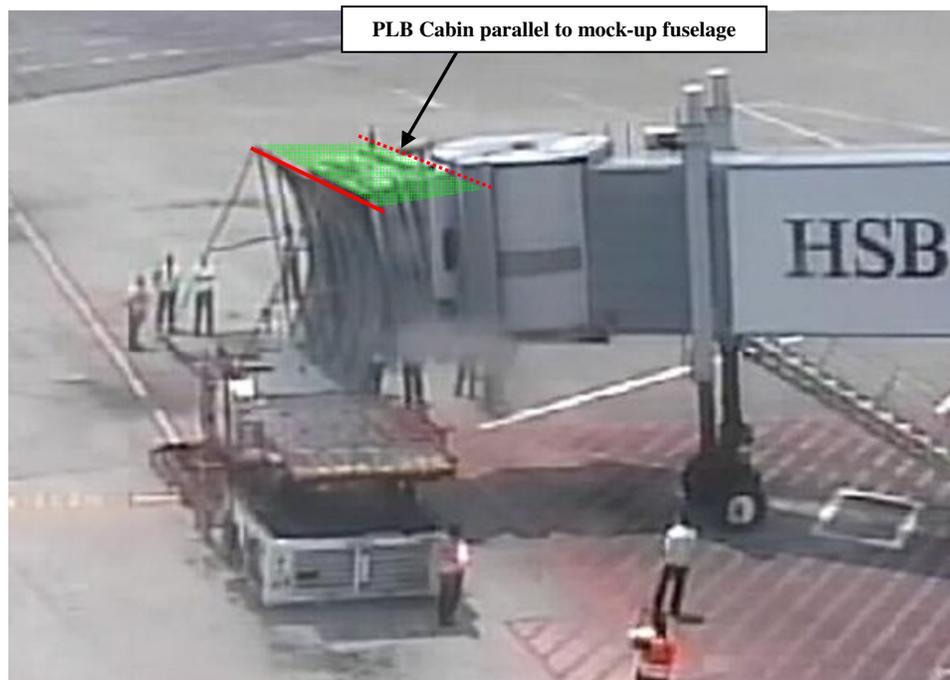
1.8.1.2 For the normal docking, the PLB cab was positioned parallel to the aircraft fuselage, and there was no contact between the PLB cab and the aircraft during the docking operation (see **Figure 10**).

Figure 10: Normal docking position of PLB during simulation

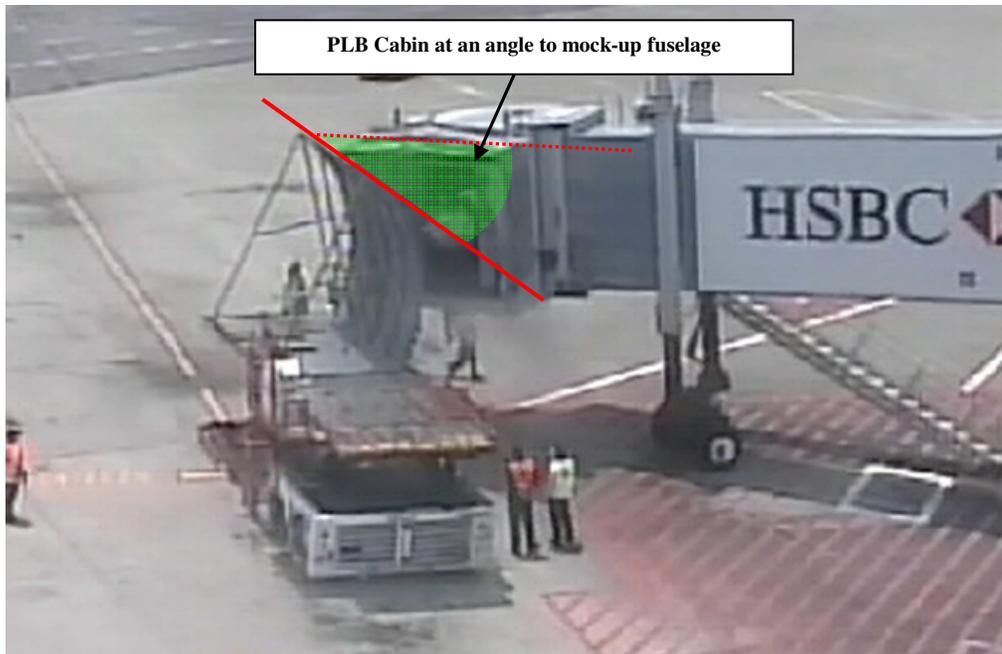
1.8.1.3 For the non-parallel angle docking, the PLB cab was positioned at an angle to the mock-up fuselage (see **Figure 11**). It was observed that the gap between the PLB cab and the mock-up was too wide for safe crossing of passengers. Although the gap produced in the simulation was larger than the gap seen in the incident footage, it should be noted that the simulation serves as a reference to demonstrate what a non-parallel docking would look like and to replicate any unsafe conditions that may exist as a result of a non-parallel docking scenario.

Figure 11: Non-parallel docking position of PLB during simulation

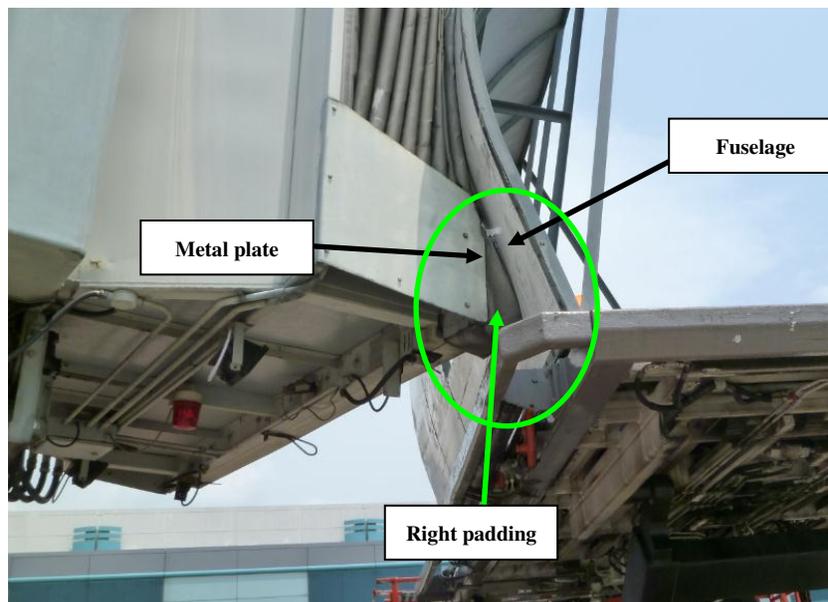
- 1.8.1.4 It was observed in the non-parallel docking scenario that the PLB cab's right padding was highly compressed against the fuselage, and the PLB's side metal plate came in contact with the fuselage (see **Figure 12**).

Figure 12: The PLB right padding and metal plate contacted the aircraft fuselage during non-parallel docking simulation

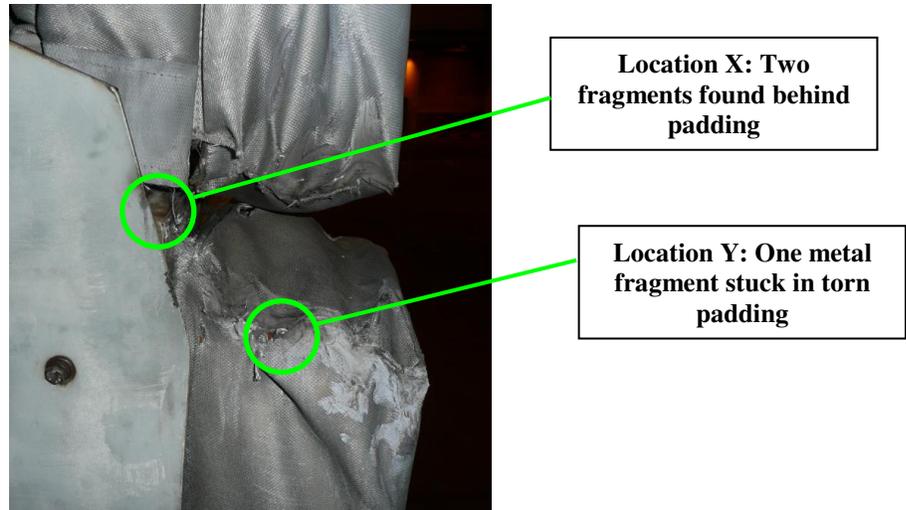
1.8.2.1 Several debris fragments were recovered from the damaged right padding on the PLB cab. The locations of the debris are shown in **Figure 13** below.

Figure 13: Metal fragments found on PLB cab padding

1.8.2.2 For the purpose of this report, the locations where the two fragments were found are referred to as Location X (behind the padding) and Location Y (the lower padding).

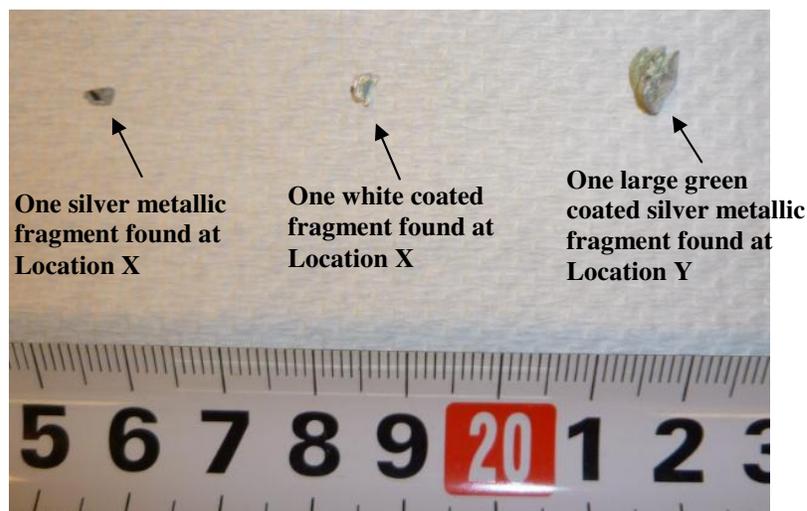
- (a) At Location X, one fragment had a silver metallic appearance and the other had a white coated surface.
- (b) At Location Y, the larger silver metallic fragment had a green coated surface (see **Figure 14**).

Figure 14: Close-up of metal fragments

- 1.8.2.5 It was found that:
- (a) the elemental composition of the two fragment samples from the silver metallic fragment from Location X and the green coated silver metallic fragment from Location Y was similar to that of the aircraft skin, which was 2024 aluminium alloy; and
 - (b) the fragment sample from the white coated metallic fragment from Location X did not match the aircraft skin³, but contained titanium and other elements like silicon, aluminium, iron and oxygen. The sample had an EDX spectrum similar to titanium dioxide, TiO₂ which is commonly used as a white pigment in paint.

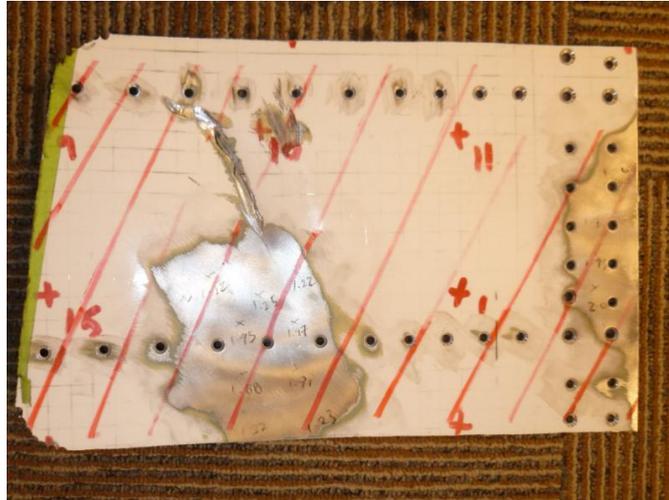
- 1.8.2.3 In order to ascertain the nature of the metal fragments, and whether the fragments had originated from contact with the aircraft fuselage skin, the fragments were sent to a test house to determine their elemental composition through energy dispersive x-ray (EDX)² analysis.
- 1.8.2.4 The elemental composition of the three fragment samples were compared with that of the original damaged aircraft skin (see **Figure 15**).

Figure 15: Cut out of the damaged aircraft skin

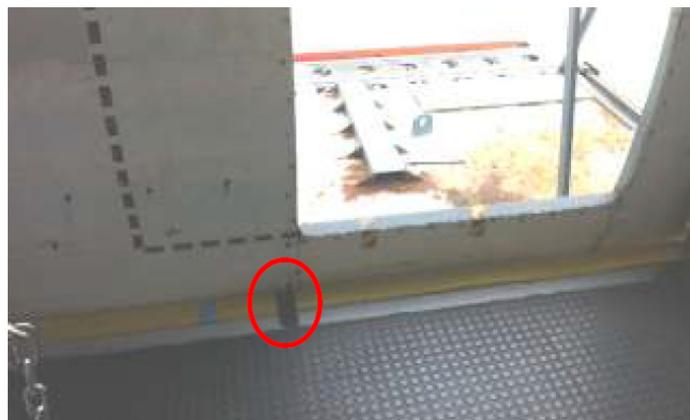
1.9.2.2 From inside the PLB cab, the PLB operator uses a black marking on the floor to gauge correct alignment with the front cabin door. For a satisfactory docking, the black marking is to be aligned with the left edge of the aircraft front cabin door (see **Figure 16**). The PLB operator told the investigation team that during the initial phase of the re-docking, the black marking was not aligned with the left edge of the cabin door but he subsequently readjusted the PLB cab and got the black marking to be 15 cm to the right of the cabin door edge. Although the black marking was not aligned, the PLB operator felt it was sufficiently safe to allow the opening of the door.

Figure 16: Position of black marking aligned with left edge of front cabin door during normal docking with the mock-up fuselage

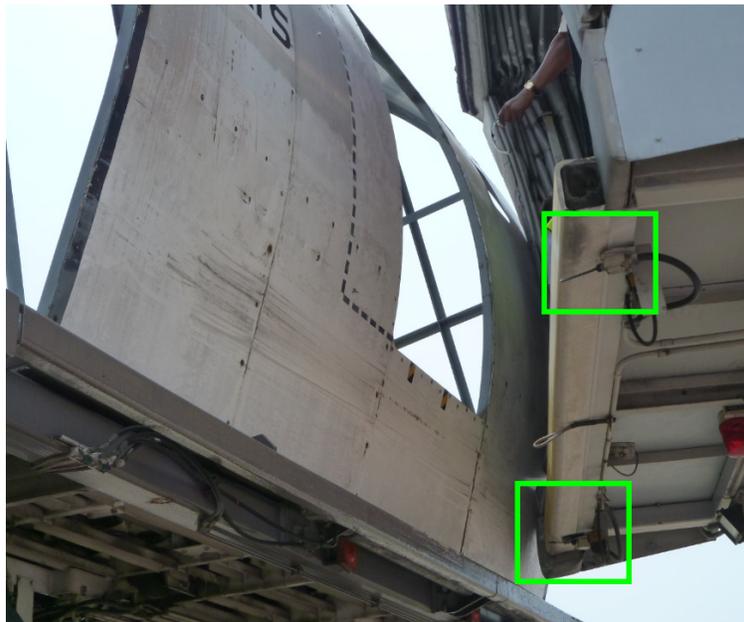
1.9.3.1 There are two safety-interlocking sensors under the PLB cab, one on the left and one on the right. They are installed to prevent the PLB from moving once the sensor rods have come into contact with an obstacle. The position of the two end sensors are shown in **Figure 17**.

Figure 17: Position of the two safety-interlocking sensors under the PLB cab

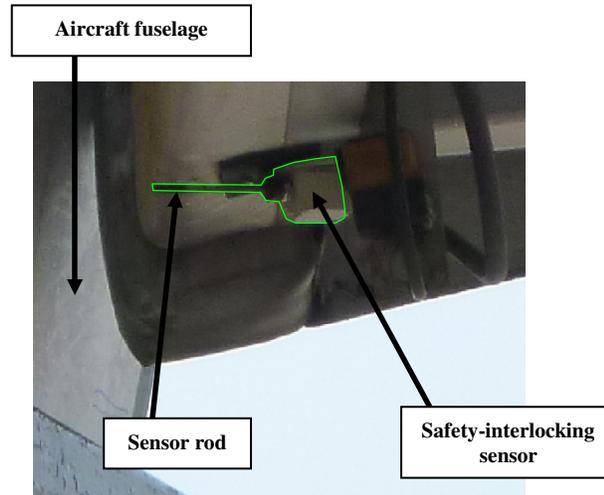
1.9.3.2 It is noted that in the non-parallel docking scenario when the PLB cab's right padding had already contacted the aircraft fuselage, the end sensor closest to the fuselage (i.e. the one on the right) was not touching the fuselage and was therefore not activated as shown in **Figure 18**. Thus the PLB cab could still be manoeuvred further forward towards the aircraft fuselage.

Figure 18: Details of the safety-interlocking sensor and its relative position from the aircraft fuselage, the sensor did not activate even after the PLB cab's right padding had contacted the aircraft fuselage in a non-parallel docking

- 2.1 Evidence from the CCTV footage shows that the PLB made contact with the aircraft during the re-docking process. The contact is also evidenced from the debris fragments found on the PLB cab's damaged right padding.
- 2.2 The safety-interlocking sensors under the PLB cab were designed to work when the PLB is relatively parallel to the aircraft fuselage. In a PLB non-parallel position, the sensor rod would be much farther from the fuselage and would not have prevented the PLB cab from contacting the fuselage.
- 2.3 Thus, as the non-parallel PLB cab was approaching the aircraft fuselage, the effectiveness of the PLB's safety-interlocking sensors was compromised. The sensor on the right side was unable to detect the closing in of the PLB onto the aircraft fuselage.

- 4.2 The aerodrome operator is currently in the process of replacing all their older PLBs (similar to the incident PLB) with a newer model of PLB equipped with an auto-docking safety feature. This feature can guide the PLB cab to within 0.5 m from the aircraft and can reduce manual operational errors.
