FINAL REPORT

BOEING B777-200, REGISTRATION 9V-SRP CARGO CONTAINER INGESTION

19 DECEMBER 2013

AIB/AAI/CAS.100

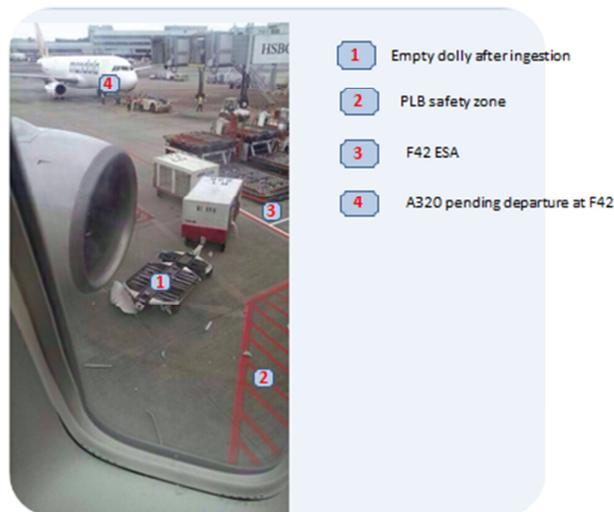
- 1.1.1 On 19 December 2013 at about 1645 hours, the Boeing B777 aircraft (registration 9V-SRP) ingested an empty cargo container (which was sitting on a dolly¹) into its left engine while docking at bay F37 at Changi Airport after arrival from Mumbai (see **Figure 1**). The engine sustained serious damage and had to be replaced. There was no injury to any person.

Figure 1: Empty dolly and surroundings after the incident

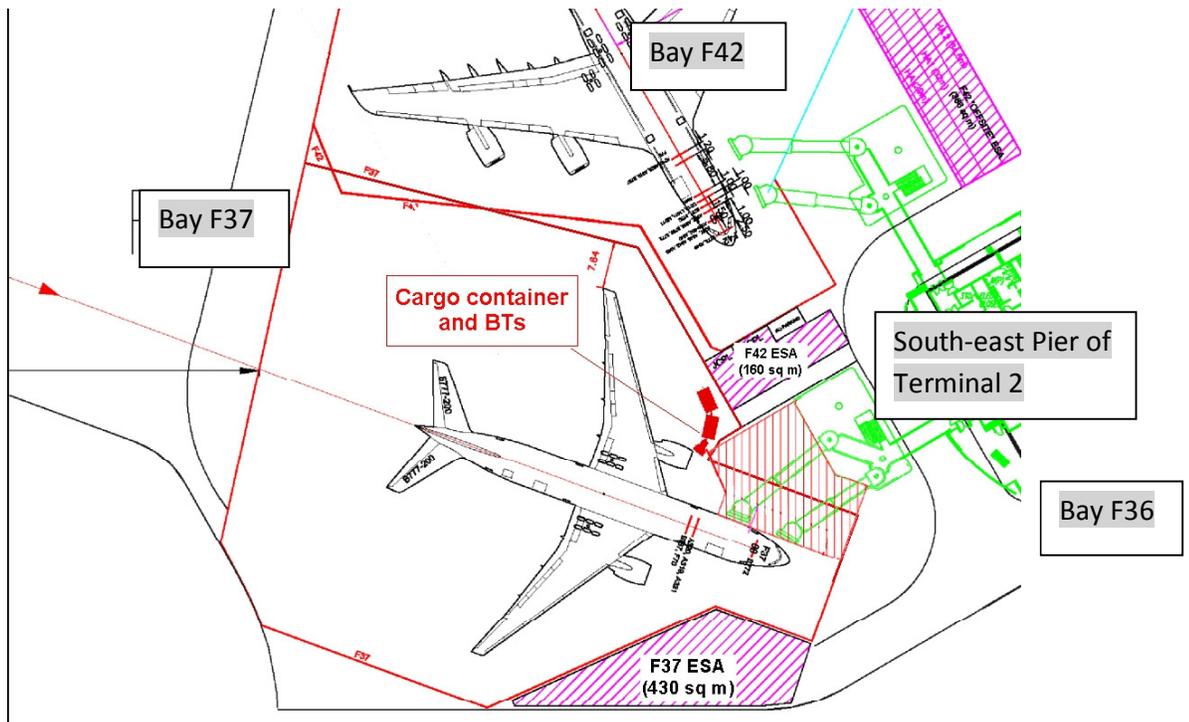
- 1.1.2 At the time of the occurrence, the cargo container and two baggage trailers (BTs) were left in the equipment restraint area (ERA)² of F37, just outside the red hatch lines of the passenger loading bridge (PLB) safety zone.
- 1.1.3 **Figure 2** shows a layout of F37. The bay's equipment staging area (ESA) is to the right of the docking aircraft. F37 is a bay at the far end of the Southeast Pier of Terminal 2 of the Changi Airport. The apron configuration is such that the ESA of the adjacent bay F42 is very close to the ERA of F37.

Figure 2: Layout of bay F37

- 3.3 The aerodrome operator has since limited the use of F37 to smaller aircraft, thus freeing up space to make for bigger ESAs for F37 and F42 as well as for better roadways for service vehicles in the area.
- 3.4 The aerodrome operator has engaged a consultant to undertake a review of the aircraft parking bay layout at Changi Airport. The review included the issue of adequacy of space for ground support equipment staging areas.

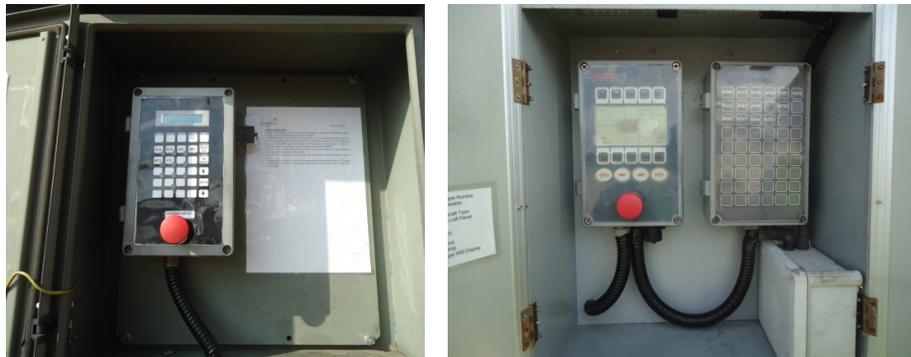
- 1.5.1 The operator panel of the ADGS installed at the airport is of either the 30-key or 54-key type (see **Figure 3**). That at F37 is of the 30-key type⁶.

Figure 3: 30-key (L) and 54-key (R) operator panel

- 1.5.2 The difference in the operating procedures between the 30-key and 54-key panel is:
 - (a) 30-key panel – One needs to press and hold the deadman switch and then key in the aircraft type to activate the ADGS for the pre-arrival check and for the aircraft arrival.
 - (b) 54-key panel – One needs to key in the aircraft type and then press and hold the deadman switch to activate the ADGS for the pre-arrival check and for the aircraft arrival. If the aircraft arrives within 30 minutes after the pre-arrival check, one need not key in the aircraft type again and just needs to press and hold the deadman switch to operate the ADGS.

- 2.5 The problem with the ADGS as perceived by PIC was due to LT's inexperience in operating the ADGS operator panel, i.e. failure to select the aircraft type, and not to any malfunction of the ADGS. LT might have mixed up the operational steps of the 30-key and 54-key operator panel of

- 3.5 The aerodrome operator has since replaced the remaining 30-key ADGS operator panel in all the three terminals of Changi Airport with the 54-key operator panel to standardise the ADGS operating procedure.

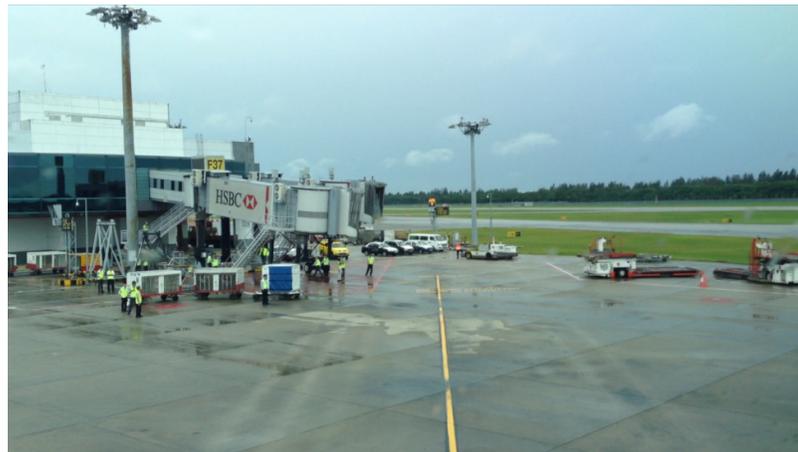
- (a) The investigators could have a reasonably good view of the equipment in the bay after turning into the bay.
- (b) It was not easy to judge whether the cargo container and the two BTs were in, or not in, the ERA (see **Figure 4**). However, one could infer, from the fact that the PLB safety zone could not be seen, that the cargo container and the BTs were in the ERA obscuring the PLB safety zone.
- (c) Likewise, one could infer, from the fact that the wheels of the aerobridge could not be seen, that the cargo container and the BTs were in the ERA.

Figure 4: View of the cargo container and the BTs in the simulated docking

- 4.2 It is recommended that the airline operator remind its flight crews that if the view of the hatch lines of the PLB safety zone or the wheels of the aerobridge was obscured, it could suggest an abnormal situation in the ERA. [AAIB Recommendation R-2015-006]
