FINAL REPORT

**DA 40, REGISTRATION 9V-YFM
RUNWAY EXCURSION**

AIB/AAI/CAS.096

**Air Accident Investigation Bureau of Singapore
Ministry of Transport
Singapore**

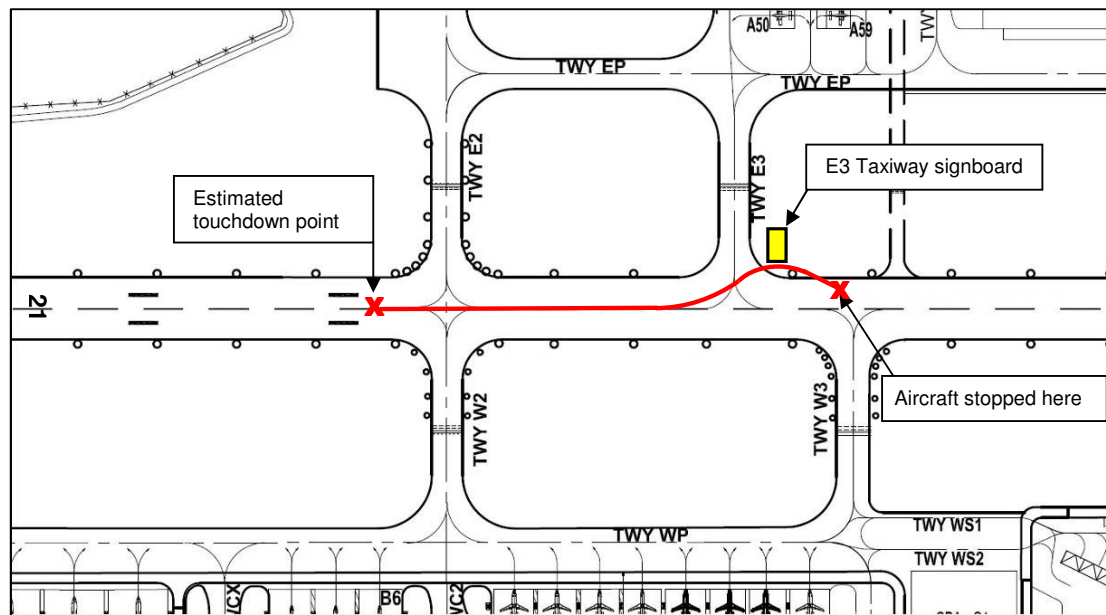
- 1.1.1 At 1537 hours on 11 August 2013, a DA40 aircraft from a local flying school, piloted by a student pilot on a solo flight, veered off the left edge of the paved runway surface and the left wingtip of the aircraft hit the Taxiway E3 signboard during a landing on Runway 21 in Seletar Airport. The student pilot managed to steer the aircraft back onto the paved surface and came to a stop on the runway, past Taxiway E3.

Figure 1: Ground path of the aircraft

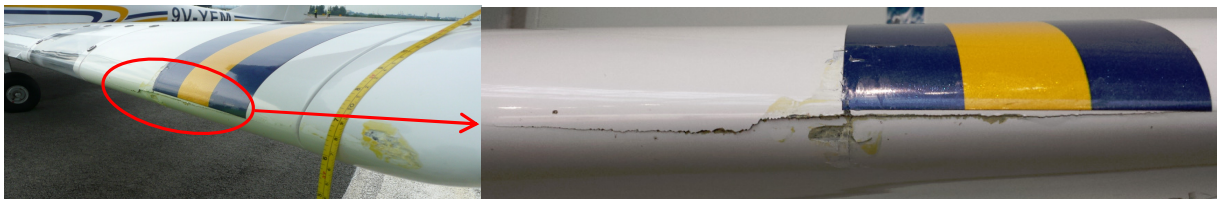
1.3.2 The left wing leading edge had a crack of approximately 35.5 cm (length) by 10.2 cm (breadth) (see **Figure 2**).

Figure 2: Damage on left wing leading edge

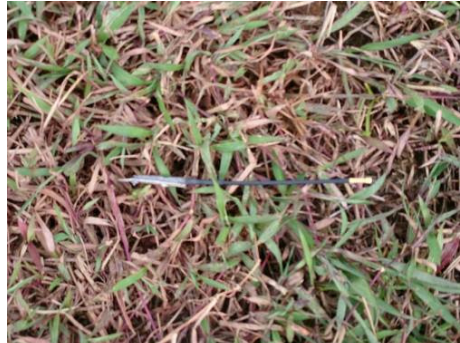
- 1.3.3 The second static discharger from the left wing tip broke off from the bottom of the wing tip assembly after hitting the signboard. There were scratches on the underside of the left wing tip assembly. The tie-down hook on the left wing was also twisted due to impact. See **Figures 3** and **4**.

Figure 3: Dislodged static discharger

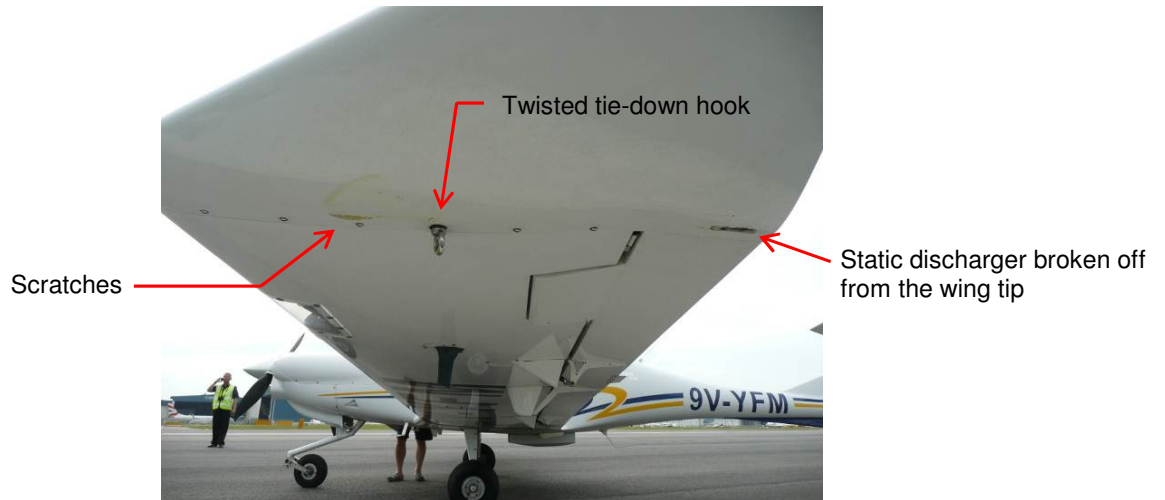
Figure 4: Damage on the bottom of the wing tip assembly

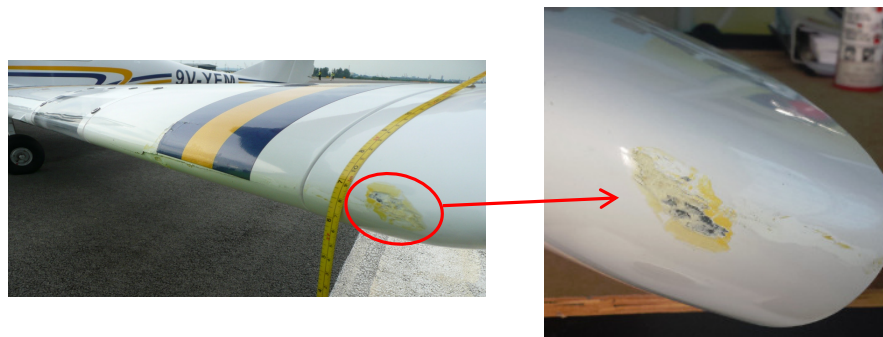
- 1.3.4 The front of the left wing tip assembly also sustained minor scratches. See **Figure 5**).

Figure 5: Scratches at the front of LH Wing Tip Assembly
