FINAL REPORT

**RUNWAY EXCURSION INVOLVING
BOEING 777-200, REGISTRATION 9V-SRN
SINGAPORE CHANGI AIRPORT**

AIB/AAI/CAS.057

**Air Accident Investigation Bureau of Singapore
Ministry of Transport
Singapore**

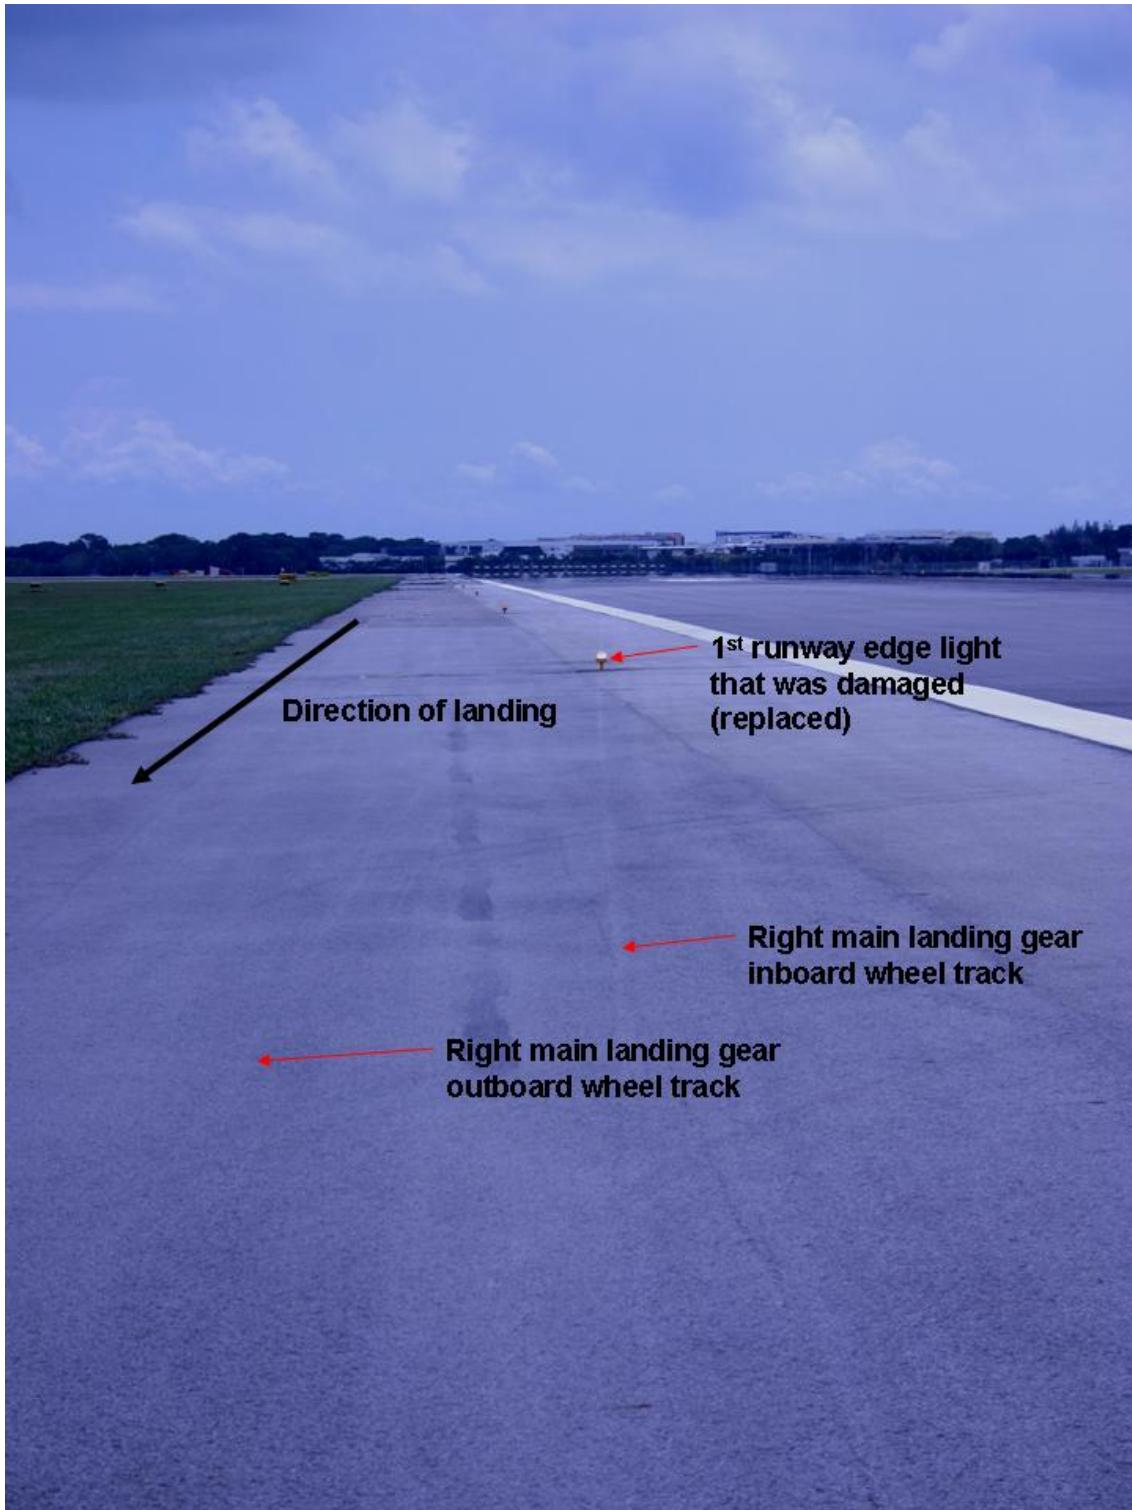
- 1.1.16 The right main gear hit and damaged one runway elevated edge light as the aircraft exited the runway (**Figures 1 and 2**) and rolled on the grass patch for about 92 m before re-entering the runway at the intersection of Taxiway W7 and Runway 02L.

Figure 1: Wheel track of right main landing gear (looking against the direction of landing)

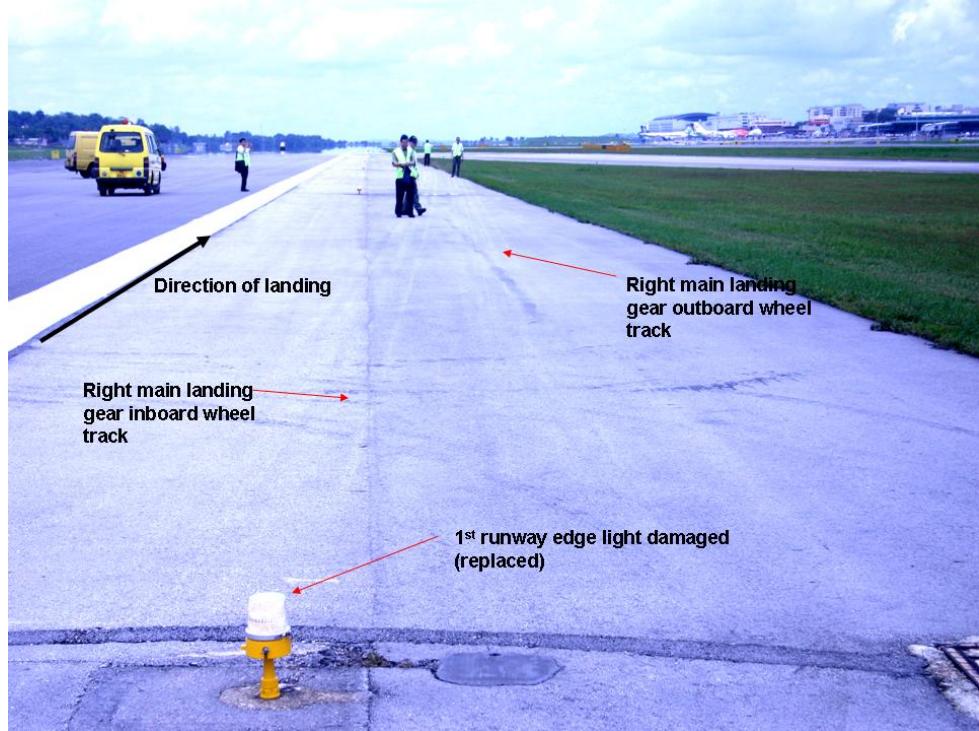
Figure 2: Wheel track of right main landing gear (looking in the direction of landing)

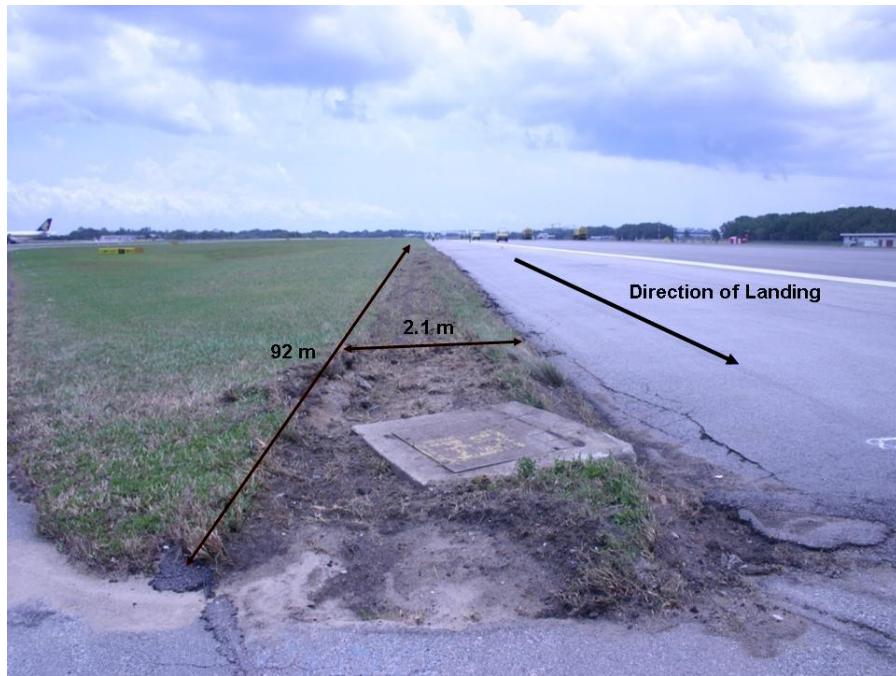
- 1.1.17 The maximum displacement of the right main gear from the runway pavement edge is 2.1 m (**Figure 3**). As the aircraft returned to the runway centreline, the right main gear's inboard wheels hit and damaged a second elevated runway edge light (**Figure 4**).

Figure 3: Wheel track on grass patch adjacent to runway edge (looking against the direction of landing)

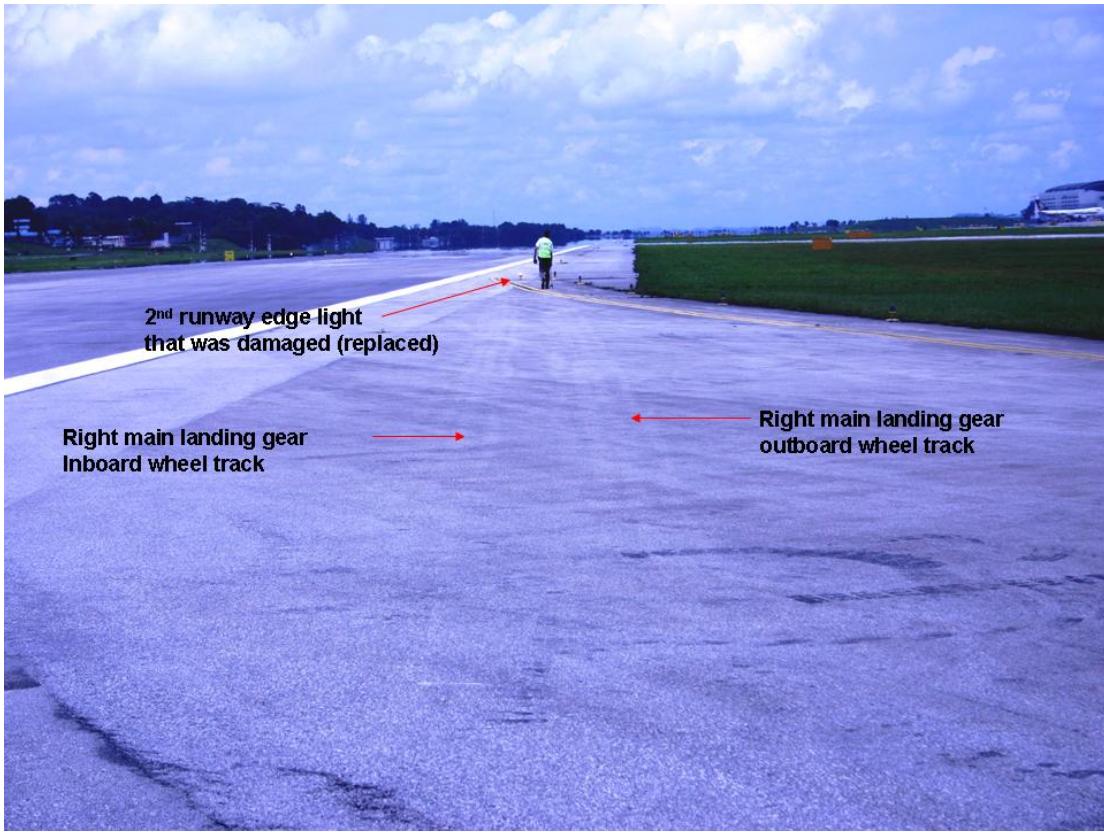
Figure 4: Wheel track of right landing gear on intersection of W7 Taxiway and runway (looking in the direction of landing)

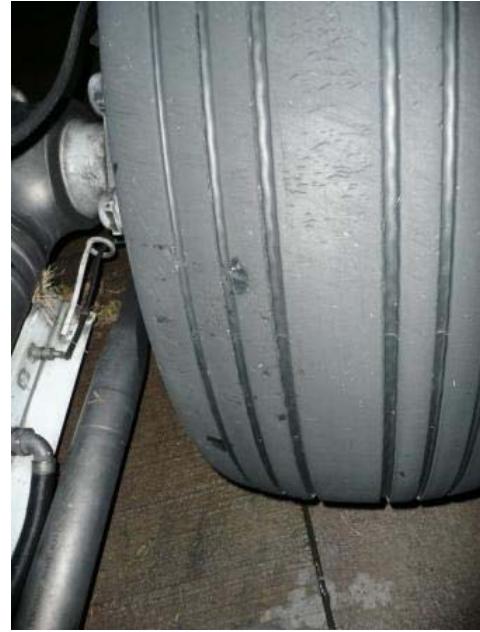
- 1.3.1 Wheel tyres # 4 and # 11 sustained deep cuts (**Figures 5, 6 and 7**). There was no deflation of any tyre. There was no sign aquaplaning.

Figure 6: Number 4 tyre cuts

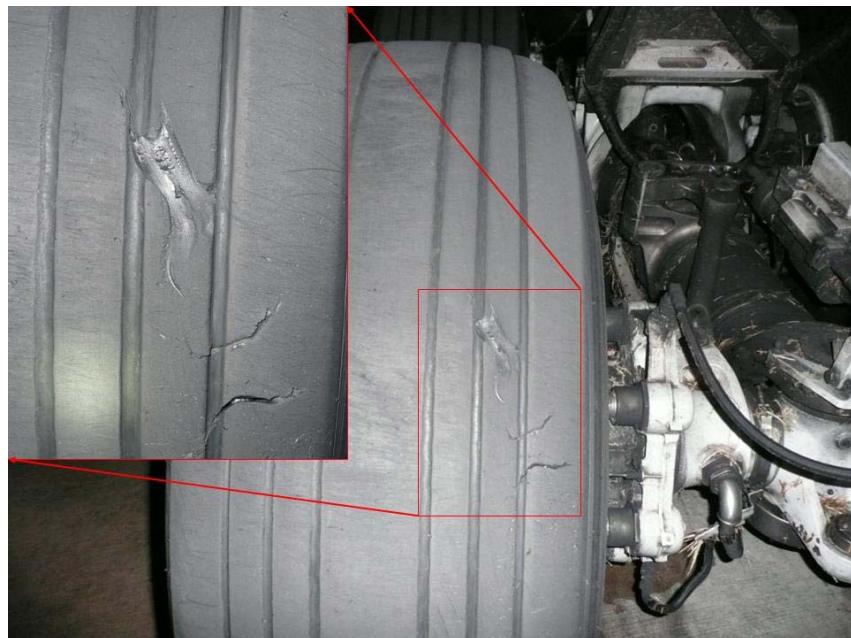
Figure 7: Number 11 tyre cuts

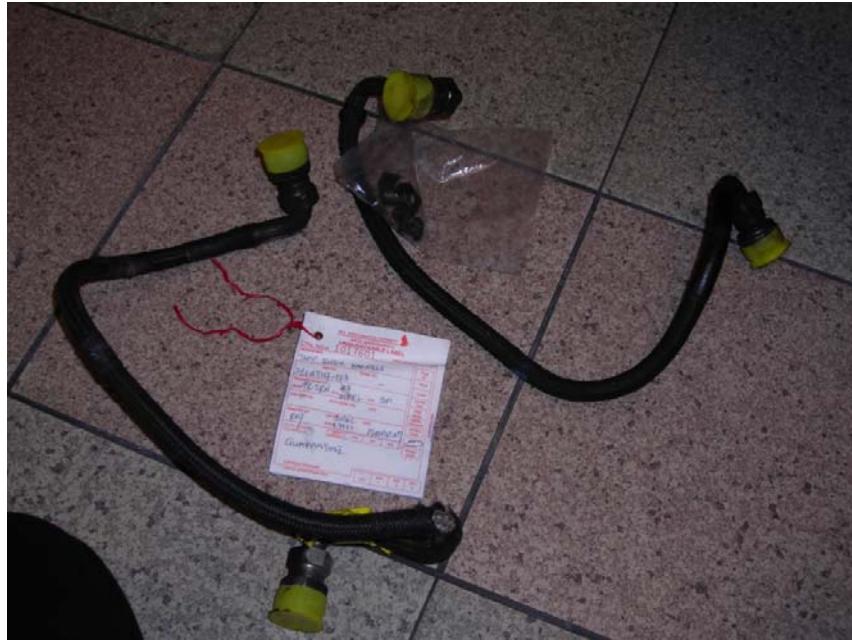
1.3.2 The right main landing gear's left hand brake temperature wire harness support bracket was found distorted and # 7 brake temperature harness damaged (**Figure 8**).

Figure 8: Damaged brake temperature harness
