# **FINAL REPORT**

## **AIRBUS A320, REGISTRATION 9M-AHA FOREIGN OBJECT INGESTION INCIDENT AT SINGAPORE CHANGI AIRPORT ON 28 FEBRUARY 2010**

**AIB/AAI/CAS.063**

**Air Accident Investigation Bureau of Singapore  
Ministry of Transport  
Singapore**

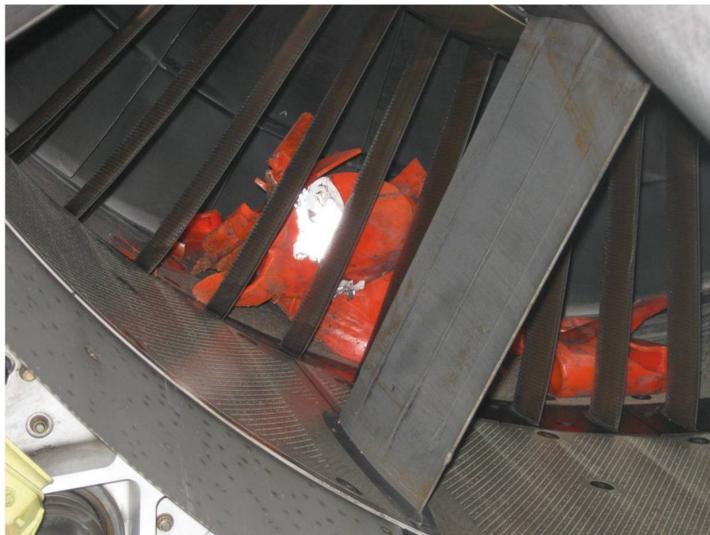
- 1.1.4 Both the EOs approached the aircraft to perform their allocated tasks. Upon seeing the ADGS “stop’ display, EO 2 moved towards the No. 2 engine. He was carrying one cone in each hand, with the intention of placing the cones to mark the hazard zone around the engine. After placing one cone in front of the No. 2 engine, the second cone was sucked out of his hand and was ingested into the engine. The ingestion of the cone resulted in a loud “POP” sound. The ingested safety cone was shredded by the engine blades. (see **Figure 1**)

Figure 1: Cone ingested into the No. 2 engine

1.3.1 The No. 2 engine was inspected and tested. No damage or anomaly was found.

2.2 According to the GHA, EO 2 was aware of the ramp safety procedures when working around parked aircraft, whereby he should wait for the anti-collision lights/ aircraft engine to be switched off and for the thumbs up signal from the headset man before approaching the aircraft. However, he had apparently forgotten about this safety precaution and took the ADGS "stop" display as a signal for clearance to approach the aircraft.

- 3.1 The GHA conducted refresher training on airside safety for all the handling staff immediately after the incident, paying particular attention to aircraft arrival procedures and safe practices when working around aircraft. Since June 2010, the GHA had instituted recurrent training for their staff. All staff who work at the ramp are required to attend recurrent training once every two years.
- 3.2 The GHA shared the safety lessons arising from this incident with its ground handling staff.
