FINAL REPORT

PIPER 28A, REGISTRATION 9V-BON

RUNWAY INCURSION

AIB/AAI/CAS.067

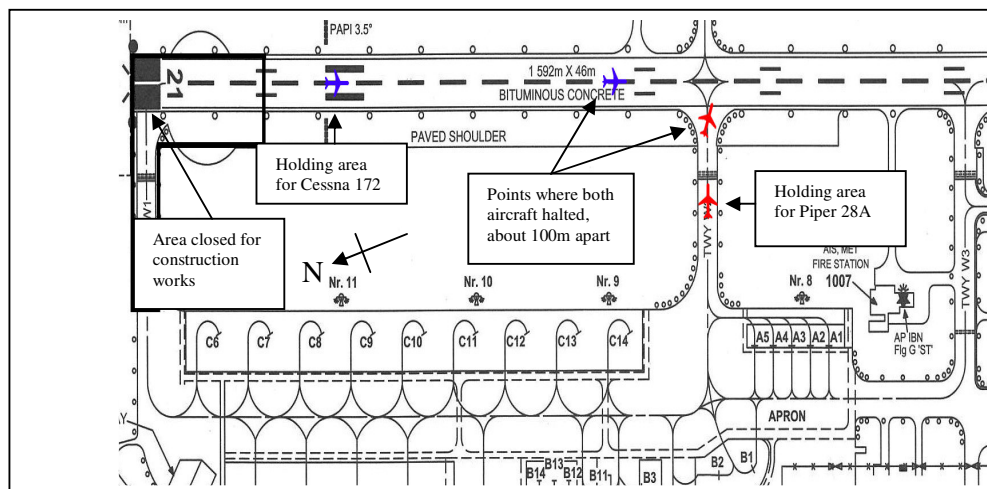
Figure 1. Positions of the Piper and the Cessna (not to scale)

1.1.4 The TC was aware that the readback was from the Piper. She also noticed that the Piper was moving towards the runway while she was doing a scan of the runway. The TC waited for 10 seconds before cancelling the take-off clearance for the Cessna. The two aircraft stopped about 100 m apart of each other (**Figure 1**). There was no injury to any person and no damage to the aircraft.
