FINAL REPORT

AIRBUS A380-800, REGISTRATION 9V-SKD

SMOKE IN LAVATORY

AIB/AAI/CAS.072

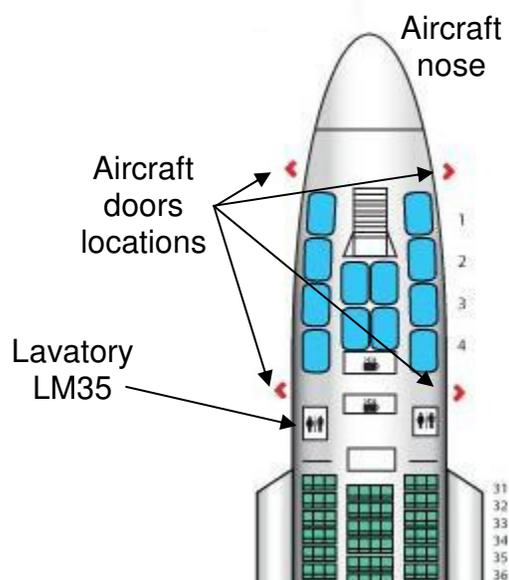
Figure 1: Location of lavatory LM35 on A380 main deck (Top view)

- 1.1.4 About 45 minutes before arriving Singapore (the aircraft was then about three hours into the flight), an ECAM message indicating smoke in lavatory LM35 on the main deck of the aircraft (see **Figure 1**) appeared.
- 1.1.5 At this time, the Cabin Crew-In-Charge (CIC) was in lavatory LM35 and he heard a loud bang. The lights in the lavatory went out and the CIC noticed an electrical burning smell.

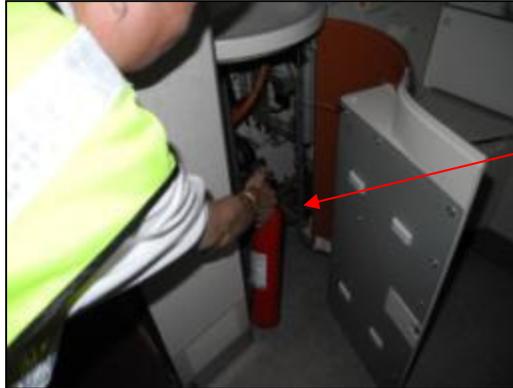
Figure 2: CIC discharging fire extinguisher (illustration only)

Smoke emitting from base of wall panel under the sink

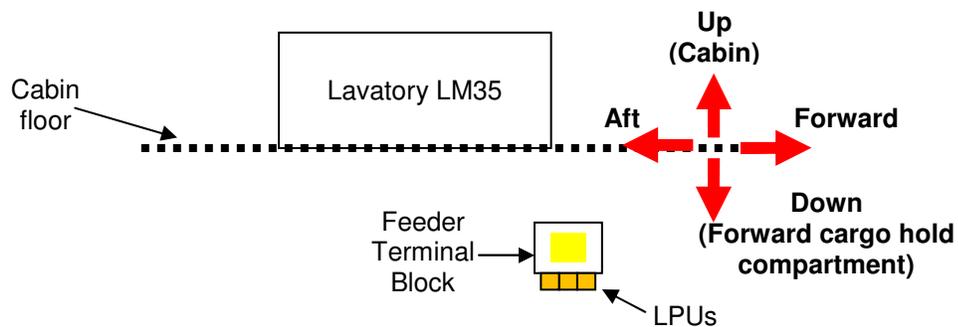
Figure 3: Location of feeder terminal block

1.2.1 The aircraft was inspected after landing in Singapore. Signs of burning were found on the feeder terminal block for the No.1 VFG located in the forward cargo compartment below lavatory LM35 (see **Figure 3**), on the feeder cables connected to the feeder terminal block and on the insulation blankets around the feeder block (see **Figure 4**). The inner surface of the cover of the feeder terminal block was partially covered with soot but did not show any sign of heat damage.

- 4.2 The aircraft manufacturer, as holder of the type certificate, review the need for fire detection and suppression in the vicinity of the feeder terminal block. [AAIB Recommendation R-2012-003]

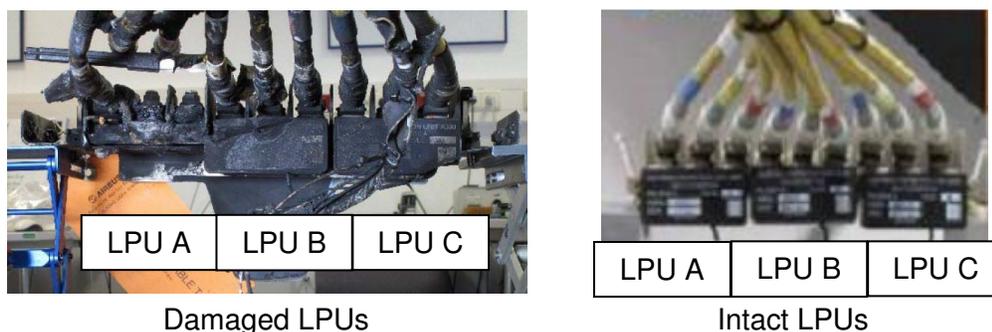
Figure 5: Damaged LPUs as compared with intact ones⁶

- 1.2.2 The Lightning Protection Units (LPUs) connected to the feeder terminal block showed signs of melting (see **Figure 5**).

- 1.4.2.2 An examination of the damage on the LPUs suggested that the damage was caused by excessive current flowing through the LPUs.
- 1.4.3 Flow of Fire Extinguishing Agent

- (b) The VFG output voltage continued to increase beyond the breakdown voltage of the LPUs, causing the LPUs to conduct. The LPUs, designed for lightning strike (high transient voltage of short duration), conducted for a duration longer than they were designed for. This resulted in a short circuit between the feeder cables attached to the feeder terminal block and the electrical ground, causing excessive currents to flow through the feeder cables. The design of the lightning protection system was such that it did not prevent the feeder cables from being shorted to the electrical ground when excessive voltage is output by the VFG.

- (c) The excessive current flowing through the feeder cables overheated and damaged the feeder terminal block and the LPUs. The Over-Current protection was eventually triggered and limited the damage due to overheating.

- 4.1 The aircraft manufacturer, as holder of the type certificate, review the design of the lightning protection system to prevent short circuiting of the feeder cables when excessive voltage is output by the Variable Frequency Generator. [AAIB Recommendation R-2012-002]

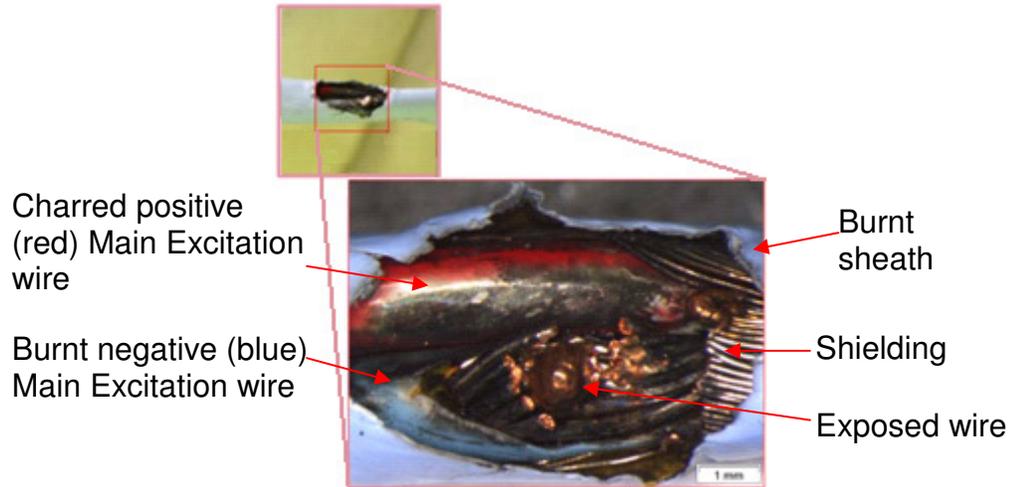
Figure 6: Main Excitation Cable damage

- 1.2.5 During the subsequent troubleshooting⁸, the Main Excitation Cable⁹ was found to be degraded. The sheath and shielding of the Main Excitation Cable and the insulation of the negative (blue) Main Excitation Wire were damaged (see **Figure 6**).

- 1.2.6 There was no heat or stress damage found in the proximity of the Main Excitation Cable damage. There was no maintenance work performed on the Main Excitation Cable since the aircraft was delivered to the operator. Figure 7 illustrates the locations of the various components.

- 1.4.1.4 Failure analysis of the Main Excitation Cable revealed that the negative Main Excitation Wire was damaged by electrical arcing between the negative Main Excitation Wire and the cable shielding that enveloped the positive and negative Main Excitation Wires.

2.1.2 Failure analysis of the Main Excitation Cable revealed that the negative Main Excitation Wire was damaged by electrical arcing (see paragraph 1.4.1.4). The electrical arcing could explain the damage to the feeder terminal block for the No.1 VFG and the LPUs connected to the feeder terminal block:

2.1.3 The electrical arcing also suggests that there might be prior damage to or imperfection of the insulation of the negative Main Excitation Wire. However, this cannot be ascertained. According to the operator, there had been no maintenance work performed on the Main Excitation Cable since the aircraft was delivered to the operator. Therefore it seems unlikely that the insulation damage, if there really was, occurred after aircraft delivery. The insulation damage or imperfection could also have arisen during the aircraft manufacturing process, but there is no evidence in this regard.

3.1.1 Following the occurrence on 20 February 2011, the operator completed an inspection of its A380 aircraft fleet for degradation of the Main Excitation Cable. No similar wire degradation was found.

3.4.1 The aircraft manufacturer revised the troubleshooting procedure on 1 October 2011. The revised procedure requires an insulation check of the excitation line circuit (which includes the Main Excitation Cable) to be performed.

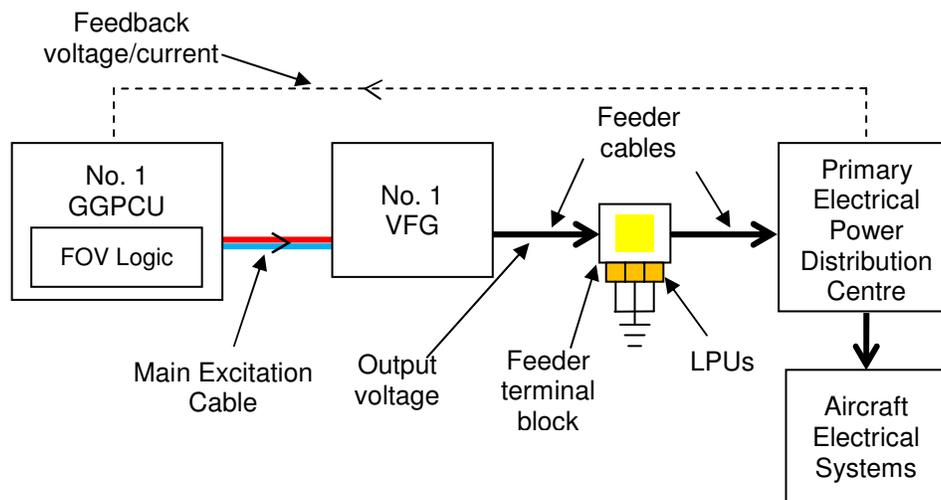
Figure 8: No. 1 electrical system

1.4.1.1 **Figure 8** shows a schematic diagram of the No.1 electrical system. The No.1 GGPCU controls the output voltage of the No.1 VFG by varying the current flowing in the Main Excitation Cable which comprises a positive (red) excitation wire and a negative (blue) excitation wire. The output voltage and current of the VFG are monitored by the GGPCU through the Primary Electrical Power Distribution Centre.

1.4.1.2 Each GGPCU has a Fast Over-Voltage (FOV) protection logic and an Over-Current protection logic. The FOV protection logic would inhibit the output of the VFG (i.e. zero VFG output) if the VFG output voltage is greater than 143Vac and the negative Main Excitation Wire voltage is less than 19Vdc. The Over-Current protection logic would inhibit the VFG output when any phase current of the VFG output is greater than 435A.

1.4.1.3 According to the data of the non-volatile memories of the GGPCUs in respect of the incident flight on 31 January 2011, the FOV protection logic did not trigger when the No.1 VFG output voltage reached 181Vac (as the negative Main Excitation Wire voltage was higher than 19Vdc, as shown by the GGPCU memory data). The data also showed that an Over-Current event was subsequently detected¹⁰, and the Over-Current protection logic triggered, when the highest phase current reached 1511A.

- (a) The electrical arcing means there was a short circuit of the negative Main Excitation Wire to the cable shielding. This could cause the VFG output to increase beyond 143Vac. However, the GGPCU FOV protection did not trigger because the negative Main Excitation Wire voltage was higher than 19Vdc.

3.3.1 The GGPCU manufacturer has redesigned the GGPCU FOV protection logic to enable it to trigger when the negative Main Excitation Wire voltage is higher than 95% of the positive Main Excitation Wire voltage. This logic has been tested to work for a range of short circuit impedances.

3.3.2 The GGPCU manufacturer will be implementing the modification to all GGPCUs.

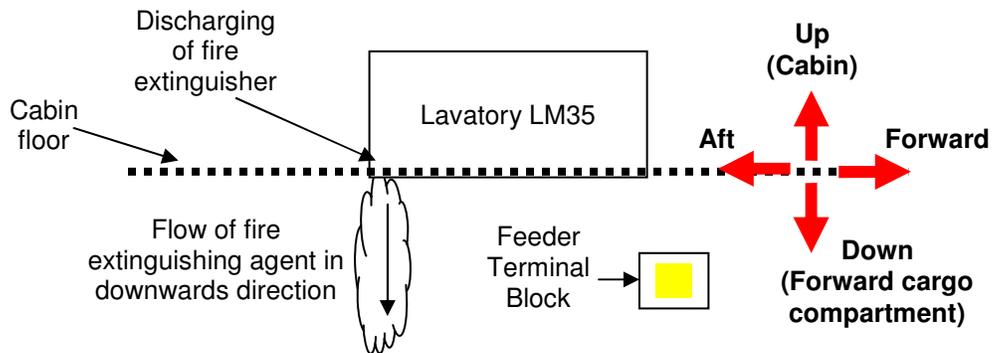
Figure 9: Flow of Fire Extinguishing Agent

- 1.4.3.1 When the CIC demonstrated to the investigation team how he had discharged the fire extinguisher, it was observed that the fire extinguishing agent did not reach the feeder terminal block (see diagram (not to scale) in **Figure 9**).

- 2.5 Fire Detection and Suppression
 - 2.5.1 There was no fire detection or suppression system installed on the aircraft to detect fire in the vicinity of the feeder terminal block nor was there a means for the cabin crew to access the damaged feeder terminal block to fight any fire there. The flow of the fire extinguishing agent discharged from lavatory LM35 (see **Figure 2** and **Figure 9**) could not reach a fire at the feeder terminal block.
 - 2.5.2 The fire that damaged the feeder terminal block had probably extinguished by itself but it remains a concern that there is no sure way of detecting and extinguishing a fire in that area.
