FINAL REPORT

CESSNA 172R, REGISTRATION 9V-FCG

AIRCRAFT VEERING OFF RUNWAY

AIB/AAI/CAS.079

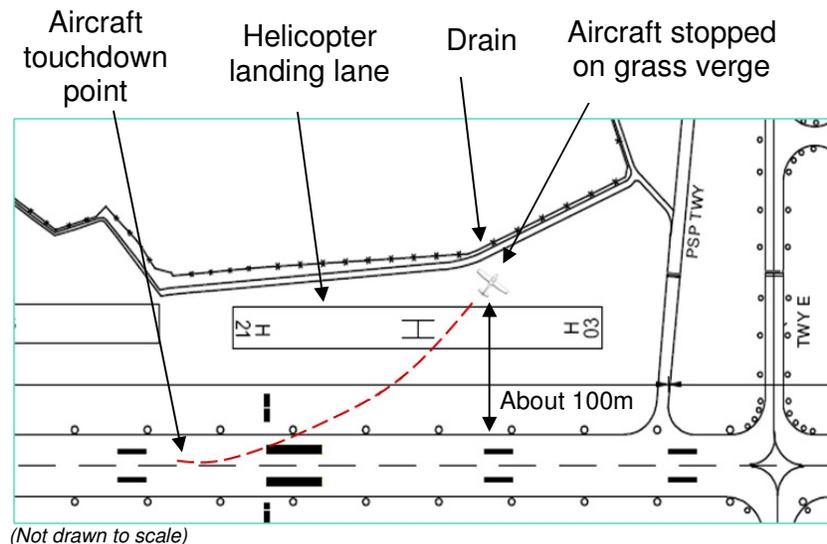
Figure 1: Ground path of the aircraft

- 1.1.1 At 4.42 p.m. on 25 October 2011, a Cessna 172R aircraft from a local flying school, piloted by a student pilot, veered off the left edge of the paved runway surface onto the grass area during a touch-and-go landing on Runway 21 in Seletar Airport. The aircraft crossed a helicopter landing lane and stopped about 100 m from the runway edge. The approximate path of the aircraft is shown in **Figure 1**. The aircraft was not damaged.

- 1.1.9 The aircraft eventually went off the left edge of the paved runway surface and onto the grass area. When the student noticed that the aircraft was heading towards a drain, he applied brakes and the aircraft eventually stopped before the drain after rolling across a helicopter landing lane.

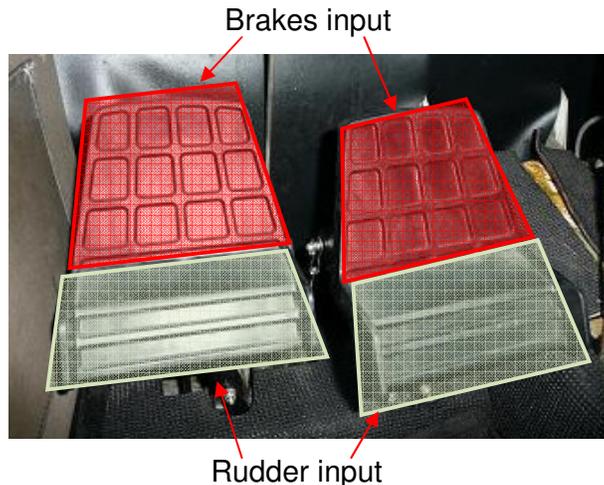
Figure 2: Aircraft foot pedals

1.6.1.1 The rudder pedals of the aircraft are slightly reclined (see **Figure 2**) and they are used to steer the aircraft and to apply brakes.

- 1.6.1.4 According to the student, when the aircraft started to veer left after touchdown, he tried to steer towards the right by stepping on the right rudder pedal. When the right rudder pedal was being pushed forward, the left rudder pedal was coupled to move rearward correspondingly. This movement of the left rudder pedal caused the student's left foot to slide upwards as, according to the student's recollection, his left foot might have momentarily frozen without his realising it. The student also said he might have inadvertently pressed on the top portion of the left rudder pedal, thus applying left brake.

his left foot did not move rearwards. As the left rudder pedal moved rearwards, due to the right rudder application, the student pilot's left foot may have slid up the rudder pedal and inadvertently applied left brake. This inadvertent application of the left brake probably explains why the aircraft continued to veer to the left.

- Reminding all the instructors to teach students the landing technique as stipulated in the school's training manual.
- Emphasising to its instructors to remind their students to keep their heels on the floor during landing to prevent inadvertent application of the brakes.
