# **FINAL REPORT**

## **AIRBUS A380, REGISTRATION 9V-SKJ TURBULENCE EVENT**

**18 October 2014**

AIB/AAI/CAS.108

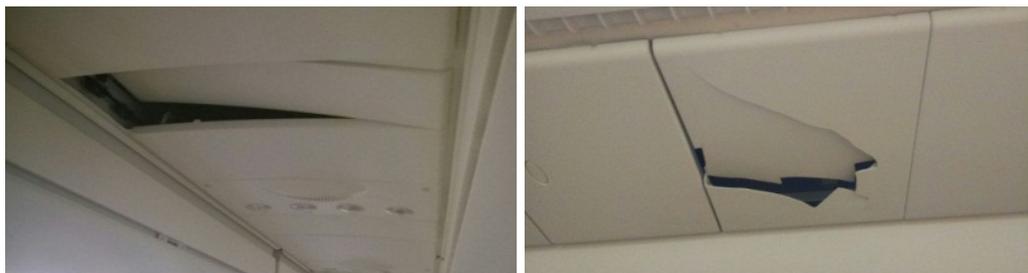
1.3.1 A smoke detector in one main deck lavatory and a ceiling panel in another main deck lavatory were damaged.

1.3.2 Some panels in the cabin (see **Figure 2**) were also damaged.

Figure 2: Damaged ceiling panels in cabin

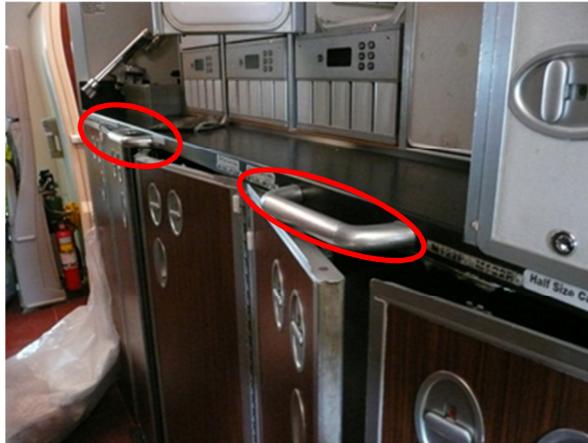
- 2.2.1 There are fixtures in the galleys (see **Figure 3**), located at a height which is easy to locate and hold on to, which a person may grab hold of at the sudden onset of turbulence. Although grabbing hold of such fixtures may not necessarily prevent injury, they are useful when one needs to steady oneself

Figure 3: Handles in galley

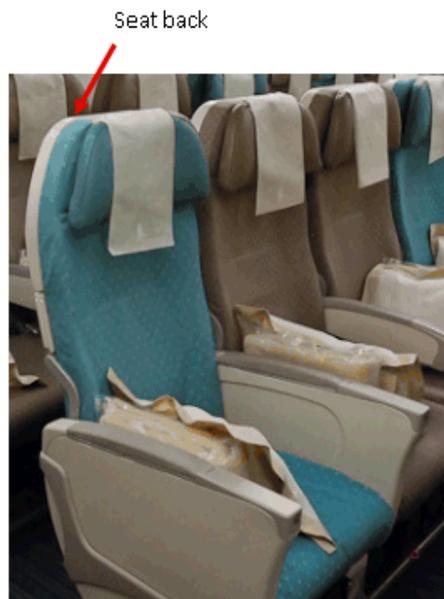
- (a) In Economy Class - Holding on to the seat back (see **Figure 4**), or squatting down and grabbing the metal rail below the seats (see **Figure 5**).

Figure 4: Holding on to the seat back

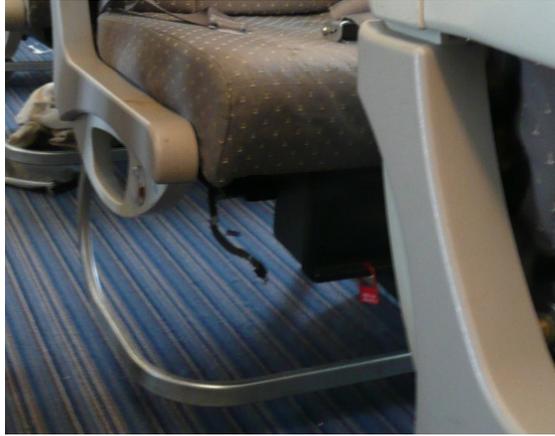
Figure 5: Metal rail below seats

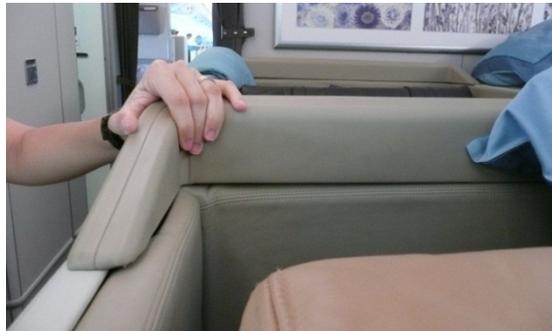
- (b) In Business Class - Grabbing the seat shell (frame) of a Business Class seat (see **Figure 6**) or squatting in between two Business Class seats (see **Figure 7**).

Figure 6: Holding on to the seat shell of Business Class seat

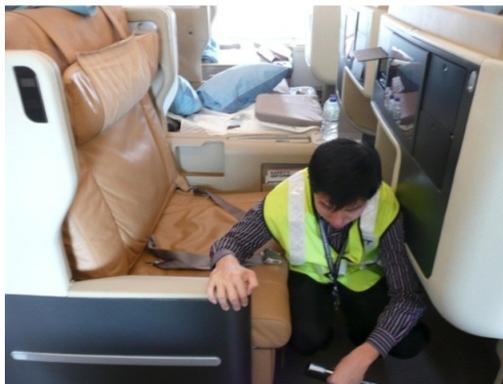
Figure 7: Squatting between Business Class seats

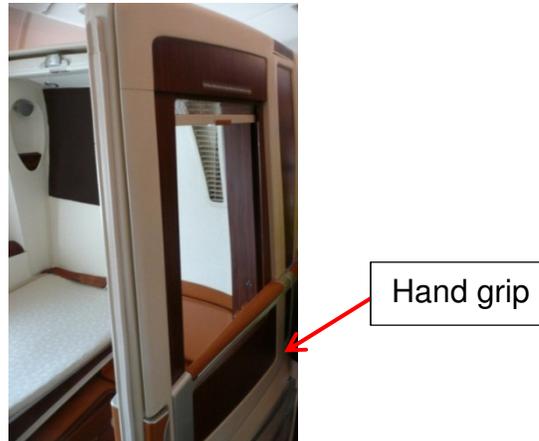
- (c) In Suite Class - Holding on to the hand grip at the window frame of the partition (see Figure 8).

Figure 8: Window frame of Suite Class seat partition
