FINAL REPORT

B747-400F, REGISTRATION 9V-SFL

AIRCRAFT VEERING OFF RUNWAY

AIB/AAI/CAS.081

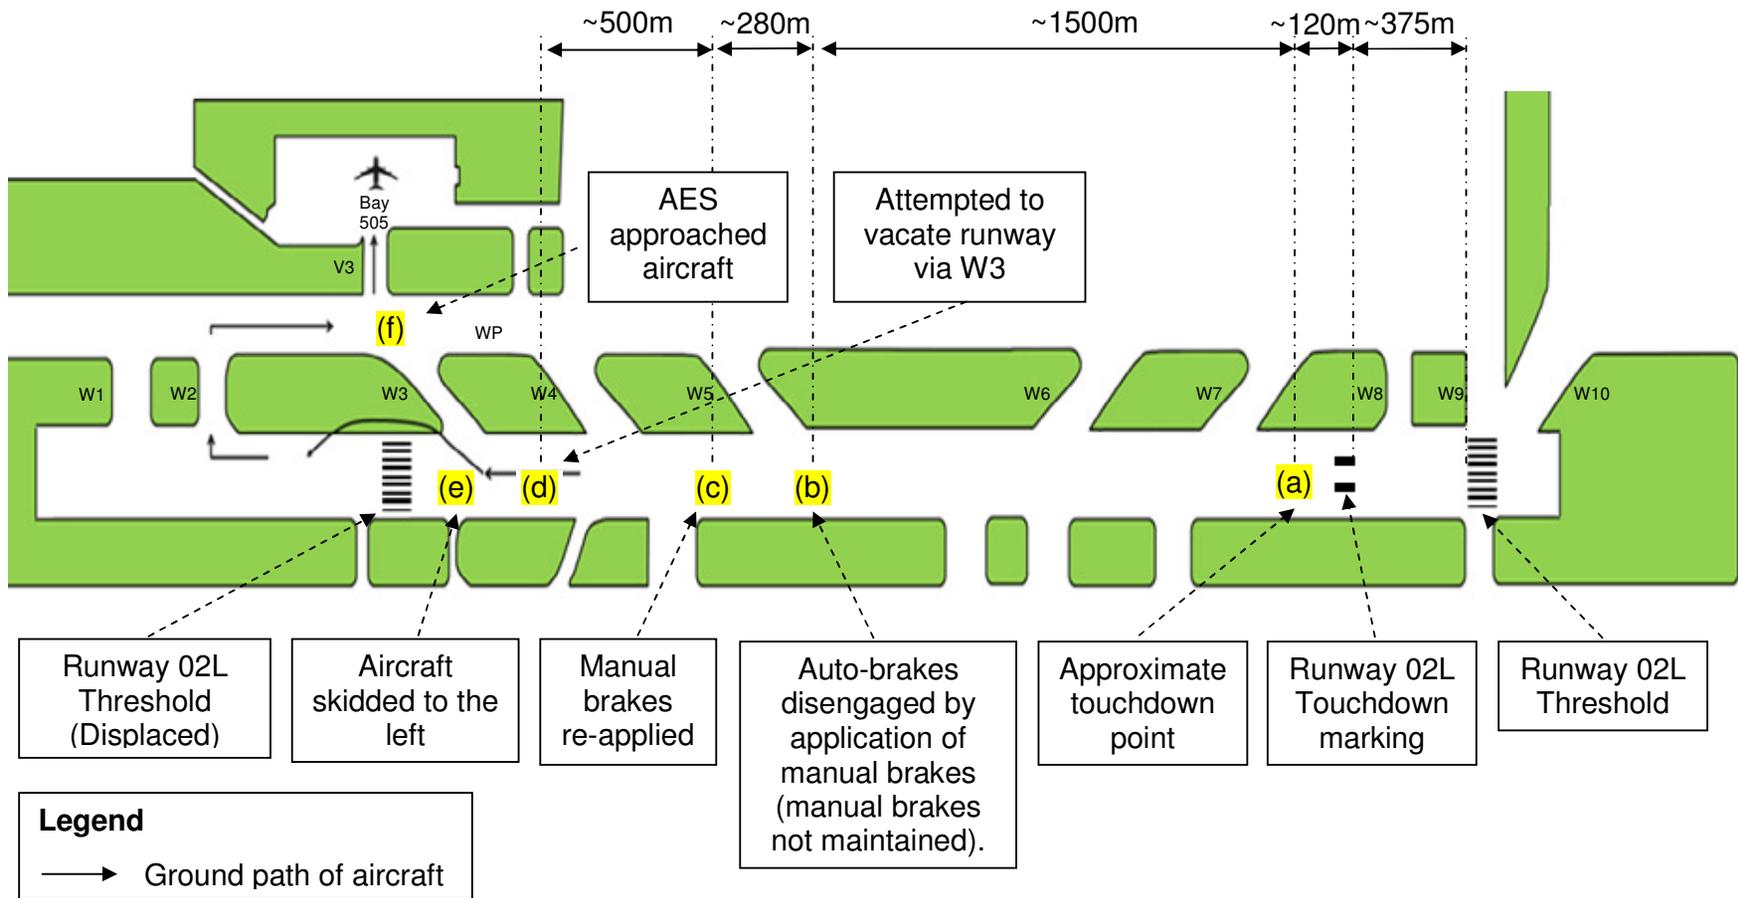
Figure 1: Ground path of the aircraft (Not drawn to scale)

- 1.1.3 The aircraft touched down about 120m beyond the touchdown marking (**Figure 1** point (a)) and the thrust reversers were activated. When the aircraft had decelerated to about 99 knots, the FO deactivated the auto-brakes by applying manual brakes² (**Figure 1** point (b)) momentarily, i.e. manual brakes were not maintained. Manual brakes were applied about five seconds later (**Figure 1** point (c)) (during these five seconds, the aircraft had travelled about 280m, as estimated from FDR data). While the manual brakes were being re-applied, the thrust reversers were stowed when the aircraft speed was about 68 knots.

- 1.1.5 Based on the visual cues, the FO felt that the aircraft had reached a speed which was safe to exit via W3. The FO said that he attempted to turn right towards W3 (**Figure 1** point (d)) by applying right rudder pedal input. (FDR data indicated that the speed was about 59 knots at this point.) However,

- 1.1.6 The FO noticed that the aircraft was not turning right despite his right rudder pedal input and he applied some tiller input³.
 - 1.1.7 The aircraft started to turn right but the FO and PIC felt the aircraft skidding towards the left (**Figure 1** point (e)). The FO immediately tried to steer the aircraft back towards the runway centreline in order to proceed on the runway to vacate via the next exit taxiway W2. The PIC took over control and also attempted to steer the aircraft towards the runway centreline.

- 1.1.9 The Control Tower saw the aircraft going into the grass area and alerted the Airport Emergency Service (AES).
 - 1.1.10 The aircraft rolled towards the end of the runway after it had returned to the centre of the runway. It vacated the runway via the taxiway W2 and taxied to and stopped at the intersection of taxiways V3 and WP (**Figure 1** point (f)) where the AES, responding to the alert by the Control Tower, approached the aircraft. **Figure 1** shows the ground path of the aircraft.

2.2.2 The FO had deactivated the auto-brakes by applying manual brakes but he did not maintain the manual brakes. He only applied manual brakes again about five seconds later. Had he maintained manual brakes, the aircraft would have had further decelerated through a distance of 280m and would have reached the turning point for W3 at a speed lower than 59 knots. It was possible that the aircraft could have safely vacated the runway via W3, despite early deactivation of the auto-brakes.

- 2.3.4 Thus, while the use of the tiller managed to get the aircraft to start turning to the right, the inertia of the aircraft also caused the aircraft to skid, resulting in the aircraft's excursion off the runway.

- (a) Emphasising to all the flight crews the criteria for releasing auto-brakes during the landing roll.
- (b) Enhancing flight crews' awareness of the need to decelerate the aircraft to a safe taxi speed, especially after landing, before making a turn.

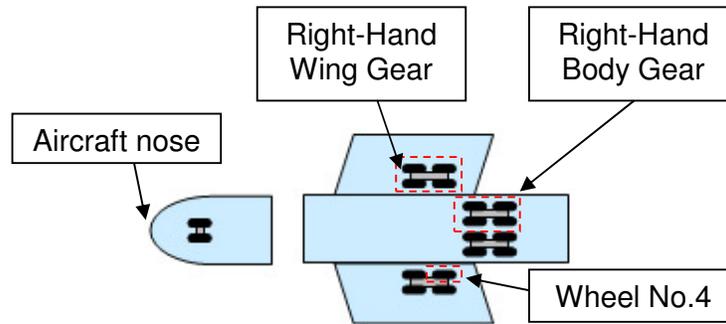
Figure 2: Landing gears of B744F (plan view)

- 1.2 Damage to aircraft
- 1.2.1 All the wheels of the aircraft other than wheel No.4 and all the brake assemblies of the right wing gear and right body gear were damaged and had to be replaced (**Figure 2**). One of the fan blades of the No.3 engine was also damaged by mud that was ingested.
