FINAL REPORT

**BOEING B767-300ER, REGISTRATION JA-606J
ATTEMPTED TAKE-OFF ON TAXIWAY**

12 JULY 2015

AIB/AAI/CAS.114

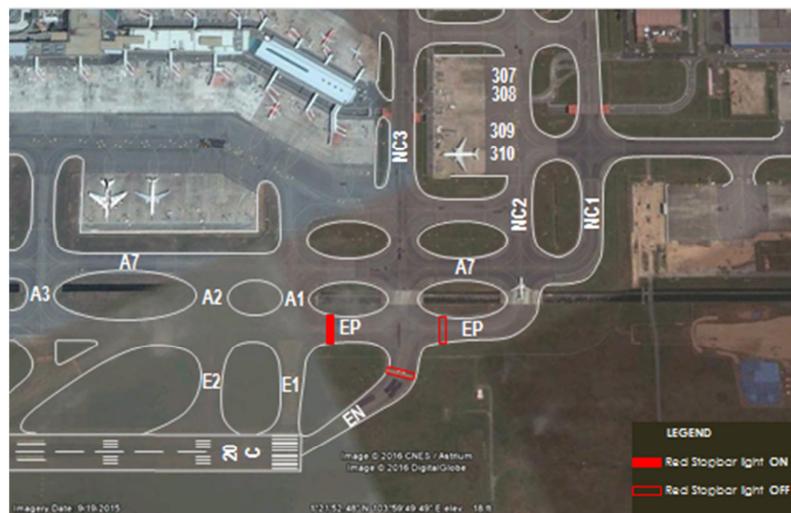
1.1.3 The First Officer (FO) was the Pilot Flying (PF)² and the Pilot-in-Command (PIC), the Pilot Monitoring (PM). The FO, as the PF, performed the take-off briefing, and he told the PIC that he expected the taxi route from the parking bay to be U1-WA-NC3-EN-R20C (see **Figure 1**).

Figure 1: Taxiways NC2 and NC3 leading to R20C via EN

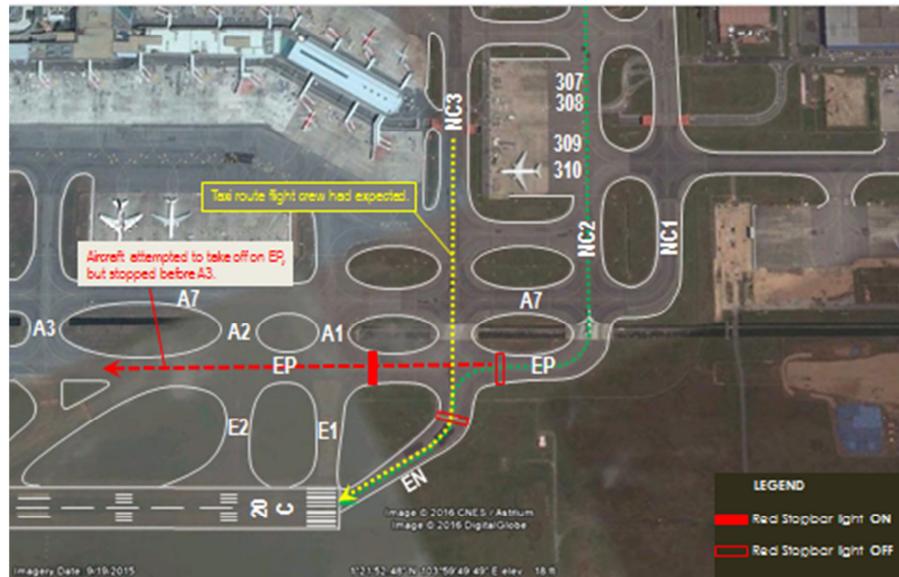
- 1.1.9 **Figure 2** shows the selected “taxi on the greens” taxiway centerline lights (in green), the actual path of the aircraft towards EP (in red), and the taxi route (in yellow) expected by the flight crew.

Figure 2: Taxiway centerline lights (in green), ground path of aircraft (in red), and taxi route expected by the flight crew (in yellow).

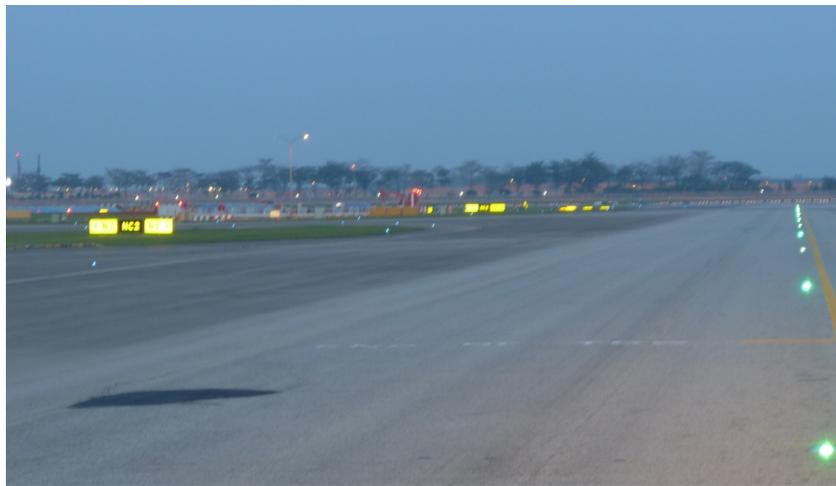
- 1.2.3 There are seven location signboards along WA-NC2-EP that could serve to remind users of this route that they are on NC2 (an example is shown in **Figure 3**). All the aerodrome's guidance and location signboards were inspected daily at about 19:30 hours. According to the records of the inspection on 11 July 2015, all the guidance signs along the aircraft taxi route to Runway 20C were operating normally. These lights were switched on at the time of the occurrence.

Figure 3: Location signs showing "NC2" along the taxiway
