**FINAL REPORT**

**BOEING 747-200F, REGISTRATION 9V-JEB  
UNCONTAINED ENGINE FAILURE**

**17 DECEMBER 2009**

**AIB/AAI/CAS.062**

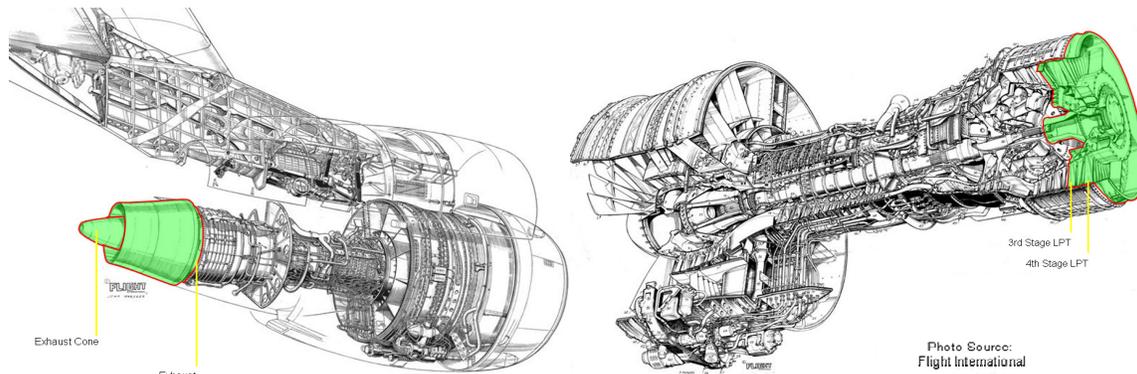
1.2.2.1 The stage 3 (S3) LPT nozzle guide vane (NGV) section of the No.4 engine was exposed, and the S3 LPT rotor and all blade sections aft of the S3 LPT rotor were missing. In addition, the exhaust cone and the exhaust were also missing (see **Figures 1, 2 and 3**).

Figure 1. Engine components found missing (highlighted in green)

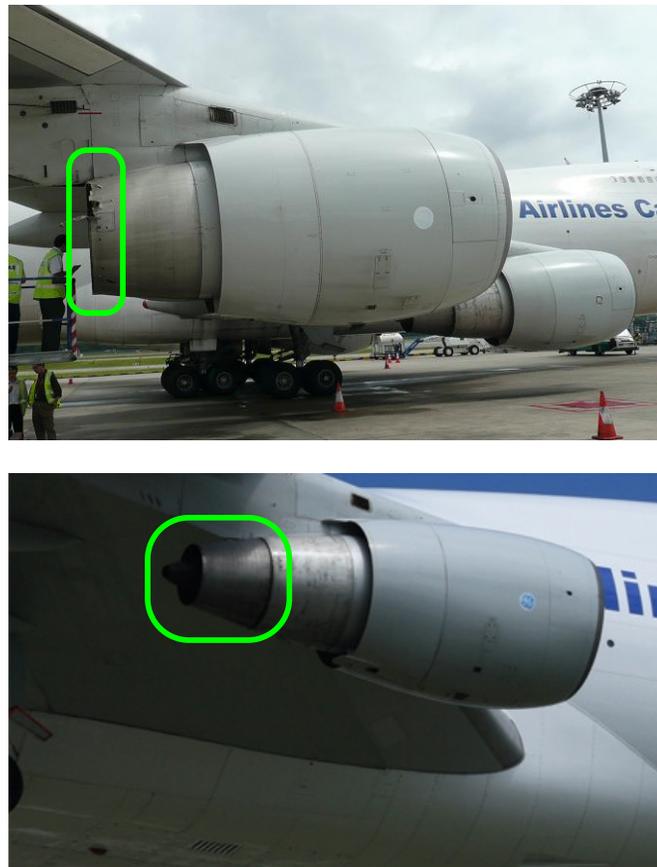
Figure 2. Side view of the damaged No.4 engine (upper picture with missing engine component) and the typical view of an undamaged engine (lower picture)

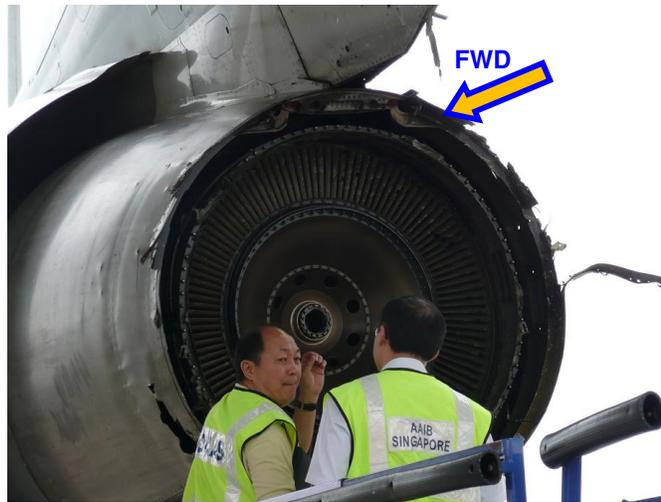
Figure 3. Rear view of the damaged turbine section

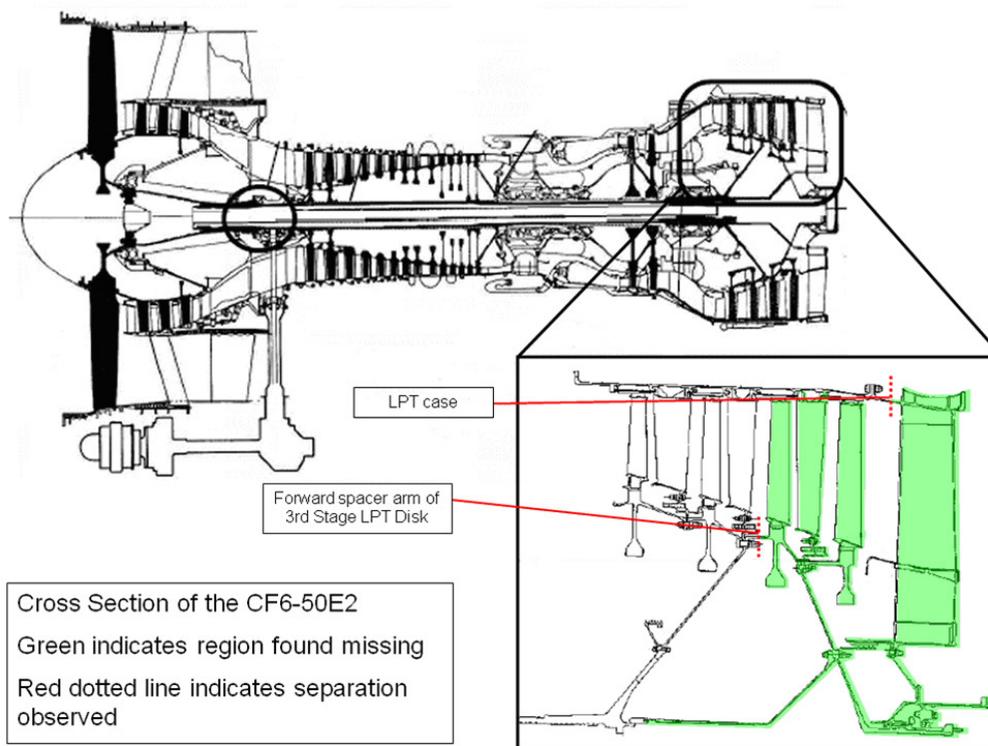
- 1.2.2.2 The S3 LPT disk forward spacer arm was separated circumferentially 360° at the intersection of the spacer arm and the S3 LPT disk forward flange (see **Figure 4**).

Figure 4. Separation of S3 LPT disk

- 1.6.2 Metallurgical analysis of the S3 LPT disk fracture surfaces showed that multiple high-cycle, high-amplitude fatigue (HAF) cracks had initiated around the forward spacer arm. The cracks linked together, forming a circumferential crack that resulted in the separation of the disk.

2.1.1 The circumferential fracture of the S3 LPT disk forward spacer arm led to the uncontained engine failure to the aircraft.

- 4.3.2 The engine manufacturer introduced a new design of S3 LPT disk through SB 72-1315 in May 2011. This new design is intended to address the S3 LPT forward spacer arm failure. This SB is part of a package of SBs (consisting of SB 72-1316, SB 72-1317 and SB 72-1318) which detailed the introduction of the new disk and formalised the inspection requirements for engines with the new disk installed. The FAA certificated this new-design CF6-50 LPT S3 disk that has improved tolerance to HPT unbalance forces in June 2011.

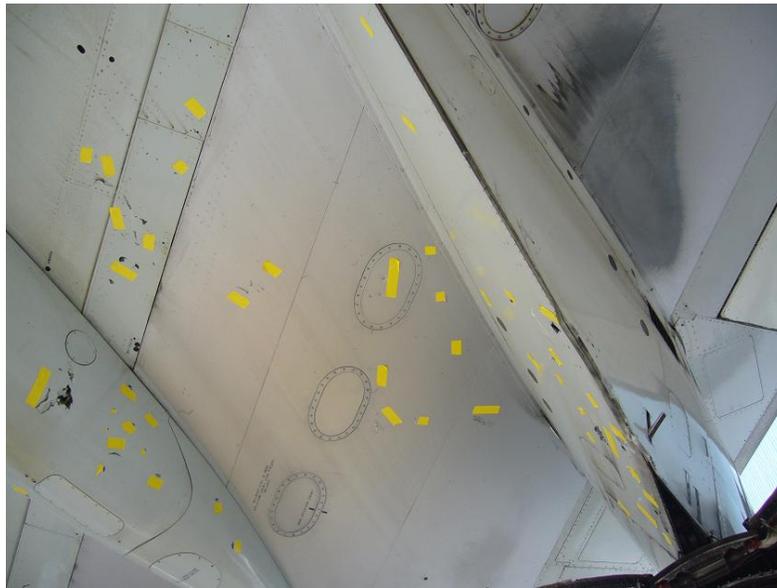
- 1.2.2.3 The S1 LPT and the S2 LPT blades showed blade tip shrouds rub wear that was consistent with stator case outer shroud rubbing.
- 1.2.2.4 Multiple turbine blades debris fragments were recovered from both halves of the engine cowls. There were multiple damages on the No.4 pylon structure; one puncture on the bulk cargo door and one puncture on the right side of the vertical stabiliser (see **Figures 5, 6 and 7**). There were also multiple minor dents and punctures on the lower surface of the right hand wing. An under-wing fuel tank access panel inboard of No.4 engine was also punctured resulting in some fuel leakage.

Figure 5. Damage on the No.4 pylon, fuel tank access panel and the lower wing surfaces

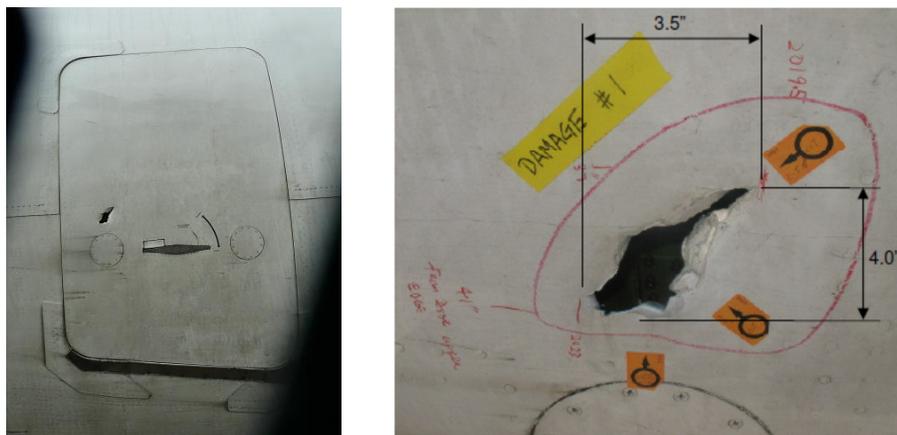
Figure 6. Damage on bulk cargo door

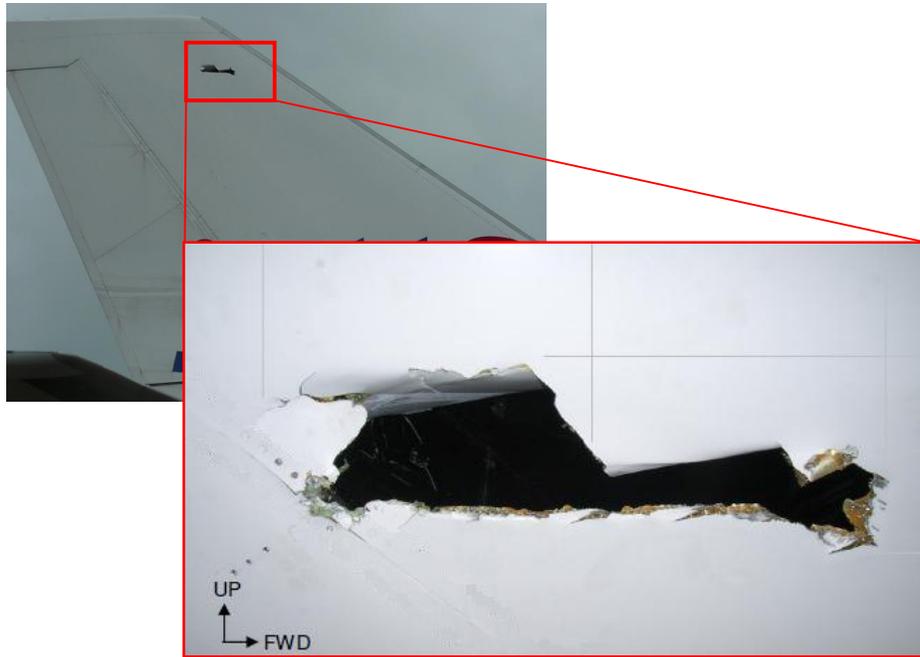
Figure 7. Damage on vertical stabiliser

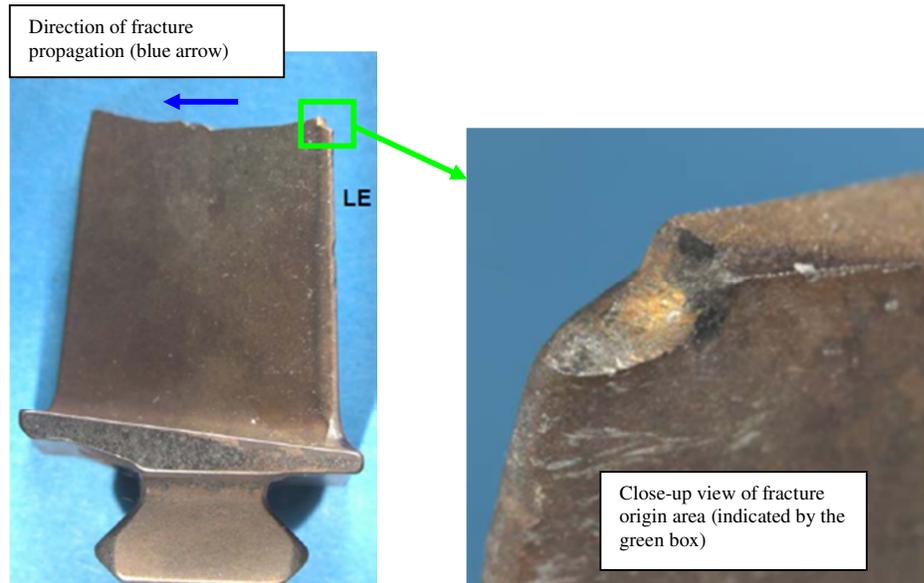
- 1.2.3.1 The HPC airfoils exhibited minor tip curl and burrs from S1 through S8, consistent with stator casing rubbing. One S9 HPC blade was found with a large airfoil portion missing from about 1 inch from the blade platform (see **Figure 8**). Two S10 HPC blades were also found with half of their airfoil missing. There were signs of heavy impact damage on many of the blades of S10 to S14 HPC.

- 1.2.3.2 The damage to the S10 to S14 blades was assessed to be a consequence of the impact with the airfoil debris from the broken S9 HPC blade. The remainder of the S9 HPC blade with a large airfoil missing was sent for metallurgical examination, which revealed that the S9 HPC blade had fractured from the leading edge area and that the fracture had propagated with features consistent with high cycle fatigue (HCF). The fracture origin area was found to have been damaged and it was not possible to determine exactly how the fracture had originated. There is no evidence of any foreign material at the fracture origin area.

Figure 8. S9 HPC blade showing fracture origin area and direction of fracture propagation (indicated by blue arrow)

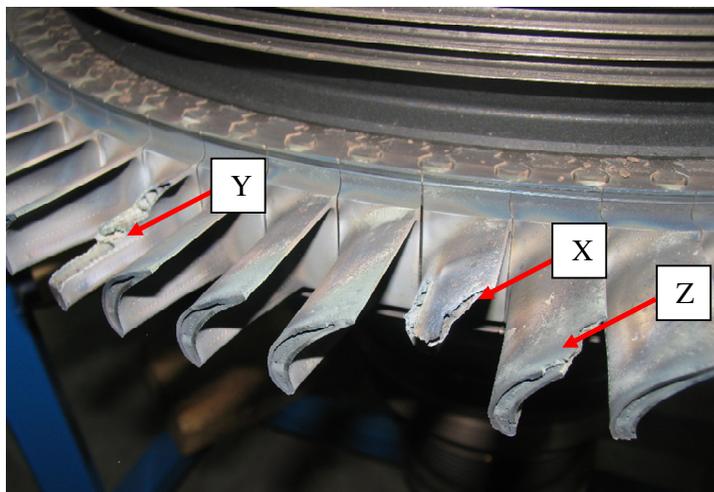
- 1.2.4.1 Two of the S1 HPT blades (marked 'X' and 'Y' in **Figure 9**) were found with more than 50% airfoil loss. These two blades were not adjacent to each other and were in fact separated by three undamaged blades. For the blade marked 'X', the airfoil loss was from blade tip to mid-section. For the blade marked 'Y', the airfoil loss was along the trailing edge area. The damage to these two blades did not appear to have arisen from impact as otherwise the three blades that were in between would almost certainly be damaged as well.

Figure 9. Two broken S1 HPT blades (marked 'X' and 'Y') with more than 50% airfoil loss

1.2.4.2 The S1 HPT blade (marked 'Z' in **Figure 9**) that was adjacent to blade X sustained damage on the trailing edge area. Thirteen of the S1 HPT blades were found damaged with nicks, oxidation or cracks (see **Figure 10**). The rest of the S1 HPT blades appeared to be normal (see **Figure 11**), although erosion consistent with normal wear-and-tear had started on some blades (see **Figure 12**).

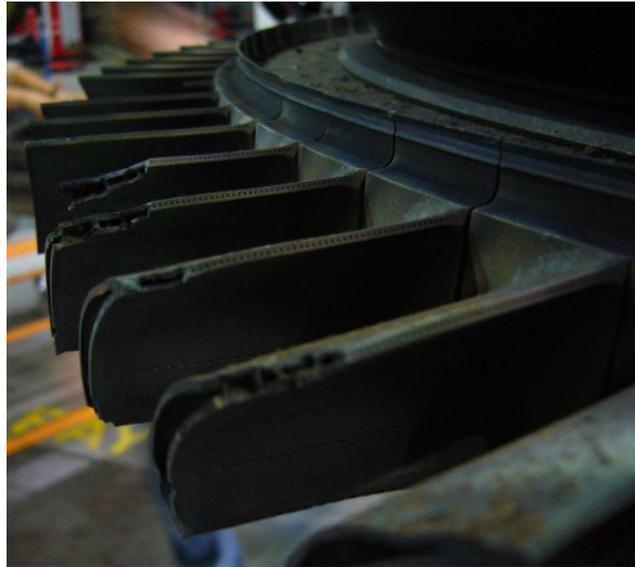
Figure 10. Some of the thirteen S1 high pressure turbine (HPT) blades found damaged with nicks, oxidation or cracks

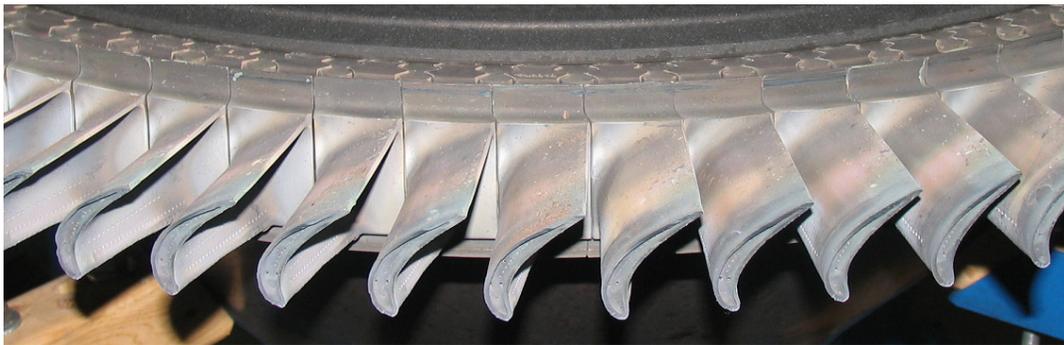
Figure 11. No signs of damage on the rest of the S1 HPT blade

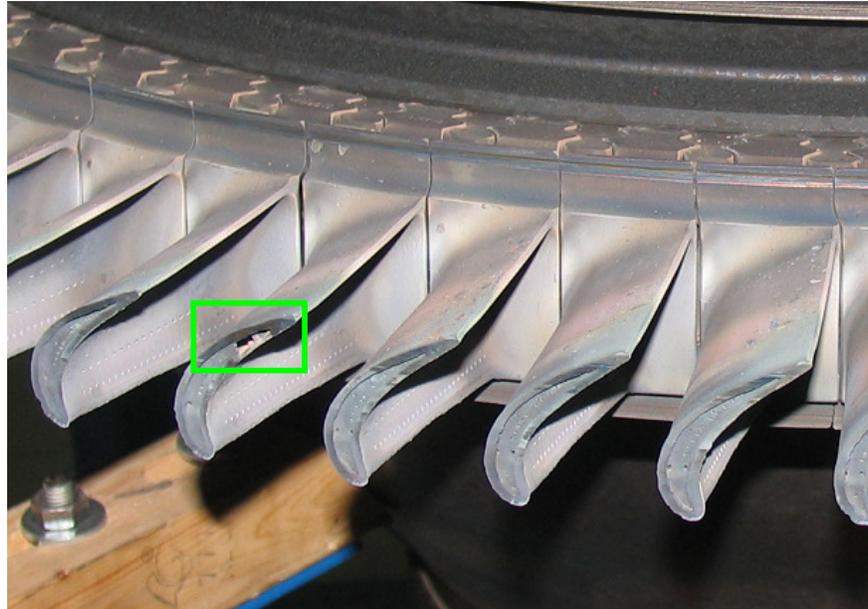
Figure 12. Signs of erosion initiating on a S1 HPT blade (indicated by the green box)

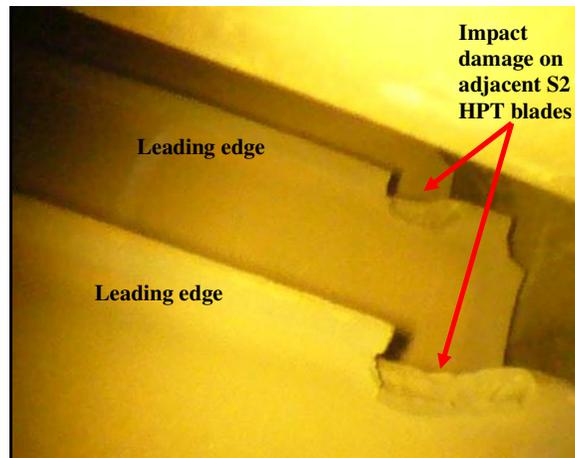
- 1.2.4.3 Seventy-nine S2 HPT blades were found to be broken, with evidence of impact on the leading edges (see **Figure 13**).

Figure 13. Borescope inspection image showing impact damage on the leading edges of the S2 HPT blades

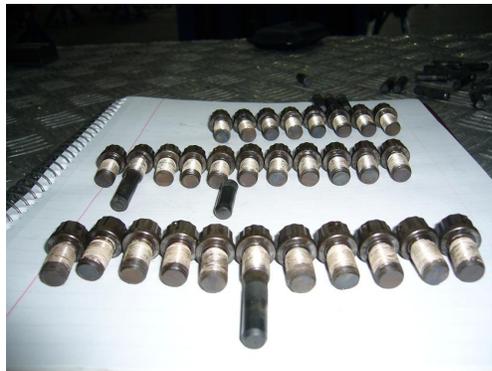
- (b) There was evidence of vibration-induced fatigue damage on components fitted on the engine, indicating the presence of prolonged cyclic vibration. An example is the 28 (out of 30) combustor mount pins that were found broken and which showed fatigue wear on the broken surfaces (see **Figure 14**).

Figure 14. Broken combustor pins exhibiting fatigue wear

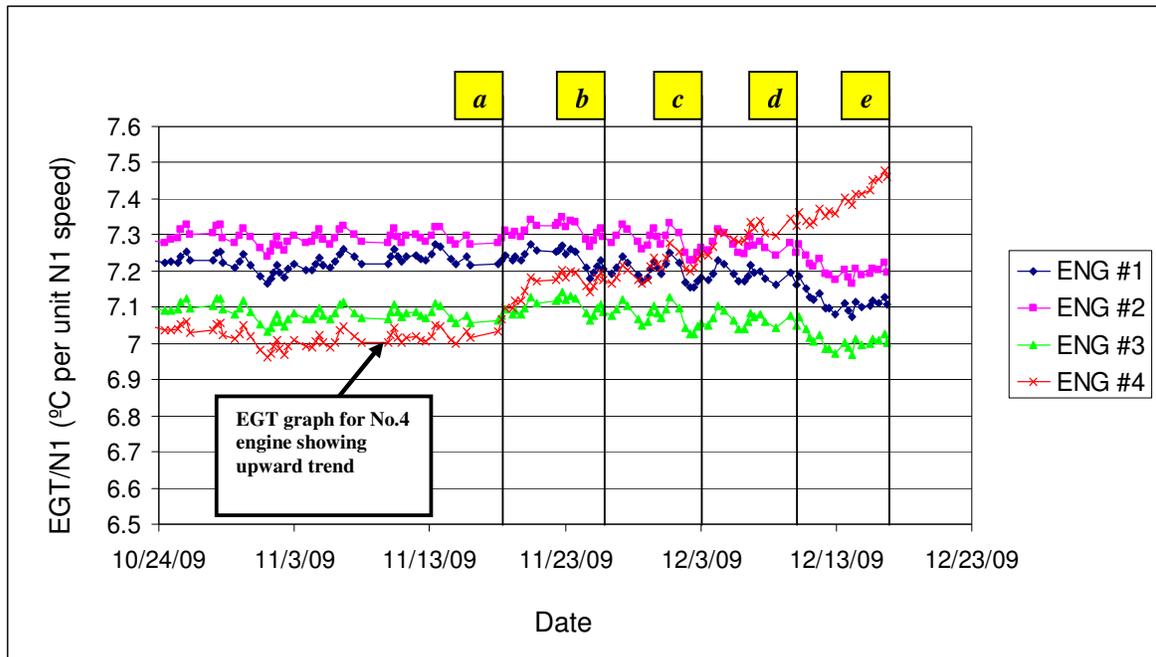
- 1.8.14 **Chart 1** shows the time history of the observed EGT trends of the four engines of the aircraft and the EHM recommendations.

Chart 1 shows EGT trends for 9V-JEB's four engines:

- a* – (19 November 2009) First observation of EGT spike for the No.4 engine
- b* – (26 November 2009) EGT uptrend confirmed with recommendation for an EGT indication check
- c* – (3 December 2009) Continued upward shift of EGT, recommendation given for an EGT indication check and a BSI of the HP section
- d* – (10 December 2009) Continued upward shift of EGT, another recommendation given for the EGT indication check and the BSI of the HP section
- e* – (17 December 2009) Failure event
