FINAL REPORT

BOEING 737-900, REGISTRATION PK-LHQ WIND INCIDENT, CHANGI AIRPORT 26 MAY 2013

AIB/AAI/CAS.093

**Air Accident Investigation Bureau of Singapore
Ministry of Transport
Singapore**

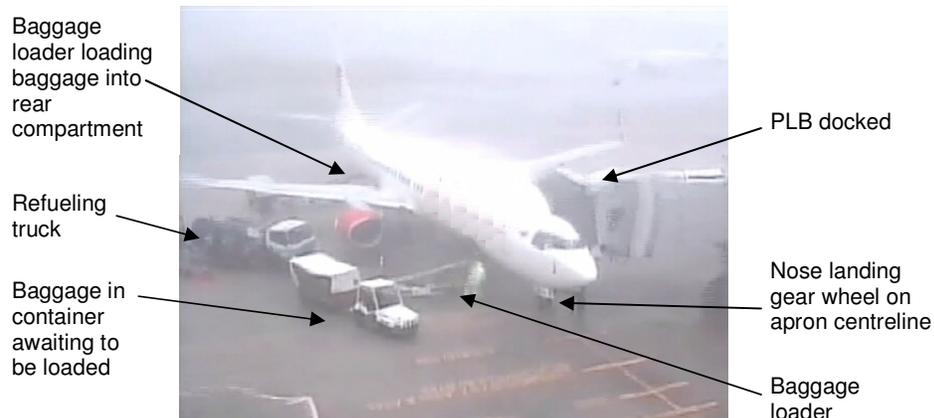
Figure 1: Positions of aircraft, PLB, baggage loader and refueling truck

- 1.1.1 At about 1342 hours on 26 May 2013, a Boeing 737-900 aircraft taxied to its designated gate at Bay C17 after landing at Changi Airport. The aircraft was scheduled to depart at 1450 hours. There was no aircraft parked on adjacent bays.

- 1.1.4 Two baggage loaders were parked on the right side of the aircraft, one each at the front and rear baggage compartments, for the loading of the baggage. After the arrival baggage had been offloaded, the GHA commenced the uploading of 50 pieces of departure baggage into the rear baggage compartment. The front baggage compartment was empty at that time and remained empty until the incident. Refueling was also being conducted simultaneously. The refueling truck was parked beside the No.2 (i.e. right) engine. The positions of the aircraft, PLB, baggage loaders and refueling truck before the incident are as shown in **Figure 1**.

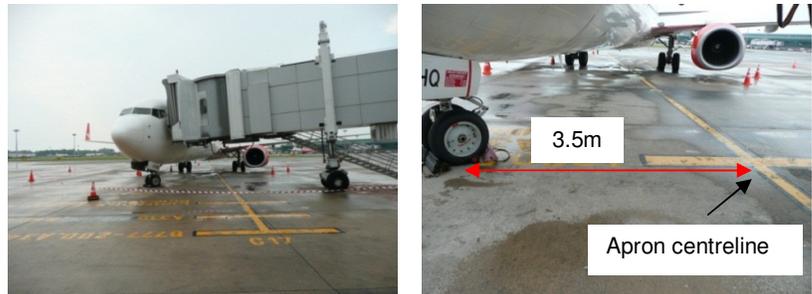
Figure 2: Resting position of the aircraft

1.1.5 At 1400 hours, it started to rain heavily. The rain was accompanied by winds up to about 26 knots. At about 1405 hours, the wind caused the aircraft nose to swing to the right (i.e. away from the PLB), with the aircraft pivoting about the right main landing gear (MLG). The aircraft nose swung through a distance of about 3.5 m from the apron centerline (see **Figure 2**). The NLG also rotated about 30° to the right about its own axis (see **Figure 3**). At the time of the incident, the parking brakes were not set¹.

- 1.3.1 The swinging of the aircraft nose caused Door 1L to hit the PLB canopy. A door hinge was damaged and the door could not be closed. The PLB sustained minor damage.
- 1.3.2 The aircraft also hit the baggage loader at the front baggage compartment. The baggage loader went under the aircraft fuselage and caused a 90-cm scratch and dent at the bottom of the fuselage. The baggage loader sustained minor damage.

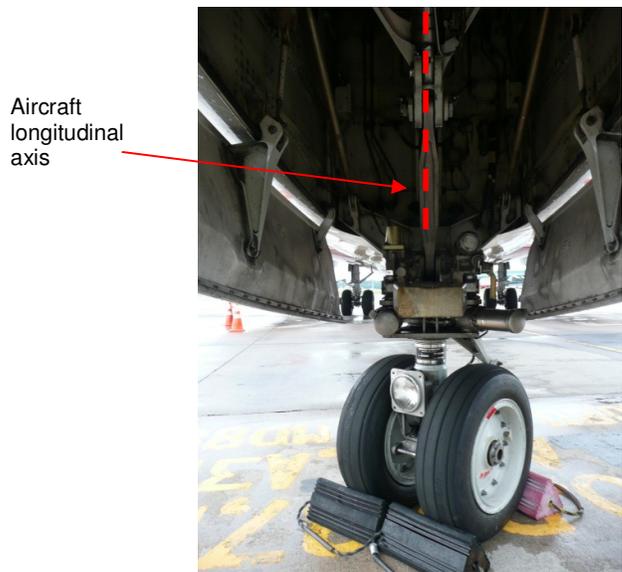
Figure 3: Rotation of NLG wheel (viewed from nose towards aft)

- 2.5 Had the NLG steering bypass pin not been inserted, the nose wheels would have remained aligned with the aircraft longitudinal axis (i.e. facing forward) and the wheels' resistance to sliding could have contributed towards countering any tendency of the aircraft nose to swing.

- (a) Eight wheel chocks (configuration as per **Figure 5**) should be inserted for transit aircraft when the wind intensity is below 35 knots.
- (b) Baggage should be loaded into the front baggage compartment first.
- (c) The nose landing gear steering bypass pin should only be inserted when the tow bar is about to be connected with the aircraft.

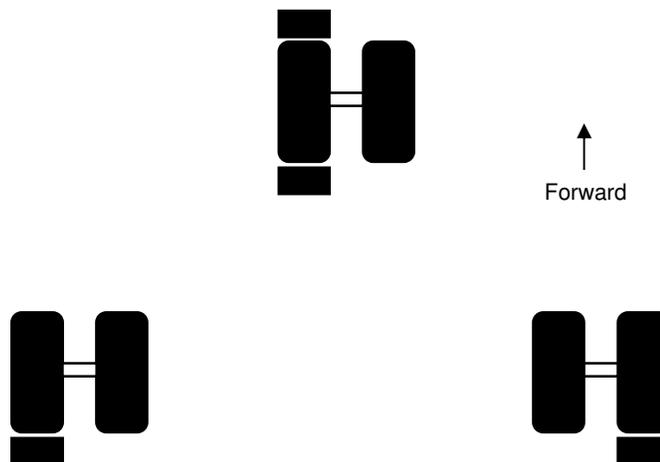
Figure 4: Actual wheel chock positions on incident aircraft

1.5.3.2 When the aircraft taxied into Bay C17, the GHA placed four chocks against the wheels; one each at the front and back of the NLG, and one at the back of each MLG (see **Figure 4**). It was GHA's default configuration for the wheel chock positions for narrow body aircraft such as the incident aircraft², unless otherwise instructed by the operator.

- 2.4 Thus, the aircraft was vulnerable to being moved by the wind. The shifting might have been preventable had the baggage been loaded in the front baggage compartment, or had wheel chocks been inserted at the front of the MLGs.

- 2.6 Although the number of wheel chocks (four) used is the same, the wheel chock configuration employed by the GHA for the aircraft involved in this incident was different from configuration recommended by the aircraft manufacturer.

- 2.7 While the GHA may adopt a default configuration for the wheel chock positions, it should have made its default configuration known to the operator and ascertained if the configuration was acceptable to the operator.

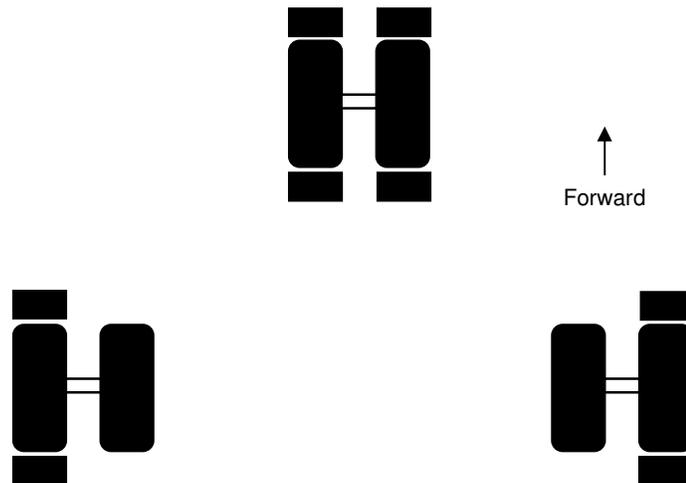
Figure 5: Wheel chock positions as per operator's Quality Assurance Notice

- 1.5.3.3 According to the aircraft manufacturer, the minimum wheel chock configuration comprises one chock each at the forward and aft of one tyre (either inboard or outboard) of each main landing gear (i.e. total of four wheel chocks).
- 1.5.3.4 According to the station manager of the operator, the operator required six wheel chocks to be inserted (one each at the front and back of each landing gear) instead of four. This requirement was apparently not conveyed to the GHA.
- 1.5.3.5 Arising from past incidents where aircraft were inadvertently moved during adverse weather, the operator issued a Quality Assurance Notice dated 21 March 2013 to require eight chocks to be inserted for transit aircraft parked in less than 35 knots wind velocity³ (see **Figure 5**). This requirement was apparently not conveyed to the GHA.
