FINAL REPORT

MAN OVERBOARD (LOSS OF LIFE)

FROM SUPPLY BOAT OPL 66

MIB/MAI/CAS.077

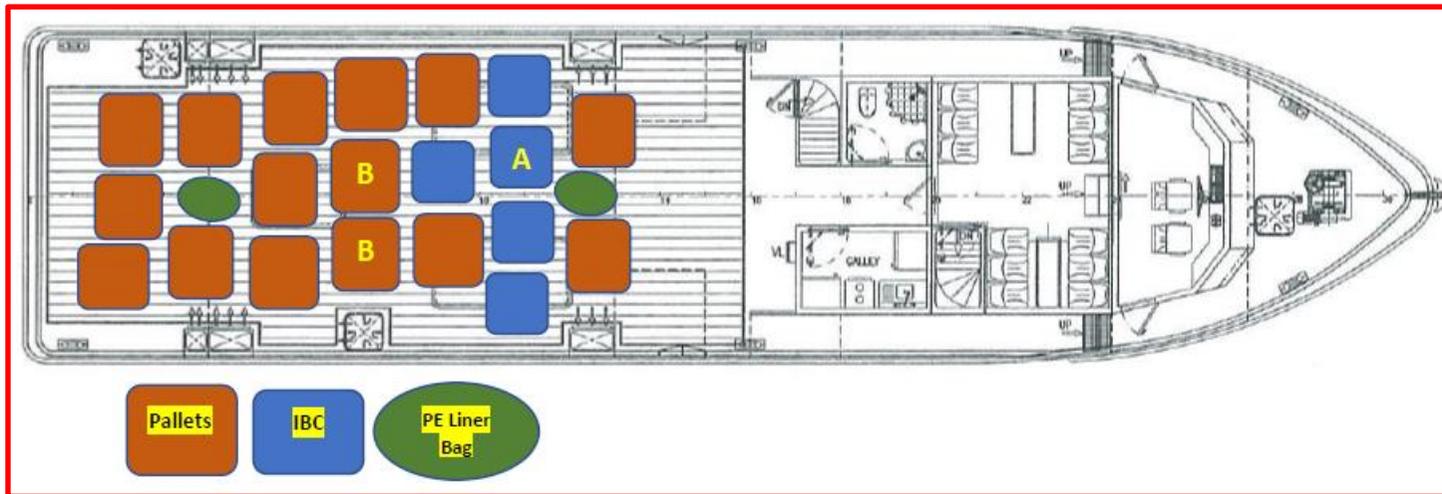
Figure 1: Illustration on the positions of cargo and stores (for FLC) on board OPL 66. Sequence of unloaded cargo denoted as "A" and "B" – *not to scale*. (annotated by TSIB)
Photograph Source: MT Falcon – taken after the occurrence

- 1.1.10 The first lift was an IBC tank at the second row of cargo (indicated as A in **figure 1**), which was uneventful. For the second lift, according to the marine assistant, the Chief Officer of FLC requested¹⁷ for two pallets of stores and provisions (indicated as Bs in **figure 1**) in the fourth row to be lifted together. From the CCTV footage, the investigation team noted that both the engineer and marine assistant had climbed on top of the cargo. According to the marine assistant, the duo was struggling to put the slings of the two pallets onto the crane hook while holding on to the safety latch of the crane hook.

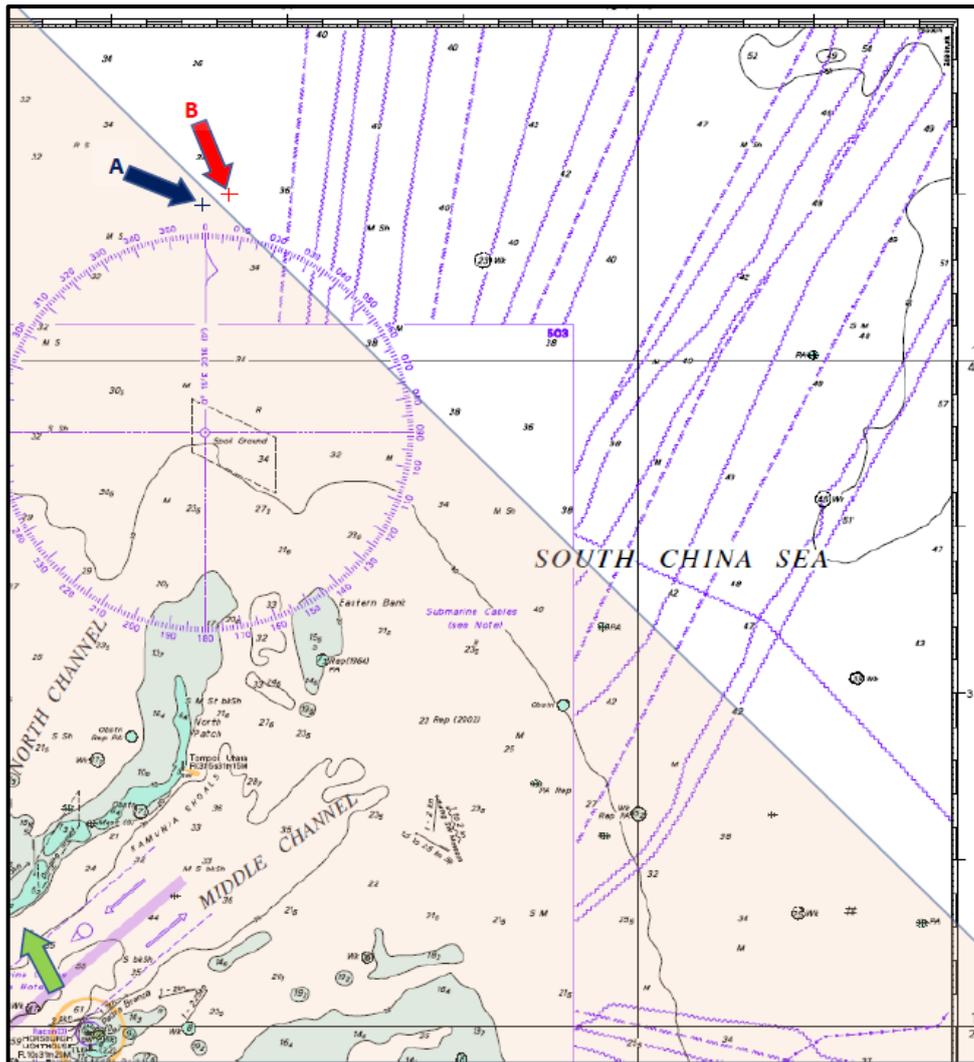
Figure 2: Blue crosshair indicates FLC's initial anchored position. The Red crosshair indicates FLC's shifted anchored position. The shaded area shows the Special Limit Voyage Limits (annotated by TSIB) – not to scale

⁹ The investigation team noted that on 25 December 2019, FLC had shifted its anchored position to a new position about 1nm NE of position A. This new position (B) was outside the Singapore Special Limit Voyage Limits.

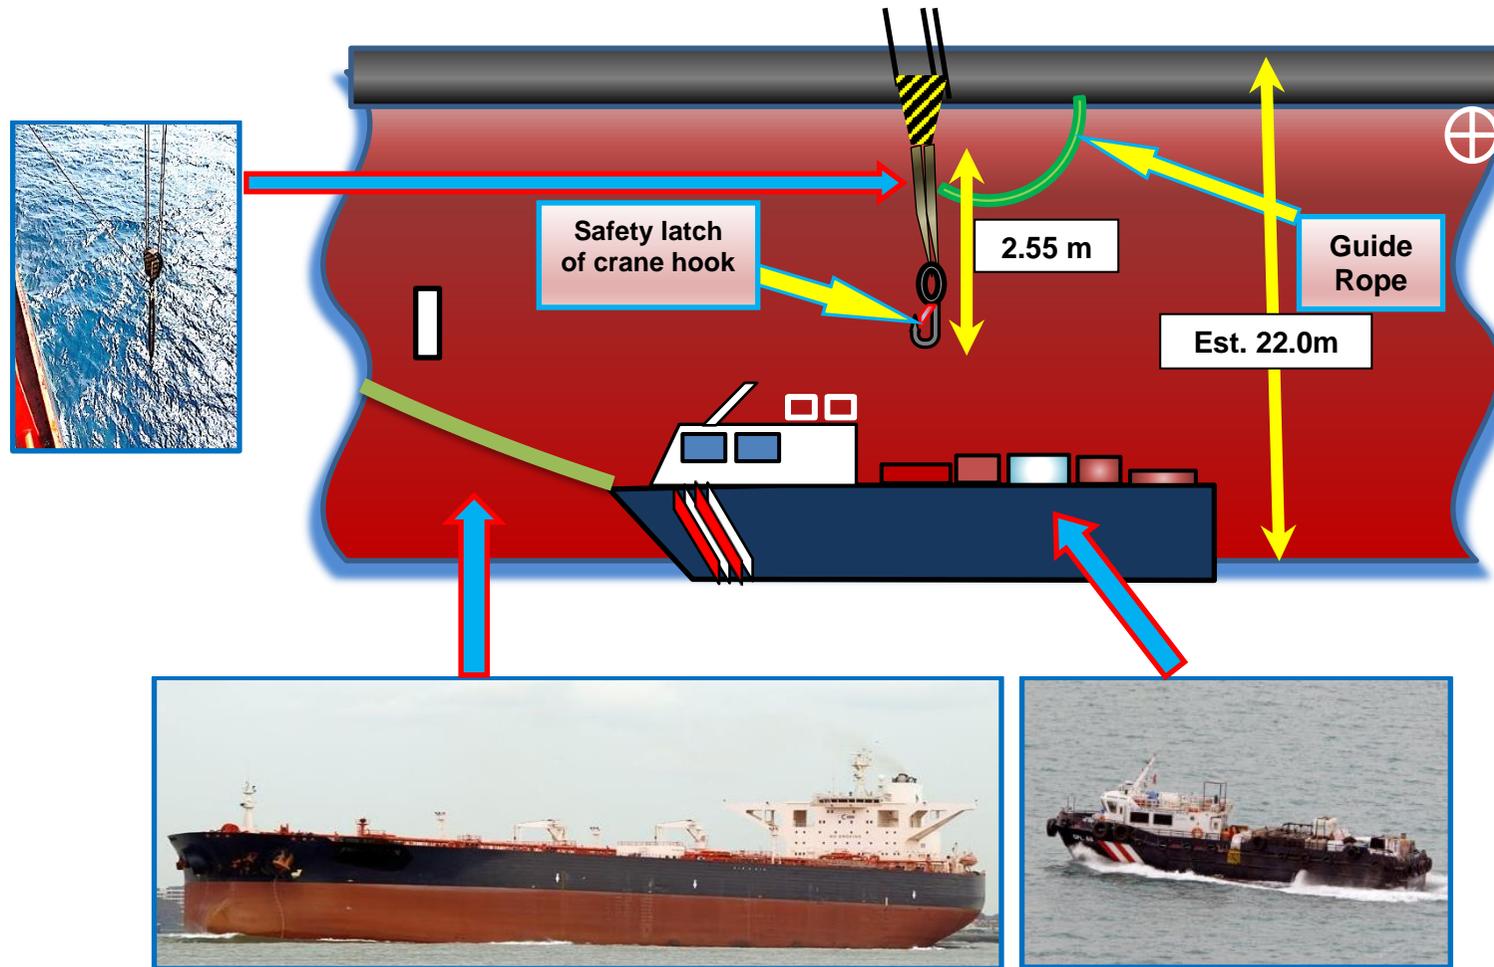
Figure 3: Illustration of the position of OPL 66 when alongside to FLC in preparation for lifting operation – *not to scale*. Lower part of the figure shows the individual images of the two vessels.

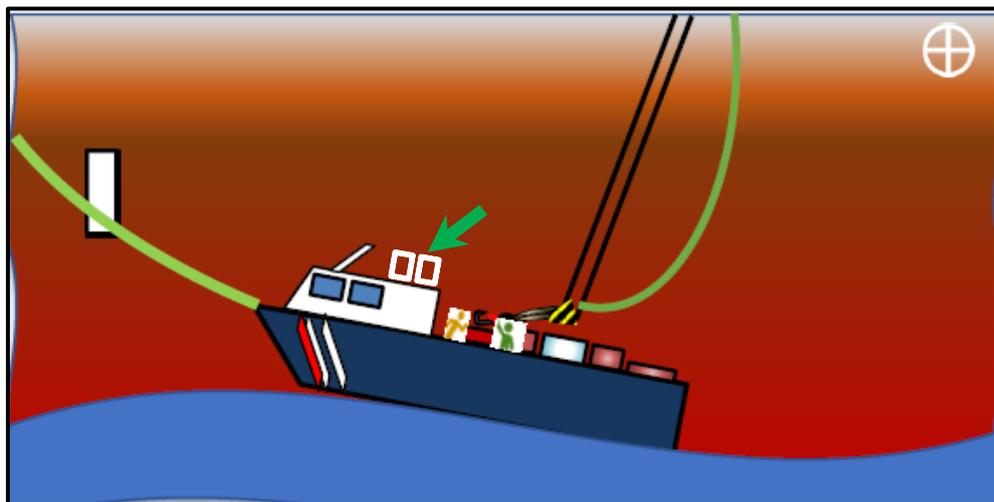
- 1.1.9 Reviewing the CCTV¹⁵ footage from OPL 66, the investigation team noted that OPL 66 was pitching considerably at the time of commencement of the lift, causing the crane hook, and at times the crane block, to rest on the cargo. The engineer¹⁶ and marine assistant were not wearing any personal floatation devices and safety helmets and they were seen balancing themselves while trying to hook up the eyes of the lifting slings onto the crane hook (see **figure 4**) at the same time.

Figure 4: Illustration of the pitching during the first lifting operation with the estimated positions of the marine assistant in yellow and the engineer in green. The green arrow indicates the position of the skipper – *not to scale*.

2.1.1 The CCTV footage captured the pitching condition that OPL 66 was experiencing before the first lift. The sling connecting the crane block and crane hook was about 2m long. Correlating the witness accounts and instances where the crane block was seen resting on the cargo and at times the hook was seen separating from the cargo, it is estimated that the swell height was about 2.5m.

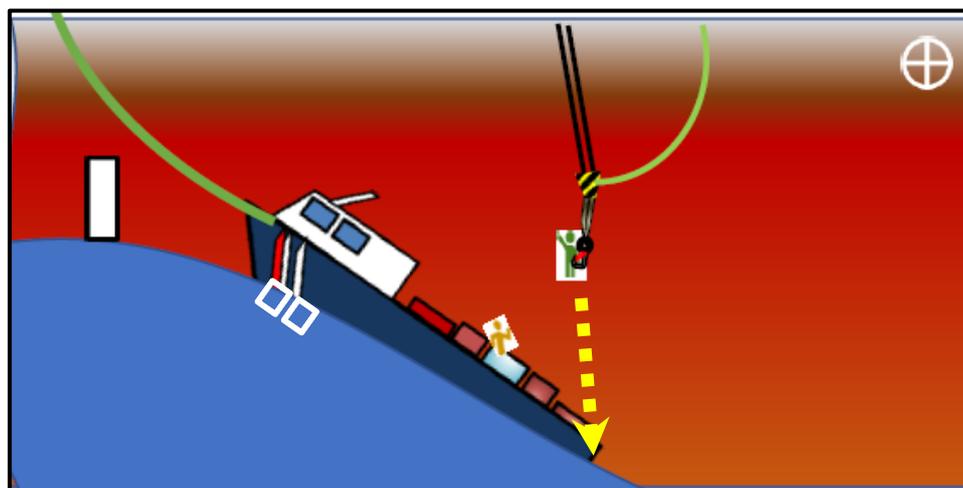
- 1.1.11 According to the CCTV footage, OPL 66 suddenly took a sharp dip at the stern causing the marine assistant to slip on top of the cargo and the engineer was seen to be lifted up with the crane hook and separated (lifted off) from the cargo. Soon after, the boat's stern rose upwards and at the same time, the engineer was seen falling from the crane hook to the deck.

- 1.1.12 According to the marine assistant, there was a loud thump and the engineer was seen landing briefly on the port quarter's gunwale before falling into the sea¹⁸. The skipper recalled losing his footing and slipping on the roof of the wheelhouse as well as losing sight of the crew temporarily when the boat's stern dipped (see **figure 5**).

Figure 5: Illustration of the second lifting operation when the boat experienced a sharp dip at the stern at about 1020H. The yellow-dotted arrow shows the subsequent fall of the engineer into the sea – *not to scale*.

2.1.2 During the second lift, both the engineer and the marine assistant were on top of the pallets of cargo for about two minutes trying to rig the sling to the crane hook before the sharp dip of OPL 66's stern happened. The sharp dip had likely caused the crane hook (which was earlier close to the pallets for securing the eyes of the sling to facilitate the lift) to separate from the pallet. The CCTV momentarily captured the engineer being separated from the cargo (and boat) and then falling about 3m in height (shortly after).

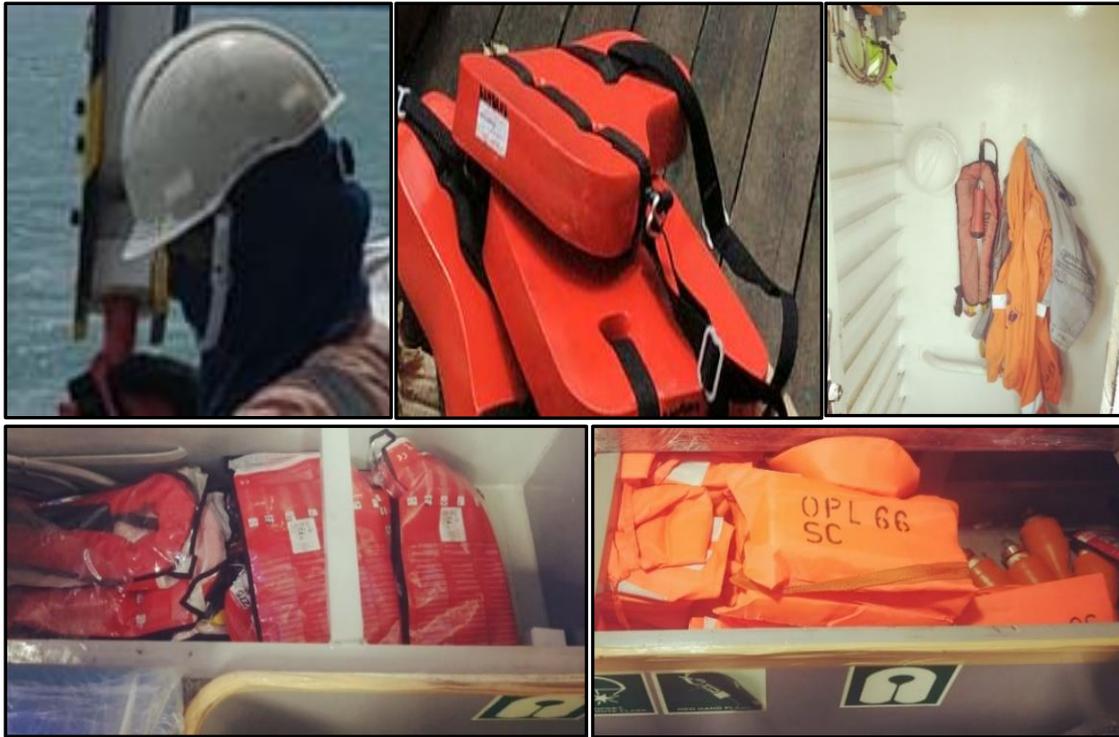
- 1.2.1 The investigation team gathered that each of the OPL boat was provided with three types of personal floatation devices. One of them was a work life-vest available as common stock for the use by their crew. The other two were SOLAS lifejackets as per the LSA²⁴ plan and inflatable lifejackets issued individually to each crew member (see **figure 6**).

- 1.2.2 During the investigation team's interactions, the marine assistant clarified that based on his understanding, the work life-vest was not used, as it hindered cargo lifting operations most of the time and the inflatable lifejackets were meant only for passengers. The safety helmet was not worn by him because it did not come with a chinstrap.

Figure 6: (Clockwise from top left)
Helmet with chinstrap, work life-vests used on the boats, the PPEs - inflatable lifejacket and clothing of the deceased (engineer) hanging at the engine room access (post incident),
SOLAS lifejackets as per the LSA plan and additional inflatable lifejackets for passenger transfers under the passenger benches of OPL 66
Source – the Operator

- 2.3.3 The Operator had provided the PPE on board but there was no process in place to mandate its usage. A PPE matrix to indicate the minimum PPE to be worn under varying conditions of operations of the craft would have been useful for the crew to comply with. Accordingly, regular training and RA briefings should also be recorded, which could serve as a reminder to the crew of the importance of the PPE.

5.1.1 To review the SOP to include a PPE matrix for varying conditions of operations, such as loading/unloading and personnel transfers. **[TSIB-RM-2021-005]**

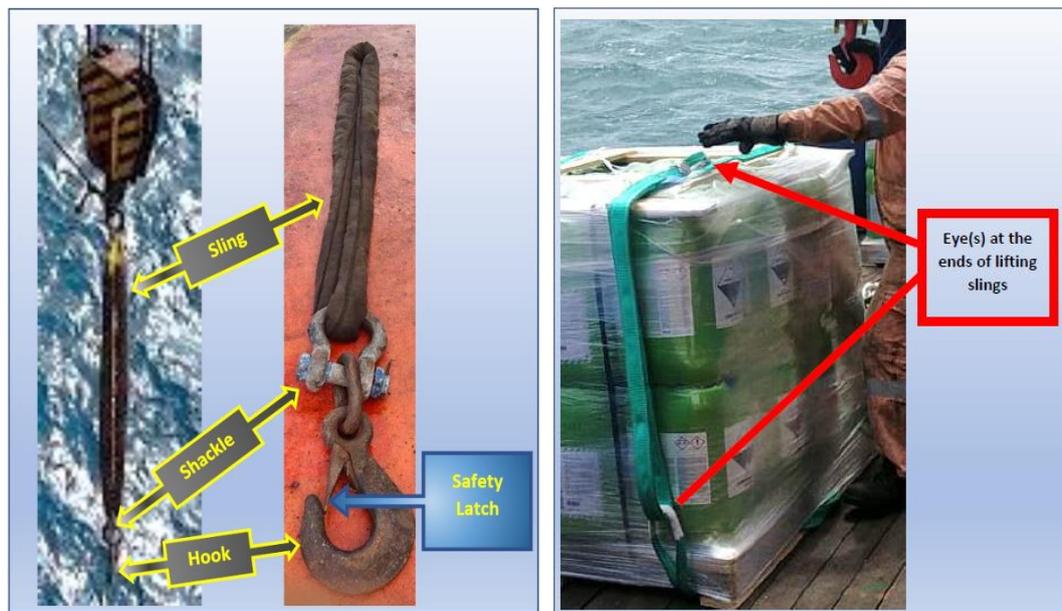
1.4.1 FLC's crane block was connected to a sling (approximately 2m in length) via a D-Link shackle. The other end of the sling was connected by a shackle to the hook which had a spring-loaded safety latch (see **figure 7**).

Figure 7: Lifting equipment arrangement of FLC. The lifting sling used by OPL 66 (right) for pallet and IBC tanks. The image (on the right) is for reference only and does not indicate the pallets in use at the time of occurrence – annotated by TSIB.
