# **FINAL REPORT**

## **PIPER PA34-220T SENECA III, REGISTRATION 9M-RBI LANDING ACCIDENT IN SELETAR AIRPORT 1 JANUARY 2016**

**AIB/AAI/CAS.120**

**Transport Safety Investigation Bureau  
Ministry of Transport  
Singapore**

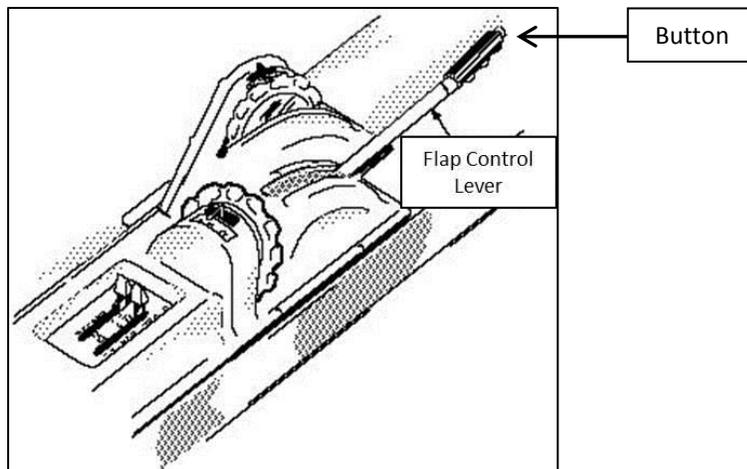
Figure 1. Flap control lever

- 1.1.7 For the go-around, the PIC applied full power and increased the aircraft pitch. He tried to retract the flaps but he could not depress the button (plunger plug). The flaps were stuck at 40°. This caused drag on the aircraft and the PIC decided to raise the landing gears to reduce drag. He raised the landing gears without first verifying that the aircraft was having a positive climb<sup>3</sup>. Despite all this, the aircraft sank. The PIC attempted to lower the gears again. The aircraft contacted the runway before the landing gears could be extended again and the aircraft came to a halt eventually.

2.8.1 The PIC indicated that he could not depress the button (plunger plug) to change the flaps setting when he carried out the go-around. However, the operation of the button appeared normal during post-accident tests of the flap. The investigation team is unable to determine the reason for the difficulty experienced by the PIC.

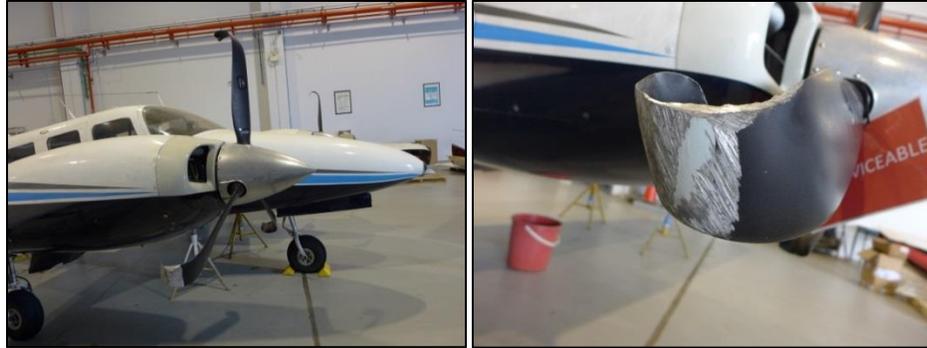
- 1.3.1 The propellers on both engines were curled and the belly area of the aircraft was damaged.
- 1.3.2 The tips of all three propeller blades on each engine were bent forward (**Figure 3**). This suggests that the propeller was being driven under positive power from the engine and that the propeller revolutions per minute (RPM) is relatively high<sup>4</sup>.

Figure 3. Propeller tip bent forward

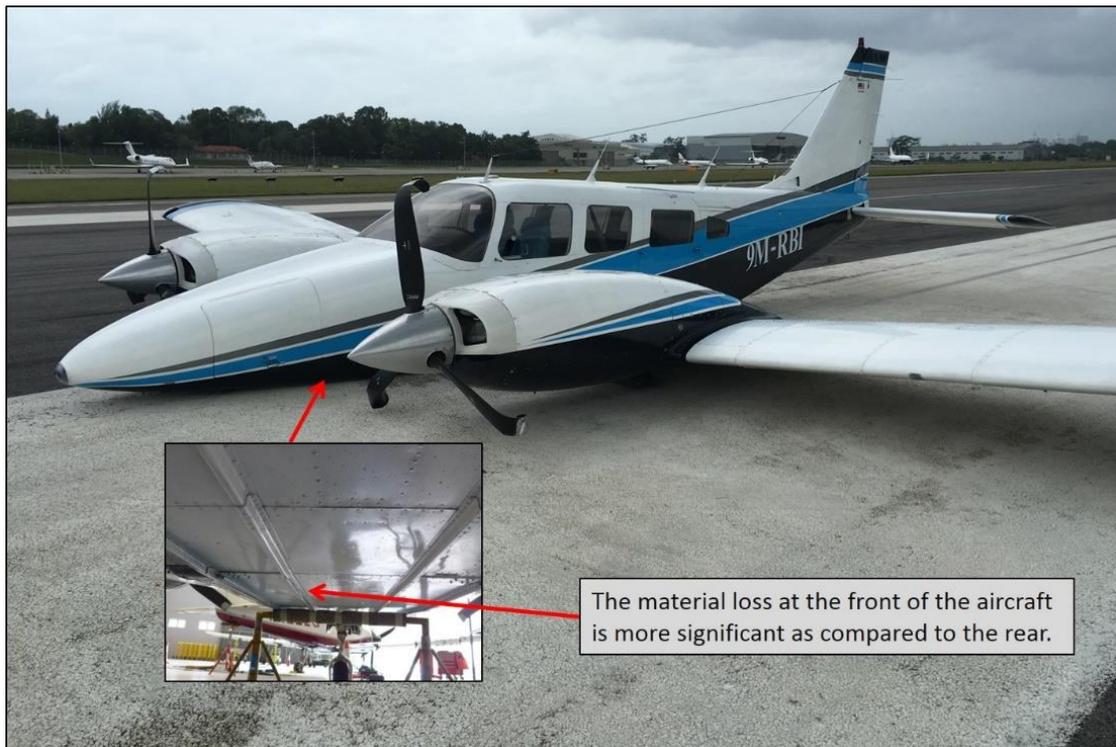
- 1.3.3 The material loss at the aircraft's belly area due to the aircraft's contacting the runway was more pronounced at the front of the aircraft than at the back (Figure 4).

Figure 4. Damage at the belly of the aircraft

2.4.2 The rear of the aircraft was not damaged and the abrasions in the belly area were limited which suggested that the impact energy was low. In addition, the abrasions in the belly area were more pronounced in the front than the rear area. This indicates that it is very likely that the front part of the aircraft had contacted the runway before the rear. This is consistent with a flat aircraft pitch attitude, which is not a normal aircraft configuration during landing. In a normal landing configuration, the aircraft is pitched at a nose up attitude to flare for landing. The nose up pitching would normally result in the main landing gears contacting the runway before the nose landing gear. A belly landing situation would have caused more damage at the rear due to the higher energy impact and more abrasion at the rear of the belly. Should the aircraft come in with landing gears retracted during the first approach; the

2.5.1 As regards the attitude of the aircraft at the moment of the belly contact with the runway, the damage at the belly area suggests that the aircraft did not have much of a positive attitude, if it had a positive attitude at all.

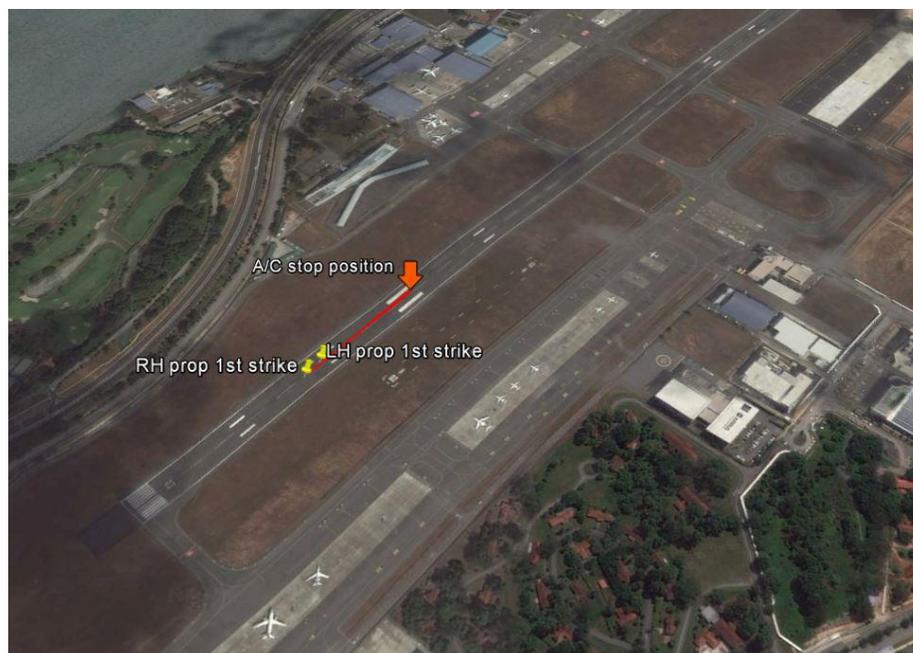
1.6.1 The aircraft came to a rest about 600m from the start of Runway 03, with a heading of about 030° (i.e. in the direction of Runway 03). There were ground marks on the runway of the right and left propellers. **Figure 5** shows the positions of aircraft and the ground marks.

Figure 5. Showing the positions of aircraft final stop; first strike marks of right propeller and the left propeller.

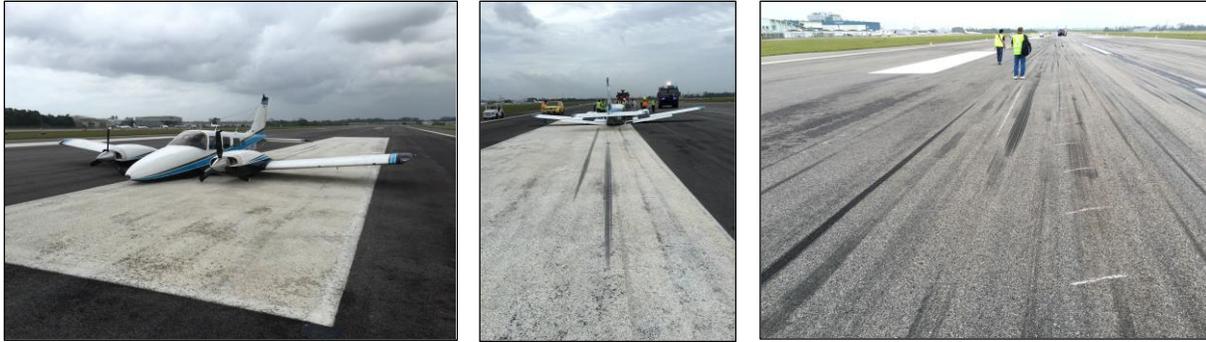
1.6.2 The propeller ground marks suggested that right propeller had struck the runway tarmac before the left propeller (**Figure 6**).

Figure 6. Position of the aircraft and impact marks

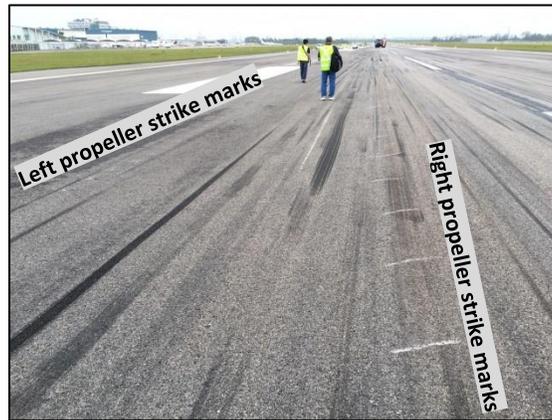
- 1.6.3 The distance between the right engine propeller first strike mark and left engine propeller first strike mark was 30m (**Figure 7**).

Figure 7. Distance between right and left engines propeller first strike marks (30m)

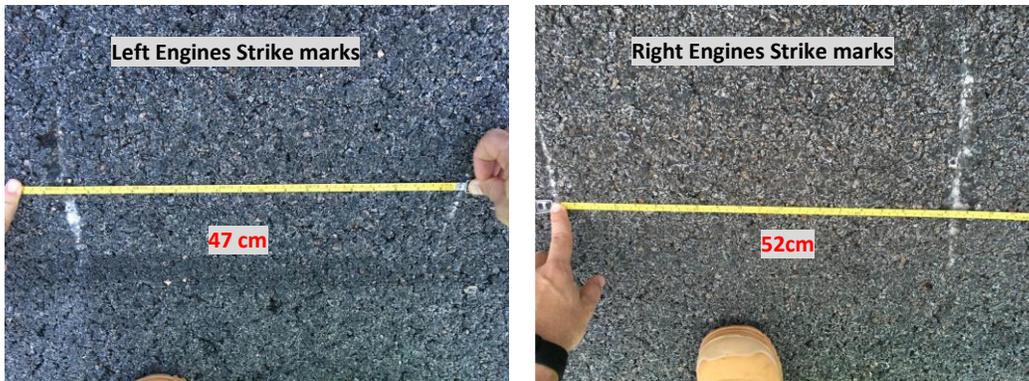
- 1.6.4 The distances between the propeller strike marks for the left and right engines were as follows (**Figure 8**):

- (a) Distance between the first and second strike marks – 47cm
- (b) Distance between the second and third strike marks – 48cm

- (c) Distance between the first and second strike marks – 52cm
- (d) Distance between the second and third strike marks – 55cm

Figure 8. Measurements taken between the propellers for the left and right engines

2.7.2 The aircraft approached Seletar Airport at a speed of about 85kts. The speed would be reduced after the aircraft's bounce on the runway. The application of the full power during the go-around might increase the speed somewhat but the increase is likely to be marginal. If we assume that the speed after the bouncing to be of the order of 80-90kts, then the RPM would be of the order of 1,550-1750 for the right engine and 1750-1950 for the left engine. These RPM values are consistent with the pilot's power application for the go-around.
