FINAL REPORT

RUNWAY INCURSION BY A VEHICLE IN CHANGI AIRPORT 22 JUNE 2016

AIB/AAI/CAS.121

22 March 2017

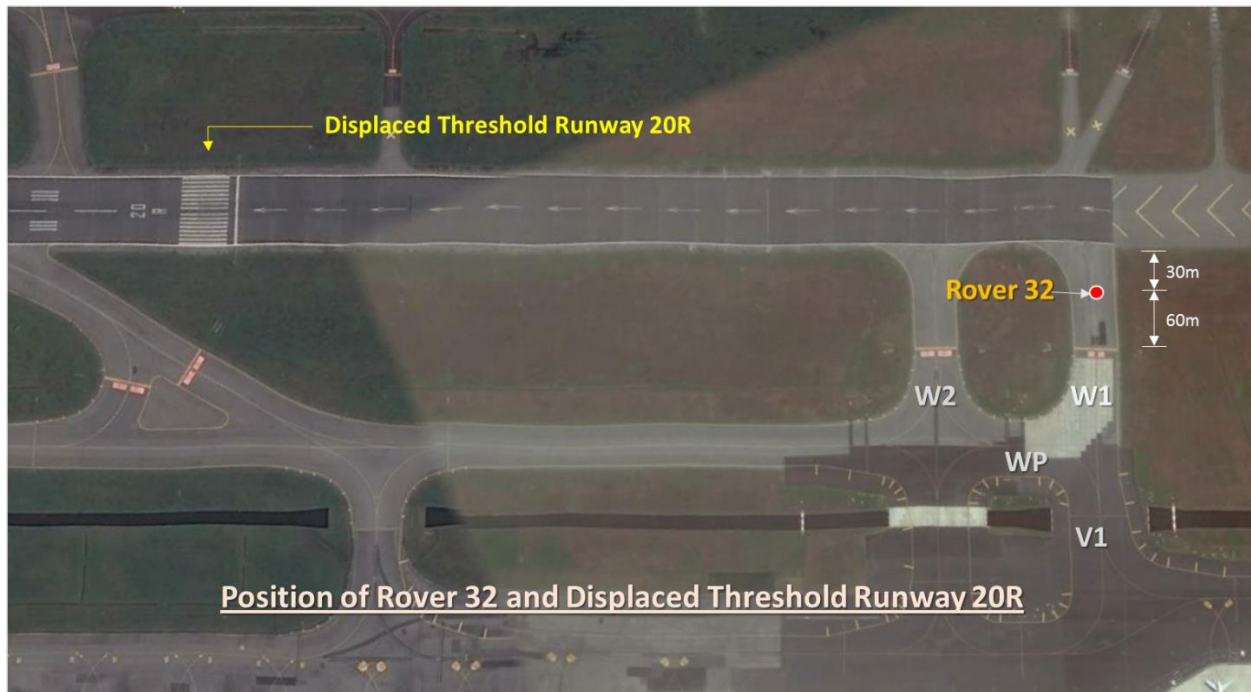
- 1.1.4 According to Rover 32, he unknowingly crossed the runway-holding position at Taxiway W1 as he was focussing on looking out for defects along Taxiway V1 and W1 and thus missed the instruction markings painted on the taxiway pavement, the stop bar lights and the runway guard lights. At its furthest Rover 32 was about 60m beyond the runway-holding position at Taxiway W1 but was still about 30m from the edge of Runway 20R.

- 1.1.5 The Changi Tower Runway 1 Controller spotted Rover 32 at Taxiway W1. At the same time, the vehicle's infringement of the microwave barrier detector (MBD) of the Airfield Ground Lighting Control and Monitoring System (AGLCMS) at Taxiway W1 triggered an alarm to warn the Changi Tower that there was an intrusion into the protected area of a surface designated for the landing of aircraft. The Runway 1 Controller then instructed Rover 32 to vacate the runway immediately on the ground frequency 121.9MHz. The Tower Coordinator also called Rover 32 on the ground frequency 121.9MHz and reiterated the instructions for the vehicle to vacate the runway. Rover 32 acknowledged the instructions and moved clear of the active runway.

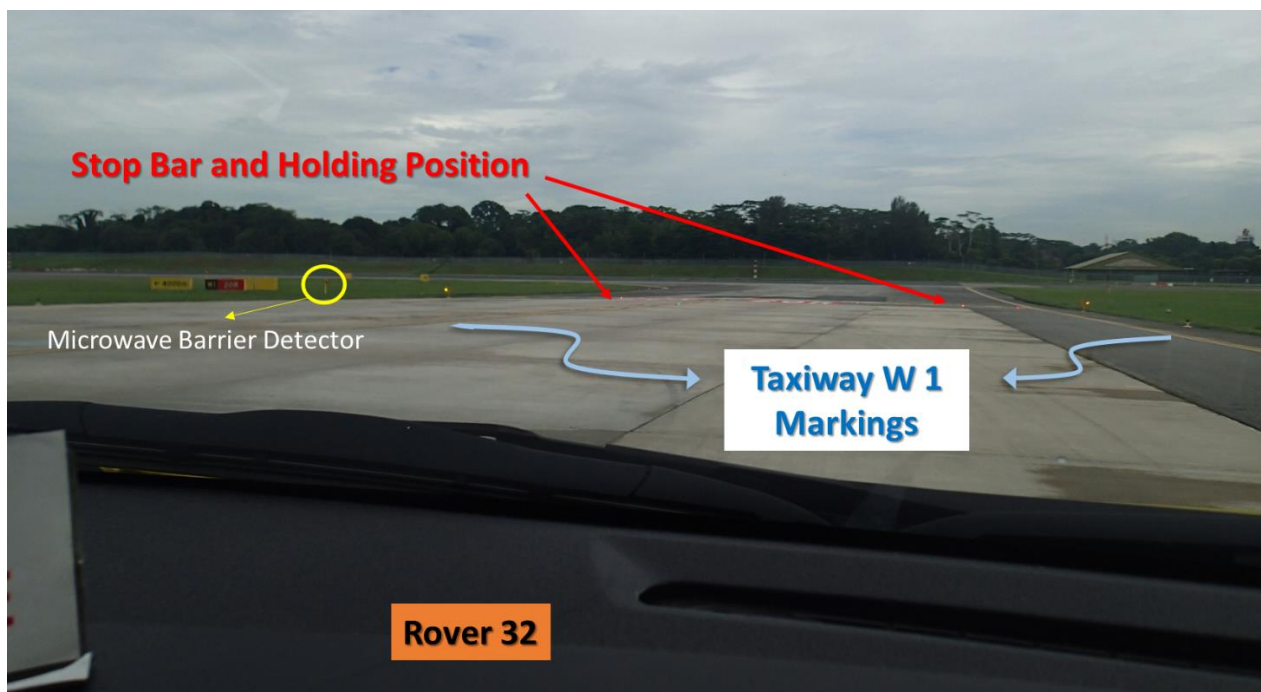
- 2.3.3 It can be quite challenging for a single person to perform the tasks of driving, looking out for aircraft, communicating with Control Tower, and carrying out inspection all at the same time. All these tasks would compete for the same attentional resource of this one person and such a competition could affect a person's situational awareness. Thus, as a result of his focusing on his inspection work, Rover 32 unknowingly strayed beyond the runway-holding position at Taxiway W1.

- 2.3.4 It would be desirable to have another person in the vehicle to share Rover 32's workload.
- 2.4 Use of technology in runway incursion warning system

3.1.1 The AMSP has since 24 June 2016 been deploying two employees for inspections of pavement conditions. One of them will be a CAT 1 ADP holder whose tasks will be to drive in the manoeuvring area of the airport and communicate with Changi Tower. The other person will inspect the pavement conditions, look out for aircraft movement, and help maintain situational awareness. The work description, procedures, roles and responsibilities for Rover 32 and his assistance have also been revised accordingly in the AMSP document *Method of Statement*.
