# **FINAL REPORT**

## **RUNWAY INCURSION BY RUNWAY SURFACE FRICTION TESTER SINGAPORE CHANGI AIRPORT 4 APRIL 2013**

**AIB/AAI/CAS.090**

**Air Accident Investigation Bureau of Singapore  
Ministry of Transport  
Singapore**

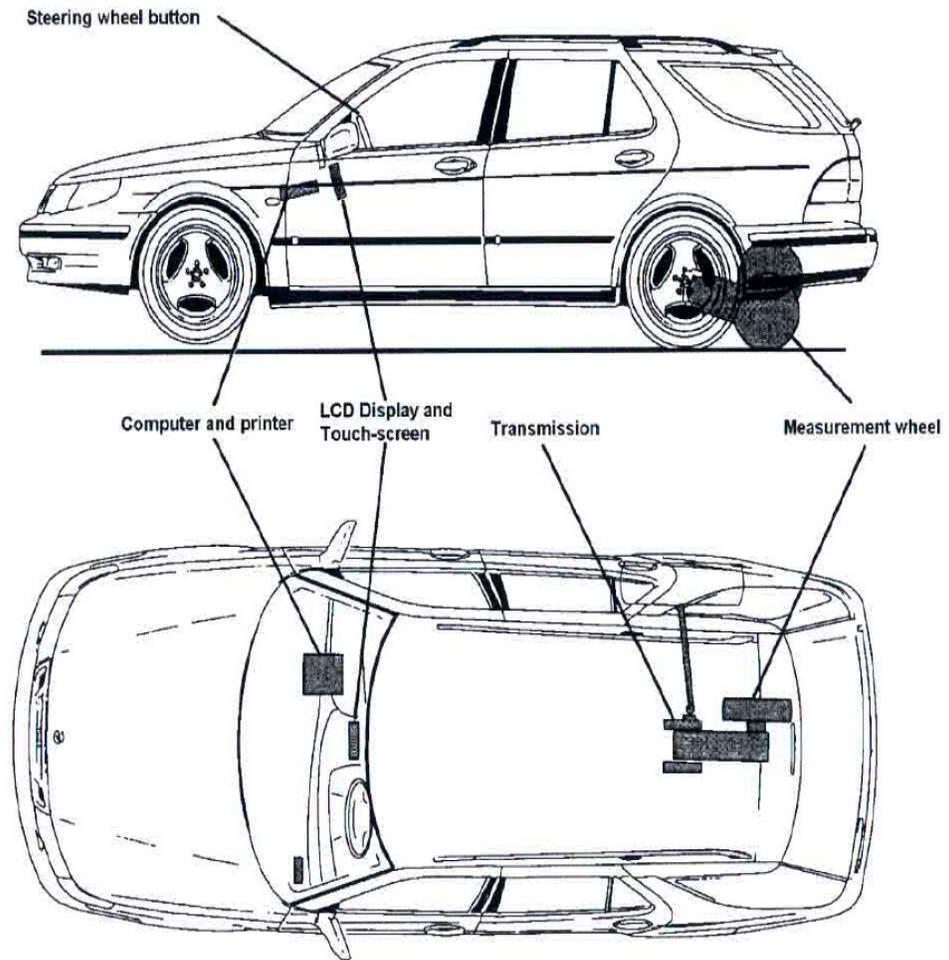
**Figure 1.** Surface Friction Tester

- 1.3.1 The runway friction tester is a car that is equipped with a system for measuring a surface's friction coefficient (see **Figure 1**). This friction tester is used for runway friction measurement in both Changi and Seletar Airport.

*Position of measurement equipment in the car.*

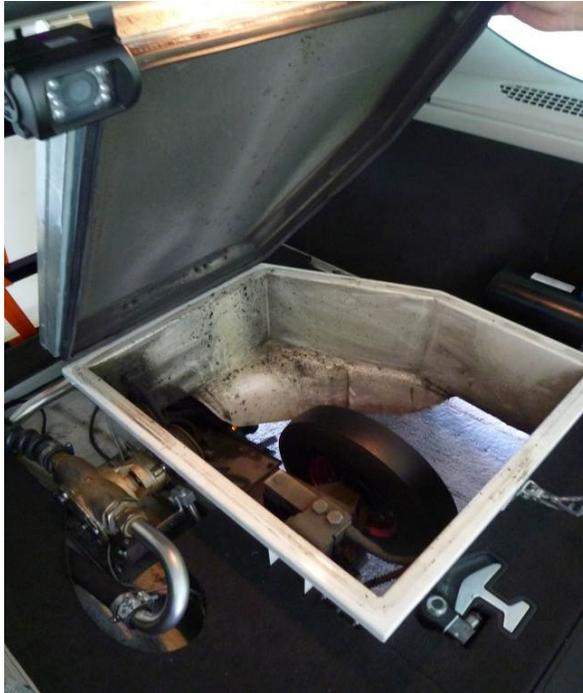
**Figure 2.** Measurement wheel

- 1.3.3 The friction measurement equipment includes a measurement wheel at the rear of the vehicle. The part of the measurement wheel system that is inside the cabin of the vehicle is boxed up with a cover (see **Figure 2**). There is also a water tank from which water will be metered out to just in front of the measurement wheel, to simulate a 1 mm depth of water on the runway. The instruments for the control of the operation of the equipment are within the driver's reach from his seat. Thus, the driver does not have to

- 1.3.6 The investigation team noted that, when the friction tester was running, the level of the noise generated by the measurement wheel was quite high. Radio transmission could not be clearly heard even when the audio output level was set to maximum. The hearing difficulty was compounded by the intermittent sound of radio static from the radio set.

- 4.2 To reduce the noise interference to the driver of the runway friction tester when friction testing is being carried out, the aerodrome operator has replaced the sealant around the edge of the cover of the box that houses the measurement wheel and has also installed a backboard over the box.

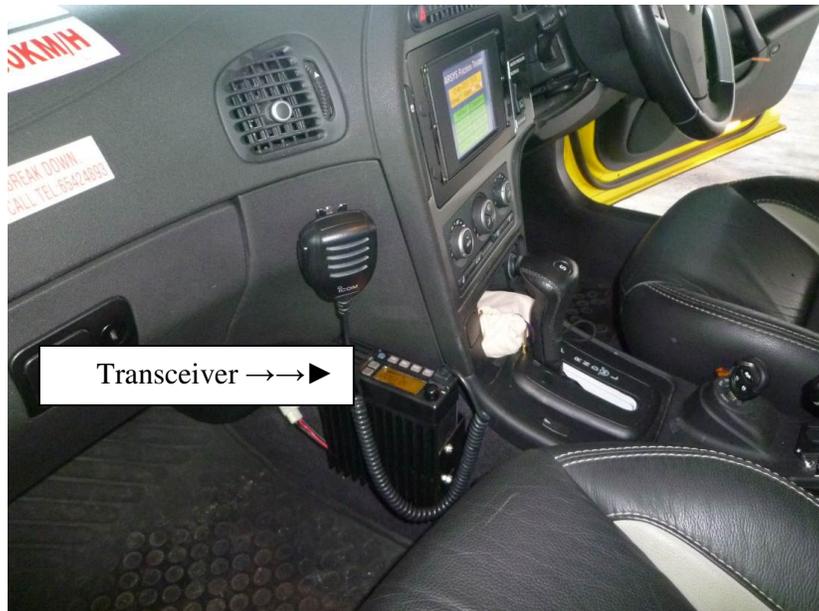
**Figure 3.** Position of the radio set

- 1.3.4 For two-way communication with the aerodrome control tower, the runway friction tester is equipped with a radio set. Although the radio set was within reach of the driver from his seat, it was positioned on the opposite of the vehicle's central pedestal (see **Figure 3**) and in such a way that it would be difficult for the driver to operate it (e.g. turning the tuning dial, viewing the frequency setting) without bending his body. Thus, if the driver needs to use the radio set for any reason during the friction test, he would need to abandon the test as he would not be able to drive straight and operate the radio set at the same time.

- 1.3.5 The radio set is a multi-band transceiver with many frequency selection possibilities. The radio set was not pre-selected to 121.9 MHz and 122.9 MHz.

- 4.1 The aerodrome operator intends to purchase an additional runway friction tester so that the Changi Airport and the Seletar Airport will each have its dedicated friction tester with the radio pre-selected to 121.9 MHz (for Changi Airport) and 122.9 MHz (for Seletar Airport). In the meantime, the aerodrome operator has added one radio set to the existing runway friction tester, so that one radio set is pre-selected to 121.9 MHz and one to 122.9 MHz and the frequencies are labelled accordingly to prevent human error in frequency selection. Also, the two radio sets are now mounted on the dashboard of the friction tester (instead of at the side of the central pedestal) for ease of operation.
